Infrared Thermography in Maintenance of Building Applied Photovoltaics

SUMMARY

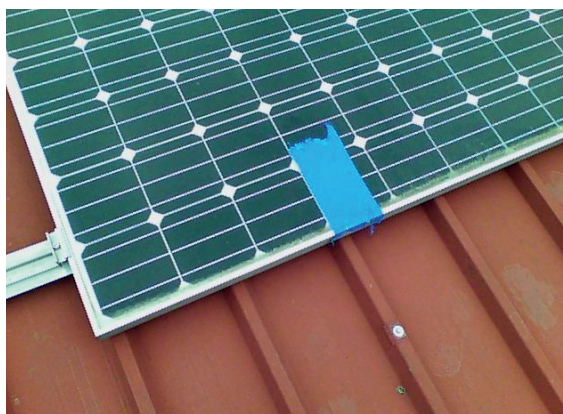
Figure 6. Shading of the panel cell

The example of shade cell in Figure 6, does not generate electromotive force and represents resistance to the flow of current from the other cells of the series, resulting with heat dissipation shown in Figure 7. The analysis was made with the FLIR E6 infrared thermal camera resolution of 160 x 120 pixels, 45 ° x 34 ° field of view, operating temperature range from -20 °C to 250 °C, noise equivalent temperature difference or NETD <0.06 °C, refresh rate of 9 Hz and accuracy of ± 2 % or 2 °C of reading, with a set emissivity of ε = 0.85 characteristics for glass. Despite the high emissivity of glass, the problem of reflection of IR radiation is not negligible, as indicated in the paper [7].

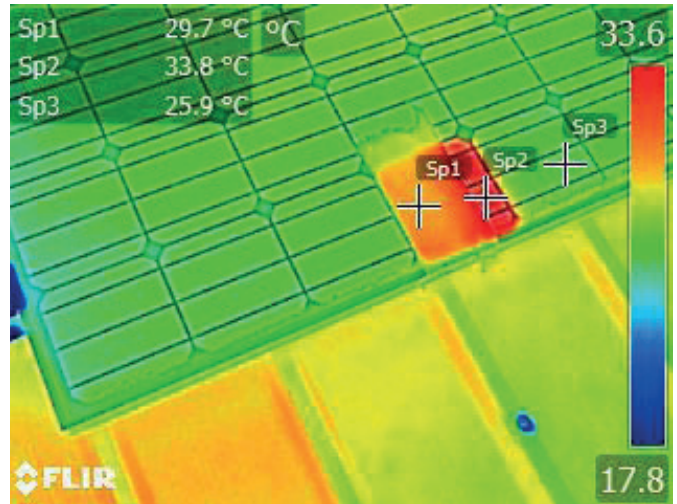
Figure 7. The thermographic pattern of the panel cell

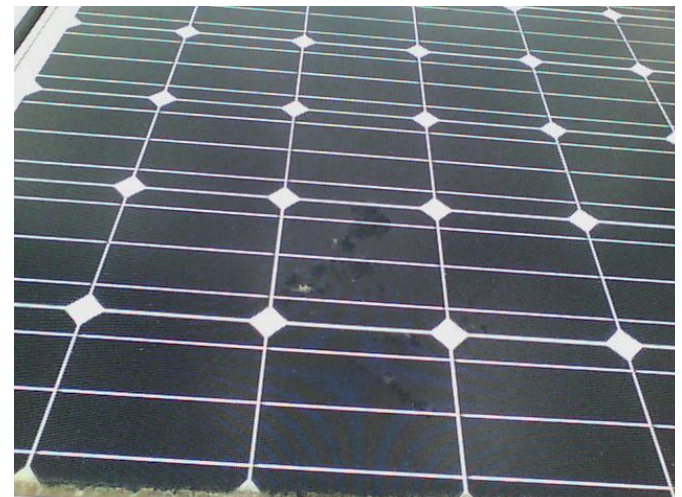
Figure 8. The surface of the panel covered with bird droppings

Shading of the PV panel does not have to be obvious in the visible part of the spectrum to be noticeable with an infrared thermal camera in the infrared part. Figure 8 shows the surface area covered with bird droppings. On the corresponding thermogram, a 1.6 °C apparent temperature increase

Bird droppings and accumulation of dust on panels lead to a decrease in production, but also to the different thermal stresses of individual cells, which cause cracking between the cells or the cells themselves. Therefore, periodic cleaning of the panel surface is important not only to maintain the production but also for the reliability of the system.

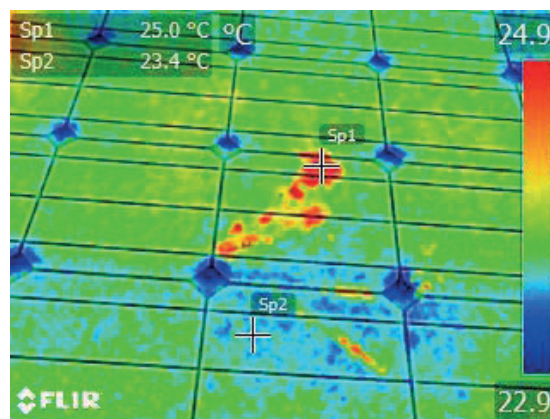
Figure 9. The thermal pattern reveals the position of the bird droppings

The above examples (illustrated in Figures 9 and 11, with temperature differences of 2 and more °C) according to Table II require observation. In the case of a connection box, the pattern will not change, but in the case of the bird droppings pattern disappears with the appearance of the first rain or PV panel cleaning. In Fig. 12, the panel temperature can be read at 24.6 °C and at the point of hotspot 41.2 °C. This is a temperature difference of almost 20 °C, which leads to the conclusion that the panel will most likely be replaced (Figure is an example from the FLIR Tools software).

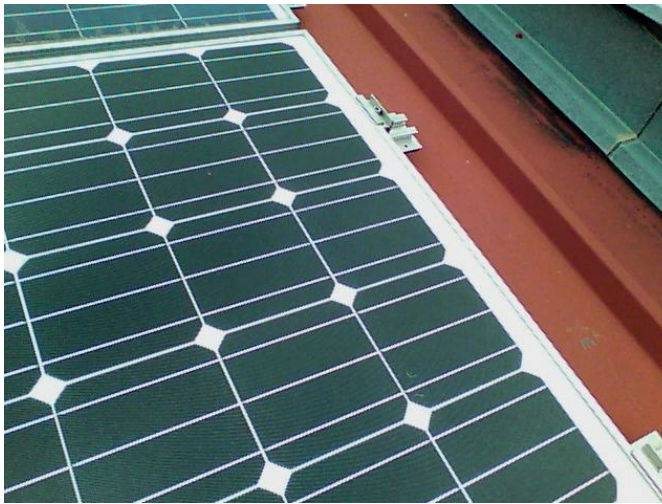
Figure 10. The side of a PV panel where the connection box is located

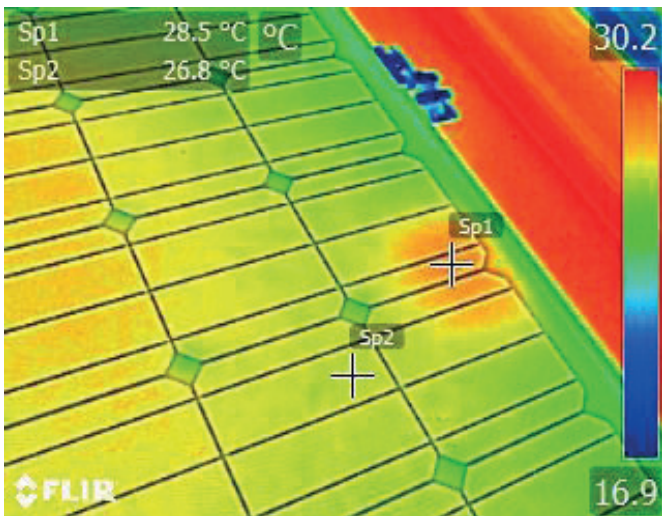
The PV panel cells are connected in the connection box by wires. The box is located at the bottom of the panel. Figure 11 shows the characteristic thermal pattern of the connection box. Because of the thermal resistance of the connection box, the place where the box is located is 1.7 °C warmer than the rest of the panel.

Figure 11. The thermal pattern of a PV panel connection terminal

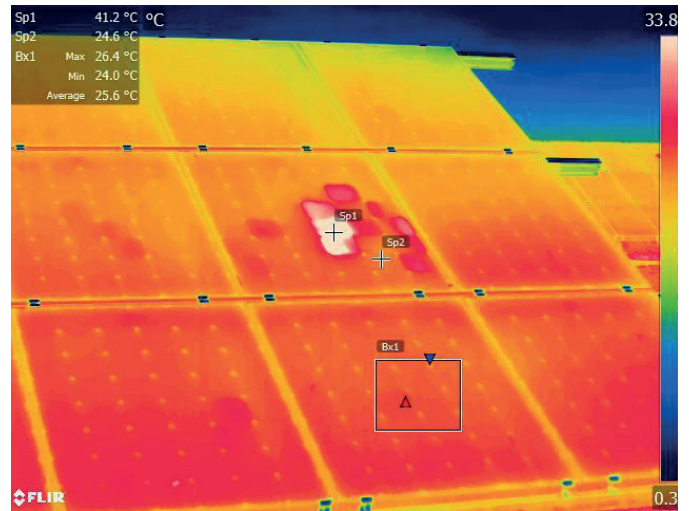
Figure 12. Thermal hot spot pattern, Source: FLIR Tools

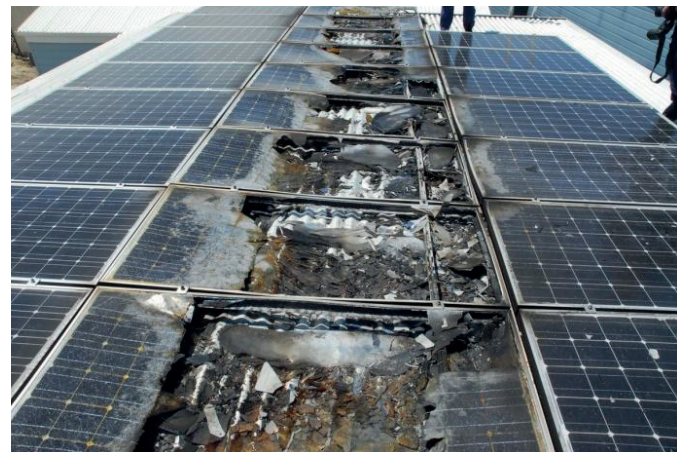
Monitoring the condition of the equipment is indispensable because defective equipment can lead to significant negative consequences. Figures 13 and 14 show the consequences of the defective PV system.

Figure 13. The consequence of fire on photovoltaic system, example [9]
