# Locating Hidden Elements in Walls of Cultural Heritage Buildings by Using Infrared Thermography

*Source / Izvornik:* **Buildings, 2019, 9**

**Journal article, Published version**

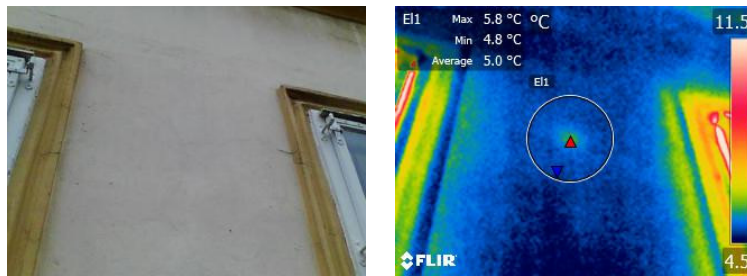
A weak dot heat bridge on the first floor was noticed (Figure 18). This was probably a result of the metallic anchorage (structural element) covered with plaster during the last facade maintenance.

Figure 18. Discovered weak point heat bridge.

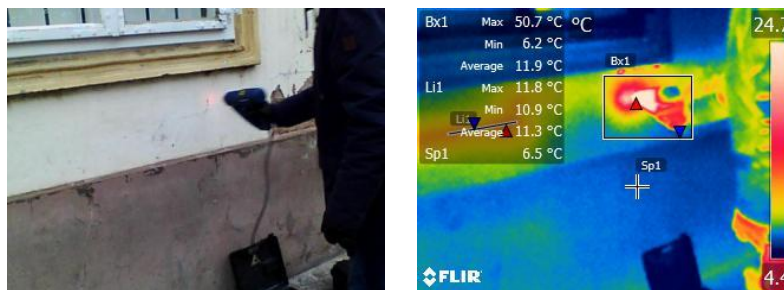
In order to determine the existence of discontinuity in the outer envelope, heating was applied, as is shown in Figure 19.

Figure 19. Initial application moment of thermal excitation.

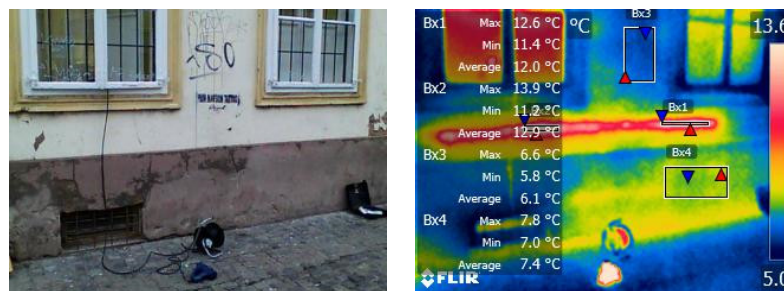
There was not any discontinuity by the analysis of the thermal pattern change. In Figure 20, a linear trace of the heating body, which is continuous and uninterrupted, can be observed.

Figure 20. Homogeneous thermal pattern on excitation along the wall.

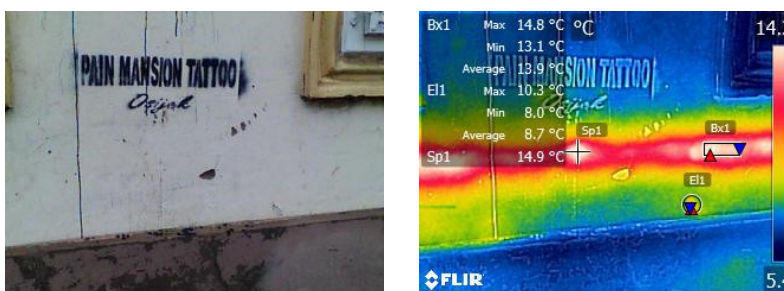
The detail below the left window in the lower left corner of the thermogram reveals that spot facade damage, due to a difference in emissivity, shows a higher apparent temperature (Figure 21).

Figure 21. Influence of damage to the thermal pattern.

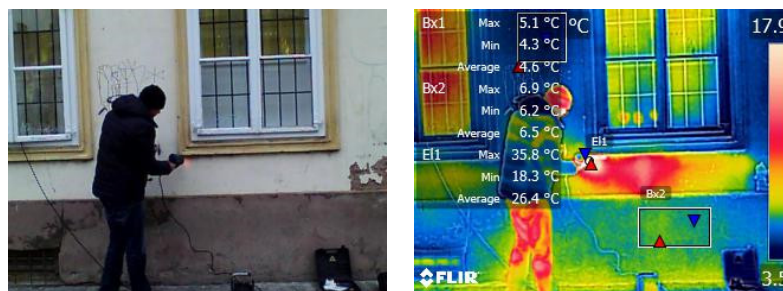
Increasing the area under the thermal excitation did not affect the result. The thermal pattern caused by the excitement was homogenous and uniformly disappeared over time (Figure 22).

Figure 22. Increasing the area of applied thermal excitation.

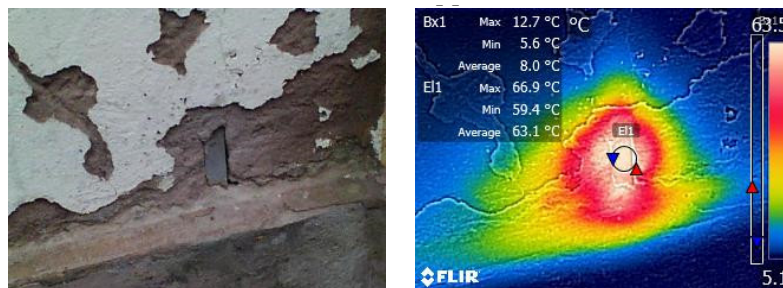
As no discontinuity in structural elements of a building was discovered, the conclusion was that there was no change of the analyzed area, or the method itself is not applicable because of the wall mass and thermal capacity. In the case of heating the lightning protection grounding line, the heating capacity of the wall and the surface character of the applied method were observed (Figure 23).

Figure 23. Thermal excitation of lightning protection installation.
