# Preliminary Observations on Historical Castle Trakošćan (Croatia) Performance under Recent $ML \geq 5.5$ Earthquakes

**Abstract:** Trakošćan Castle, built on a rocky peak in the late 13th century, is a cultural heritage site protected as a historical entity by the Republic of Croatia. The Castle is constructed as a highly irregular masonry structure with timber or shallow masonry arches, vaults or dome floors. It was substantially renewed, upgraded and partially retrofitted from the 16th century until the year 2000. The M5.5 (VIII EMS) and M6.2 (VIII-IX EMS) earthquakes, which struck the city of Zagreb on 22 March 2020 and the Pokupsko-Petrinja area on 29 December 2020, strongly shook the Castle's structure. Earthquake damage was observed and assessed by visual inspection accompanied by ambient vibration measurements. The slight cracks that appeared on masonry arches were found to be critically positioned, and can likely lead to the arches' collapse if their spreading is not prevented. Ambient vibration measurements, which were compared to pre-earthquake ones, revealed the decrease in the fundamental frequencies of the Castle's central tower unit and the second floor, thus possi

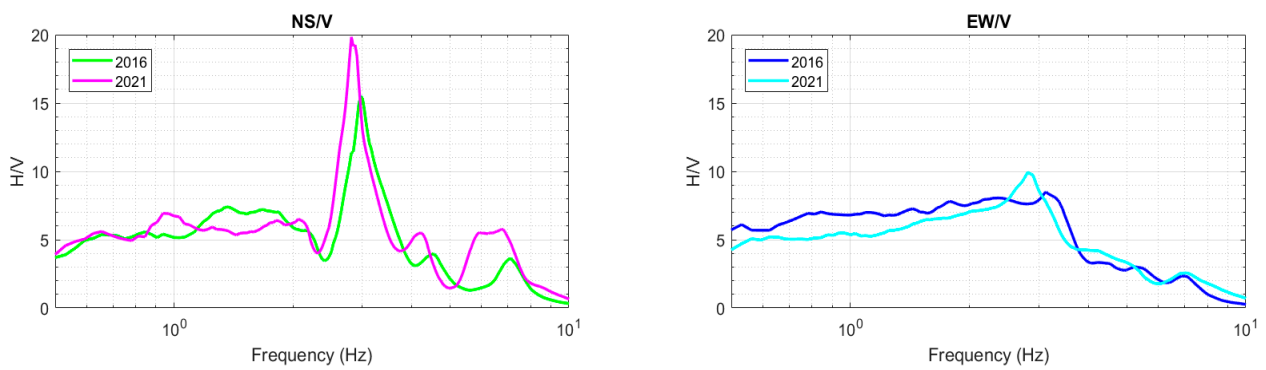
**Figure 6.** Comparison between ambient noise measurements carried out in 2016 and 2021 on the top of the Castle’s tower.

The cracking on the surface of the Castle's structural components indicates no severe or near-collapse structural damage. The measurements of the fundamental period of the structure (Figures 6–8 and Table 1), prior to and after the earthquake events, showed the period increase. This implies that the observed cracking is not related merely to the structural component's plaster coating, but for the structure itself as well. This will require further on-site assessment, as well as numerical and experimental analyses to assess the real condition of the building, which will be the basis for proposing adequate prevention and rehabilitation measures. Rigorous and detailed vulnerability assessment of such historic buildings and the implementation of appropriate retrofitting solutions can help to reduce the levels of physical damage, loss of life and the economic impact of future seismic events. However, we need to note that it is planned to install accelerometers for continuous measurement of microseismic noise and potential earthquakes inside selected buildings (one of them is Trakošćan Castle), which will help us to monitor if estimated dynamic characteristics of buildings and structural building integrity have been affected in the case of an earthquake. This is one of the objectives of the project SeisRICHerCRO.

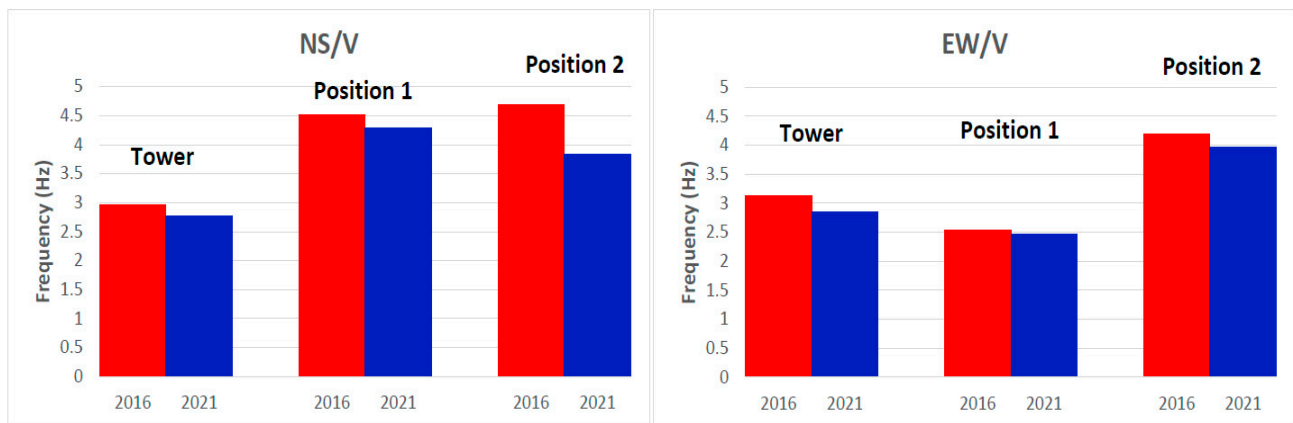
Bar charts in Figure 9 show that the change in fundamental frequency for the tower and 2nd floor (position 1) is not so significant as the change at the other location on the 2nd floor (position 2) for the average N/V component, where visible cracks were observed. Concerning the latter, the Zagreb M5.5 earthquake induced slight cracks that were spread after the Petrinja M6.2 earthquake. Therefore, the decrease in frequency may potentially suggest the loss of structural stiffness as a consequence of the earthquake damage assessed by visual inspection, accompanied by ambient vibration measurements.

**Figure 9.** Bar charts showing change in fundamental frequency on the Castle's tower, and 2nd floor positions 1 and 2.

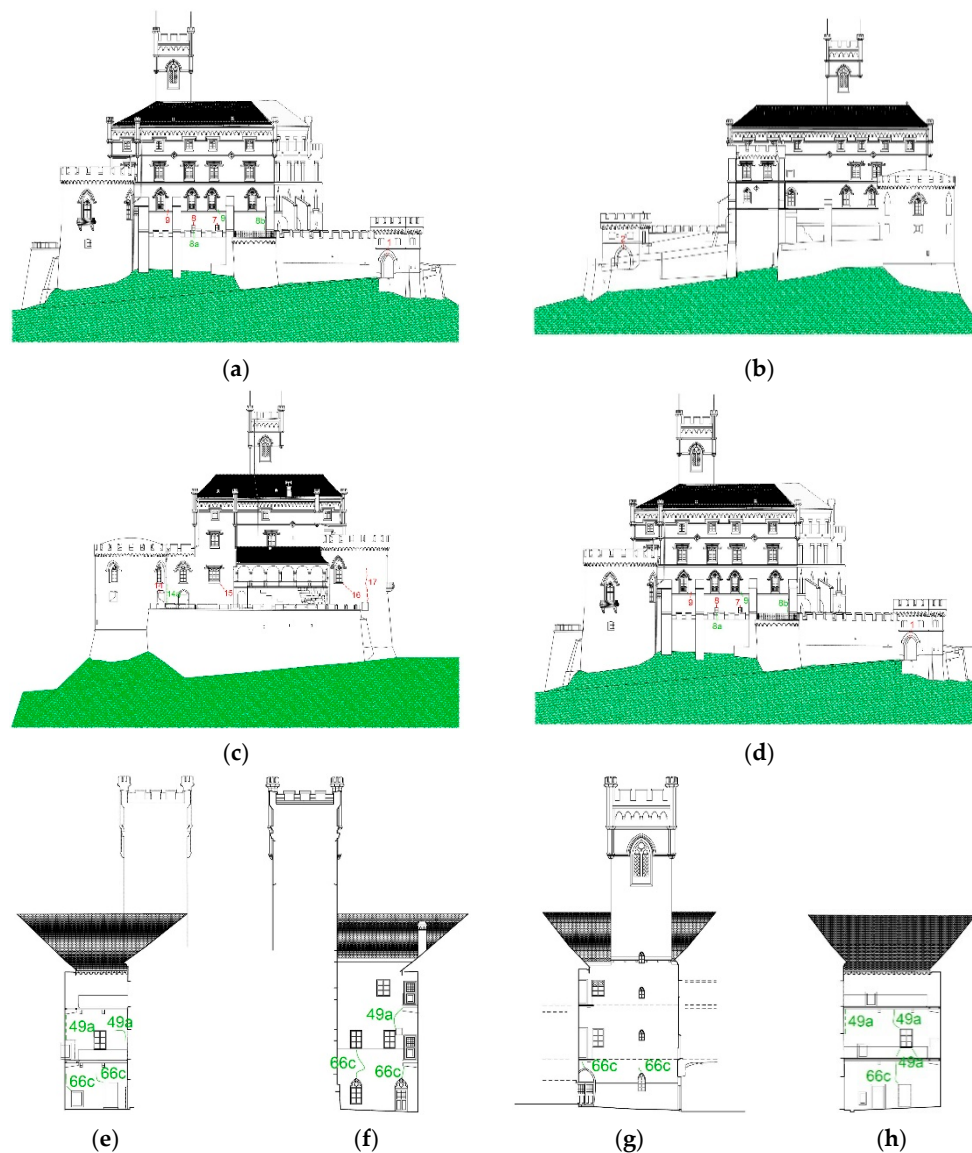
As shown in Figures 10 and 11, cracking was generally initiated in the vicinity of opening corners or wall ends, and spread throughout the building. The cracks in walls were mostly bound by fine oblique shear cracks. Based on the cracking type, distribution and characteristics (width, length, indentation, direction and location), damage to the building shown in Figures 10 and 11 belongs to the class of minor damage (Grade 1: Negligible to slight damage) in compliance with the EMS-98 scale [25]. Therefore, the observed damage does not pose a threat to the load-bearing capacity and usability of the building (see Figures 12–15 for examples).

**Figure 11.** Map of crack positions observed during the in situ visual inspection: (a) East façade; (b) West façade; (c) South façade; (d) North façade; (e) Inner east façade; (f) Inner west façade; (g) Inner south façade; (h) Inner north façade.
