Preliminary Observations on Historical Castle Trakošćan (Croatia) Performance under Recent $ML \geq 5.5$ Earthquakes

Abstract: Trakošćan Castle, built on a rocky peak in the late 13th century, is a cultural heritage site protected as a historical entity by the Republic of Croatia. The Castle is constructed as a highly irregular masonry structure with timber or shallow masonry arches, vaults or dome floors. It was substantially renewed, upgraded and partially retrofitted from the 16th century until the year 2000. The M5.5 (VIII EMS) and M6.2 (VIII-IX EMS) earthquakes, which struck the city of Zagreb on 22 March 2020 and the Pokupsko-Petrinja area on 29 December 2020, strongly shook the Castle's structure. Earthquake damage was observed and assessed by visual inspection accompanied by ambient vibration measurements. The slight cracks that appeared on masonry arches were found to be critically positioned, and can likely lead to the arches' collapse if their spreading is not prevented. Ambient vibration measurements, which were compared to pre-earthquake ones, revealed the decrease in the fundamental frequencies of the Castle's central tower unit and the second floor, thus possibly in

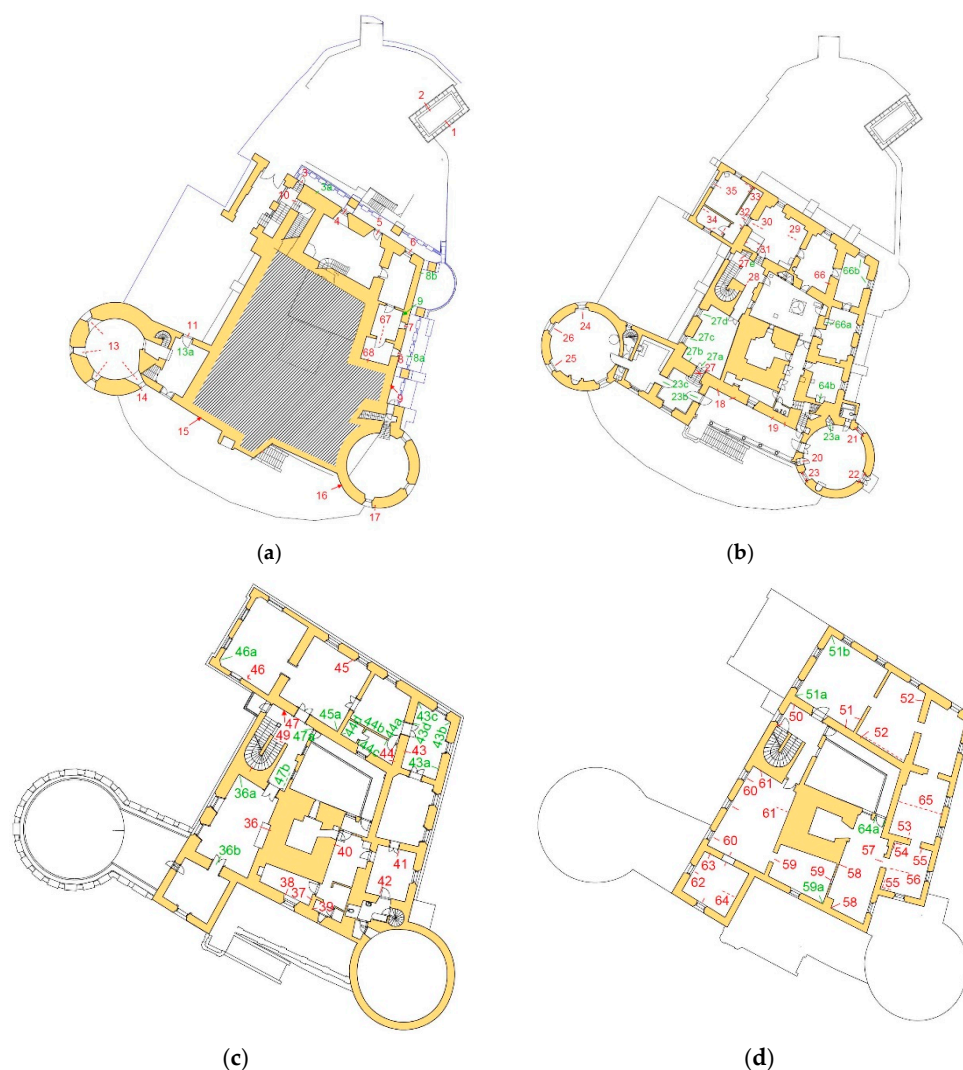
As shown in Figures 10 and 11, cracking was generally initiated in the vicinity of opening corners or wall ends, and spread throughout the building. The cracks in walls were mostly bound by fine oblique shear cracks. Based on the cracking type, distribution and characteristics (width, length, indentation, direction and location), damage to the building shown in Figures 10 and 11 belongs to the class of minor damage (Grade 1: Negligible to slight damage) in compliance with the EMS-98 scale [25]. Therefore, the observed damage does not pose a threat to the load-bearing capacity and usability of the building (see Figures 12–15 for examples).

The damage marked as 12 (see Figures 10 and 11) is a hairline tensile crack < 1 mm wide, formed at the apex of a shallow arch spanning 4.35 m, extending to adjacent arches, from which the arch assumes the corresponding part of the load. Although the crack does not indicate substantial to heavy damage according to the EMS-98 scale, due to the location of its occurrence (arch vertex), proper crack control measures should be taken. The damage marked as 52 (see Figures 10 and 11) is a crack < 3 mm wide, and represents slight damage to the part of the 2nd floor wall perpendicular to the outer wall on which the roof structure rests, and is also further weakened by the presence of chimneys. In the observed portion of the wall, the vertically continuous chimneys are placed within the wall. However, the gross wall thickness was kept the same as in the remaining portion of the wall. Therefore, due to the reduction in the net thickness of the wall, the chimneys represent the intrinsic lack of structural integrity of the particular wall or building itself. Figures 13 and 14 show the

Figure 10. Map of crack positions observed during the in situ visual inspection: (a) Basement; (b) Ground floor; (c) First floor; (d) Second floor (note: red colored marks designate the damage after the Zagreb M5.5 2020 earthquake and green colored marks designate damage after the Petrinja M6.2 2020 earthquake).

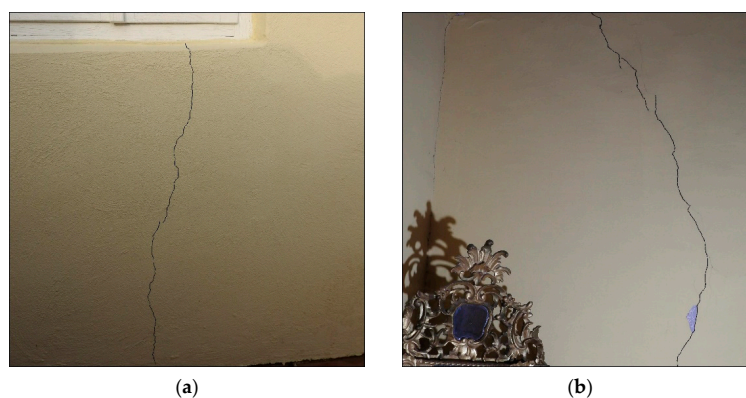
Figure 15. (a) Hairline crack of width < 1 mm in the crown of an arch (ID 12 in Figure 10a); (b) Crack of width < 3 mm on the 2nd floor wall (ID 52 in Figure 10d).
