A case study on influence of traffic-induced vibrations on buildings and residents

A CASE STUDY ON INFLUENCE OF TRAFFIC-INDUCED VIBRATIONS ON BUILDINGS AND RESIDENTS

Abstract: Vibrations induced by traffic on irregular or damaged pavement or tracks positioned near buildings, can be a source of annoyance for residents and source of damage to structural and non-structural elements. The traffic-induced vibrations, having different frequency content, propagate through the soil towards neighbouring buildings while attenuating in the process due to damping. However, when vibrations reach the basement wall or foundation of the building they are transmitted to upper floors and can be amplified in the process depending on the eigen frequencies of the building components. In this work, described is the procedure for experimental determination of the vibration measurement in comparison with the values allowed by the code provisions. Additionally an overview of the building damage due to traffic induced vibrations is given including the unavoidable description of the annoyance experienced by its residents.

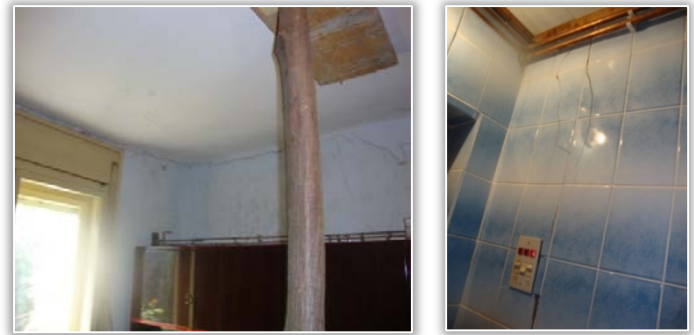
Presented are results for single building that suffered the most of the damage (see Figure 5). The building is a house with basement of dimensions 80 m², built in two parts (50 and 30 m²) with solid brick masonry without confining elements. The first, old part, was built 60 years ago, and second part was built several years ago. Due to age it is considered as sensitive building. The building is placed near road with 7 m distance to its closest point, and 19 m to its farthest. The foundation soil is rock. The building experienced both, the structural (collapse of storey slab in older part, cracks in outer and foundation wall) and the non-structural damage (cracking of windows, cracked ceramic tiles, displacement of roof tiles and rain water leakage).

Figure 5. Damage to the ceiling (left) and damage to the ceramic tiles (right)

To answer the question whether the traffic-induced vibrations caused the named building damage, measured quantities were compared to quantities prescribed by following standards: SN 64031a, DIN 4150 and ISO 2631 (see Tables 1 to 3).

The measurements confirmed the coincidence of building resonant frequency and dominant excitation frequency which can be served as a proof for the building damage. Additionally, the vibrations had disruptive and unbearable effect on residents.
