Infrared Thermography in Maintenance of Building Applied Photovoltaics

Glavaš, Hrvoje; Vidaković, Držislav; Jeršek, Željko; Kraus, Zorislav

Source / Izvornik: **Energija : časopis Hrvatske elektroprivrede, 2018, 67, 7 - 11**

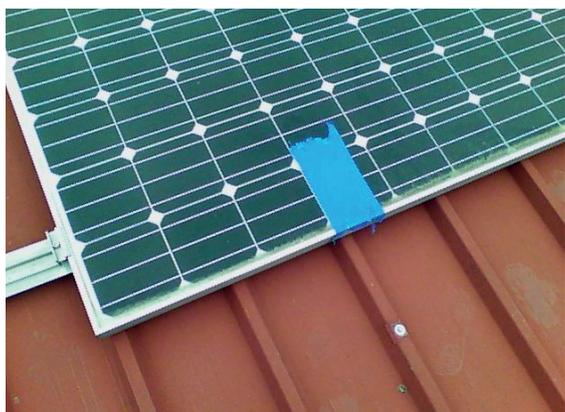
Figure 6. Shading of the panel cell

The example of shade cell in Figure 6, does not generate electromotive force and represents resistance to the flow of current from the other cells of the series, resulting with heat dissipation shown in Figure 7. The analysis was made with the FLIR E6 infrared thermal camera resolution of 160 x 120 pixels, 45 ° x 34 ° field of view, operating temperature range from -20 °C to 250 °C, noise equivalent temperature difference or NETD <0.06 °C, refresh rate of 9 Hz and accuracy of ± 2 % or 2 °C of reading, with a set emissivity of ε = 0.85 characteristics for glass. Despite the high emissivity of glass, the problem of reflection of IR radiation is not negligible, as indicated in the paper [7].

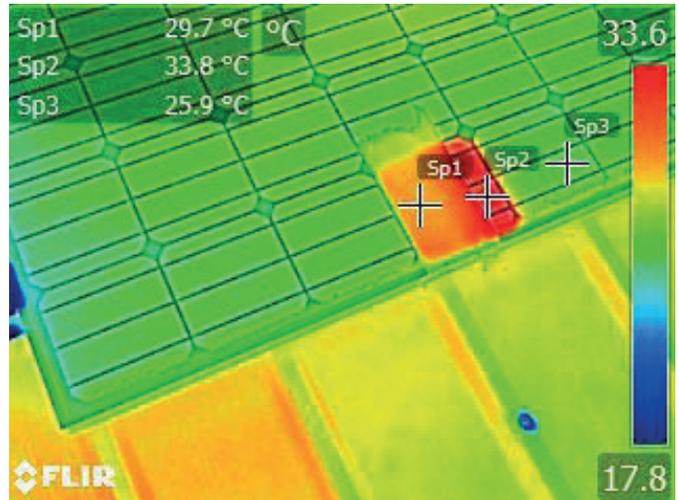
Figure 7. The thermographic pattern of the panel cell

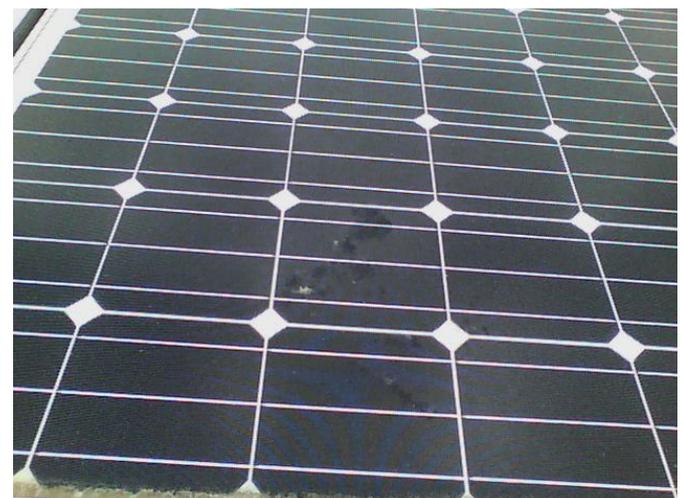
Figure 8. The surface of the panel covered with bird droppings

Shading of the PV panel does not have to be obvious in the visible part of the spectrum to be noticeable with an infrared thermal camera in the infrared part. Figure 8 shows the surface area covered with bird droppings. On the corresponding thermogram, a 1.6 °C apparent temperature increase

Bird droppings and accumulation of dust on panels lead to a decrease in production, but also to the different thermal stresses of individual cells, which cause cracking between the cells or the cells themselves. Therefore, periodic cleaning of the panel surface is important not only to maintain the production but also for the reliability of the system.

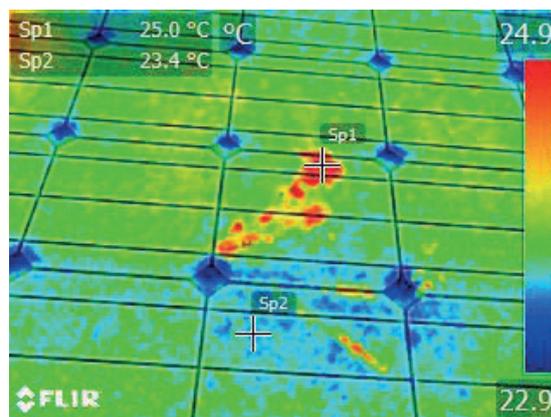
Figure 9. The thermal pattern reveals the position of the bird droppings

The above examples (illustrated in Figures 9 and 11, with temperature differences of 2 and more °C) according to Table II require observation. In the case of a connection box, the pattern will not change, but in the case of the bird droppings pattern disappears with the appearance of the first rain or PV panel cleaning. In Fig. 12, the panel temperature can be read at 24.6 °C and at the point of hotspot 41.2 °C. This is a temperature difference of almost 20 °C, which leads to the conclusion that the panel will most likely be replaced (Figure is an example from the FLIR Tools software).

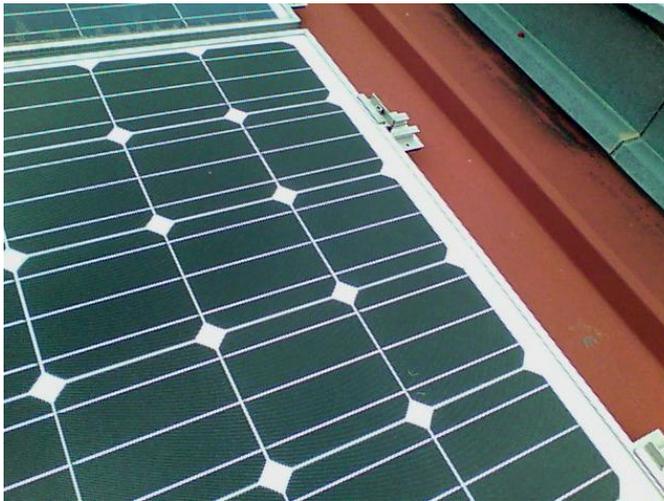
Figure 10. The side of a PV panel where the connection box is located

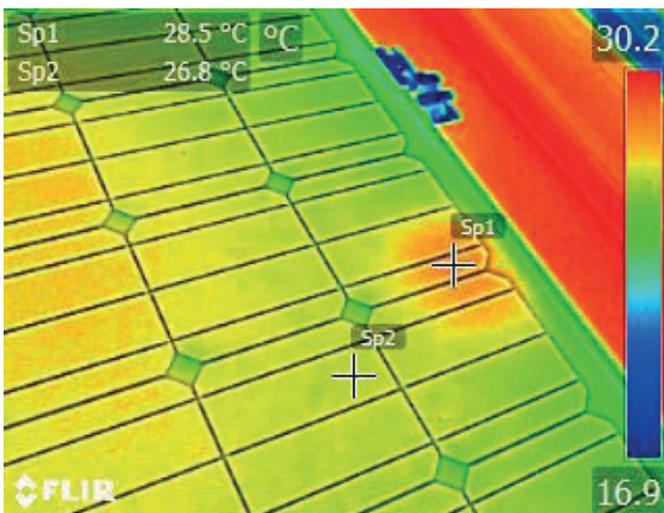
The PV panel cells are connected in the connection box by wires. The box is located at the bottom of the panel. Figure 11 shows the characteristic thermal pattern of the connection box. Because of the thermal resistance of the connection box, the place where the box is located is 1.7 °C warmer than the rest of the panel.

Figure 11. The thermal pattern of a PV panel connection terminal

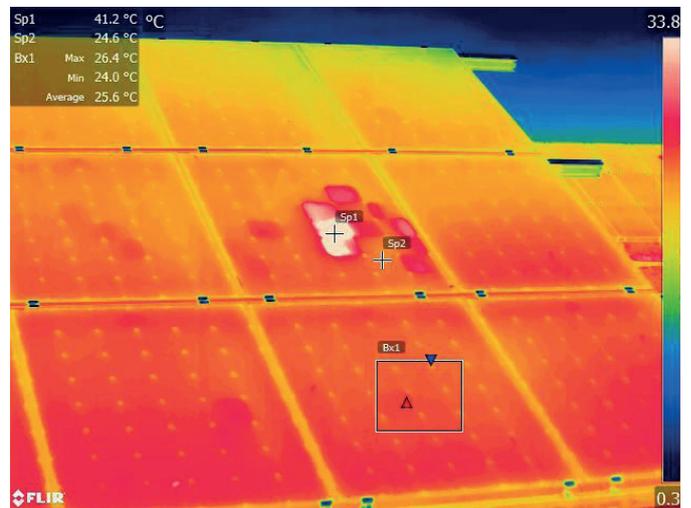
Figure 12. Thermal hot spot pattern, Source: FLIR Tools

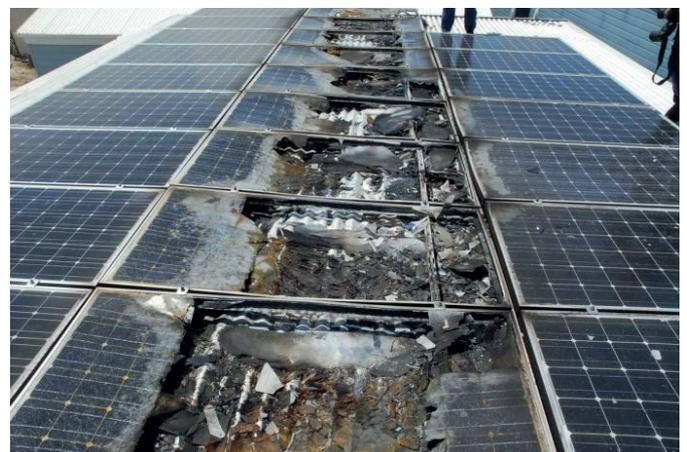
Monitoring the condition of the equipment is indispensable because defective equipment can lead to significant negative consequences. Figures 13 and 14 show the consequences of the defective PV system.

Figure 13. The consequence of fire on photovoltaic system, example [9]

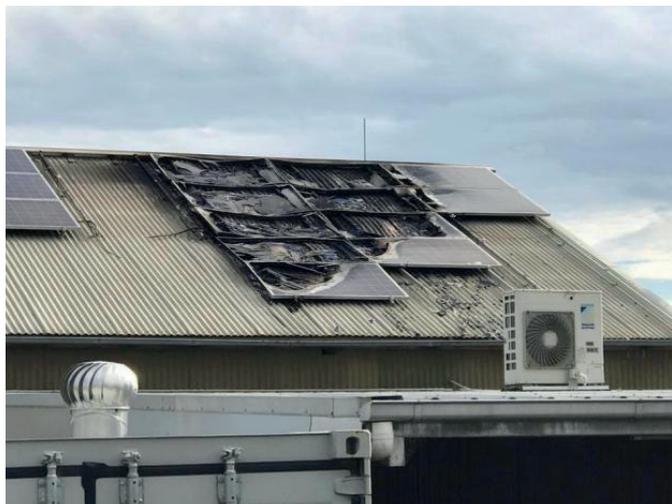
Figure 14. The consequence of fire on photovoltaic system, example, [10]
