# Locating Hidden Elements in Walls of Cultural Heritage Buildings by Using Infrared Thermography

*Source / Izvornik:* **Buildings, 2019, 9**

**Journal article, Published version**

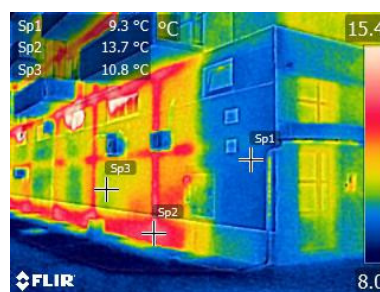
Qualitative thermography provides basic information about the temperature distribution on the surface of analyzed structures. The actual temperature values may differ significantly from those read on the camera. Figure 2 shows a residential building with the areas for commercial usage on the ground floor, where horizontal ties and structural elements are clearly visible, as well as a part of the staircase (bottom right corner of the building) which is not a heated space.

**Figure 2.** An example of highly-visible structural elements as well as a heated and an unheated space.

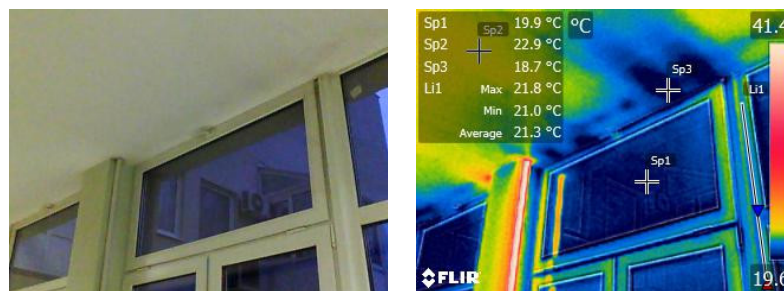
Passive thermography is a process of a thermographic analysis of structures that are in a steady state for a long period of time, i.e., in an environment where the temperature does not change. Of course, in the case of the structure in Figure 4, a temperature difference of at least 10 °C between the external and internal temperature is necessary to form a heat flow. Figure 5 shows the thermogram of the PVC opening on the outer envelope. The temperature of the structure/building is 22.9 °C; the temperature of the part of the ceiling under the infiltration of the outer air is 18.7 °C, and the reflected temperature from the glass is 19.9 °C because the glass is impervious to IC radiation, and it is difficult to measure the temperature on it correctly. The thermal reflection is best seen on the mirror image of the central heating pipe which is reflected on the surface of the glass. The line analysis on the PVC section of the carpentry shows an average temperature of 21.3 °C.

Figure 5. Thermogram of the openings in the outer envelope of the building.

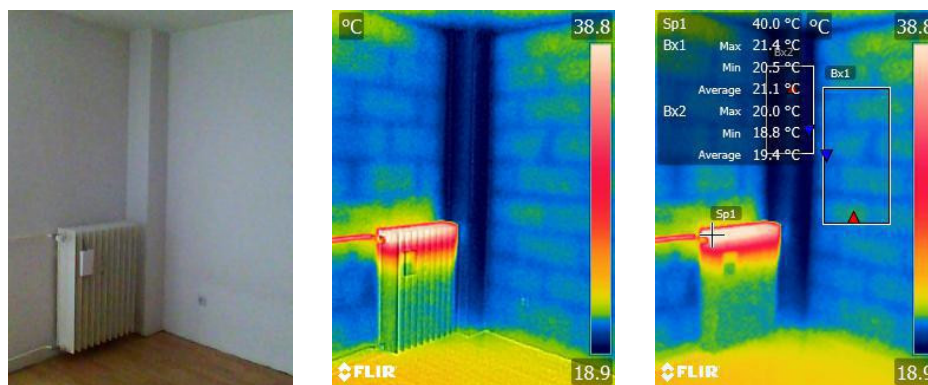
If the outer envelope is made of various materials, the heat flow will be different with different structural elements. Figure 6 shows the outer wall of a reinforced concrete multi-storey building whose walls are made of aerated concrete units. The average temperature on the aerated concrete units is 21.1 °C, while the difference between the unit and the binder is 0.9 °C. The temperature on the reinforced concrete bearing wall is 19.4 °C, with a temperature difference of 1.2 °C.

Figure 6. Thermal pattern of the outer wall.

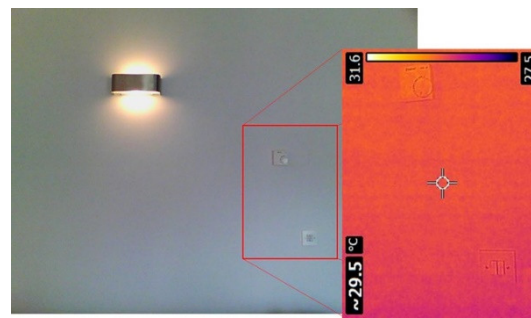
A third example of passive thermography is shown in Figure 7, illustrating the section of the partition wall in the stationary state the analysis was performed in. The mean measured temperature is 29.6 °C, with a difference of 0.7 °C between the maximum and the minimum reading value being attributed to the difference in the emissivity of the wall, switches and thermostats. Reflection of the surrounding sources exists as well, but to a lesser extent. The partition wall has no heat flow, and therefore, the temperature distribution over the surface is homogeneous. In the case of an inspected body that has the same temperature as the environment, as can be seen in Figure 7, active thermography is needed.

**Figure 7.** The partition wall and thermogram of the area where the hidden junction box is located.

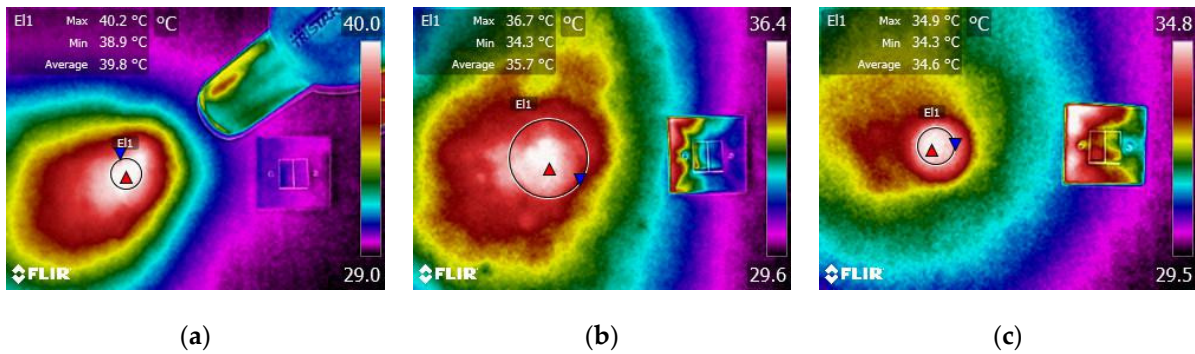
location of the hair dryer is presented in Figure 9a while the indication of the box position, as well as the structure of the bearing switch elements, can be seen in Figure 9b. Over time, the outline of the box contour can be clearly seen in Figure 9c.

Figure 9. Finding a hidden distribution box by means of thermal incentive.

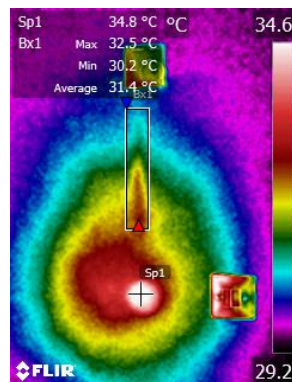
Figure 11. Thermogram of the hidden junction box.

In Figure 11, the position of the conductor under plaster is visible due to the material variation. It should be taken into account that, during the recording, the observed image is monochromatic and that, in most cases, it represents the sum of radiation in the IR spectrum. The advantages of using an IR thermal camera in finding a power supply cable can be seen in Figure 12, where materials of similar characteristics were used, namely plaster and gypsum.

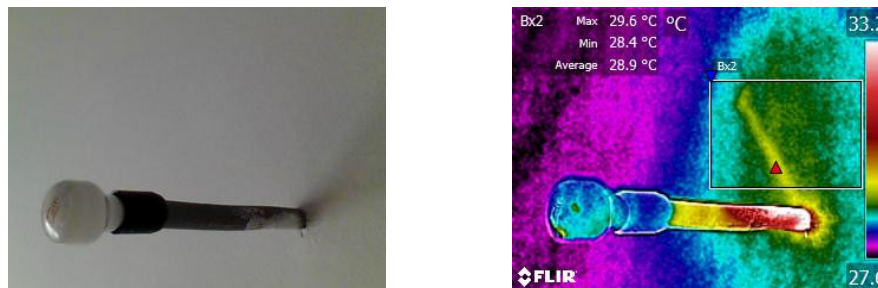
**Figure 12.** Finding a power supply cable with active thermography.

The position of the power supply cable can be often observed by applying thermal excitation. When installing a lighting fixture, the danger accidental mechanical damage of a power supply cable is, in that case, reduced to a minimum. Encouraged by the previously described experiments with thermal step excitation, the idea for research regarding finding hidden elements in historical buildings was initiated.

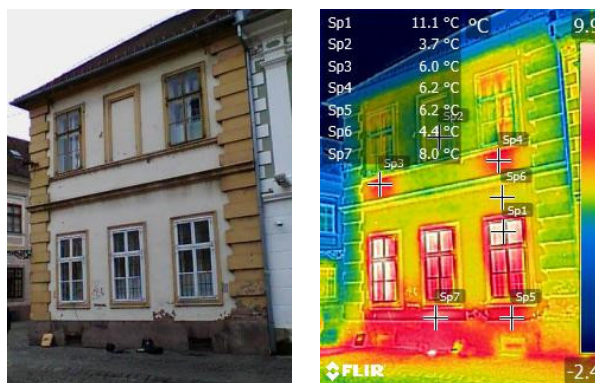
**Figure 16.** Thermogram of the whole building.

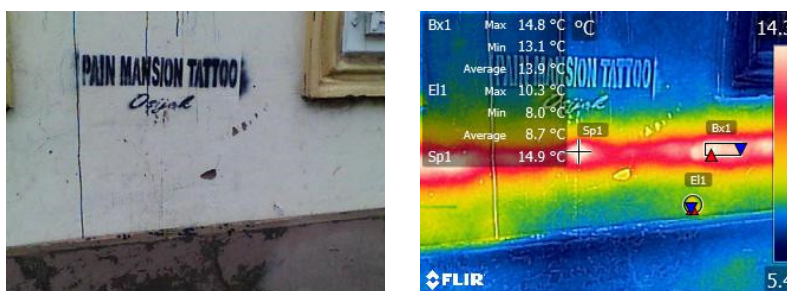
The detail below the left window in the lower left corner of the thermogram reveals that spot facade damage, due to a difference in emissivity, shows a higher apparent temperature (Figure 21).

Figure 21. Influence of damage to the thermal pattern.

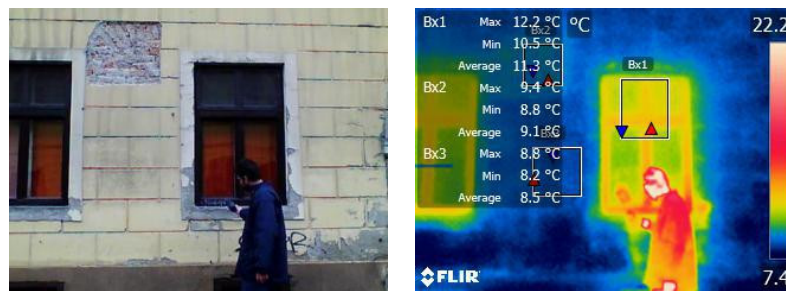
Figure 24. Termogram of Kostić house in 23 Kuhačeva Street.

By analyzing the thermal pattern shown in Figure 24, the difference in the probing area, as a result of the difference in emissivity, is evident. The expected discontinuity observed by probing did not appear during the heat excitation of the parapet wall (Figure 25a). As can be seen from Figure 25b, a further line heating process raised the wall temperature but did not result in a change in the thermal pattern. During the heating and during the time, the thermal pattern seemed to be inhomogeneous, albeit in a manner that corresponds to the presence of moisture, rather than non-discontinuity in the structural elements. By analyzing the smaller parts of the wall, no additional information (as shown in Figure 25c) was obtained.

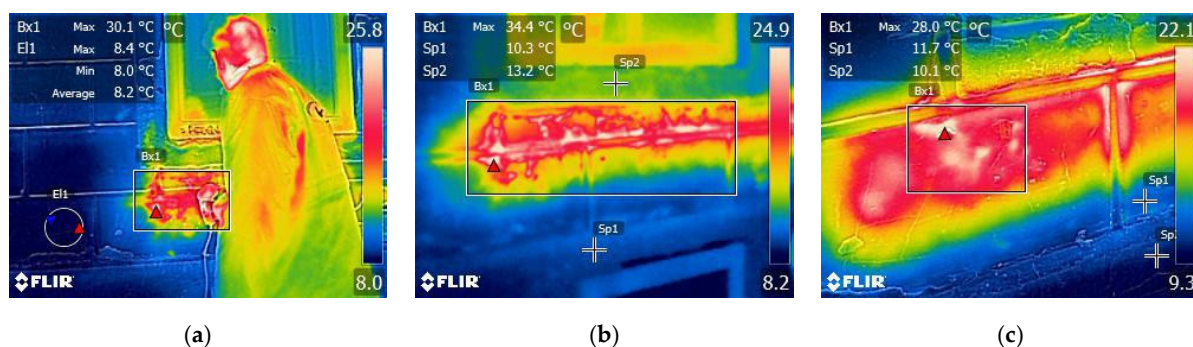
Figure 25. Changing the thermal pattern due to heating.

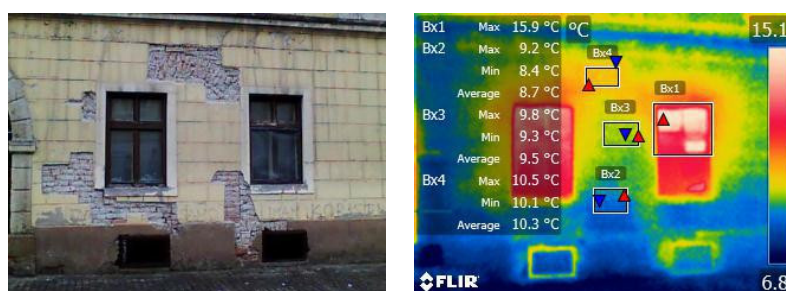
After looking at the bricked up openings as well as wall probing (Figure 26) and the associated thermal pattern, it is obvious that the thermographic analysis was not as effective in finding the bricked up openings in the massive homogeneous structures of the brick wall.

Figure 26. Thermogram of the probing building part of a known wall structure.
