# Locating Hidden Elements in Walls of Cultural Heritage Buildings by Using Infrared Thermography

**Abstract:** The structure of Tvrđa and its buildings date back to the Middle Ages. Tvrđa represents the Old Town of the city of Osijek and the best-preserved and largest ensemble of Baroque buildings in Croatia. After the withdrawal of the Ottomans in 1687, during the 18th century, the Austro-Hungarian administration systematically formed a new fortification system, regulated streets and squares and built a large number of military objects. Tvrđa took its present form in the 19th century and has kept it since then. Investigating the historical development of individual buildings, in addition to archival sources and existing architectural documentation, the obvious source of information are the buildings themselves. The aim of this paper is to explore the possibilities of using infrared thermography to find structural elements and hidden openings in historic buildings in Osijek's Tvrđa. This paper describes the exploration of the 18th century openings on the facades of the former Kostić houses. The facades were bricked into the walls in the 19th century because houses were reused and

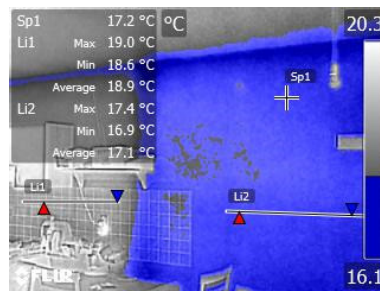
Another example of an outer envelope can be seen in Figure 3, with the area where the insulation is missing colored in blue. It is evident that the wall temperature in the areas with and without insulation vary in the range of 2 °C.

**Figure 3.** Absence of the outer envelope insulation through a homogenous thermal flow analysis.

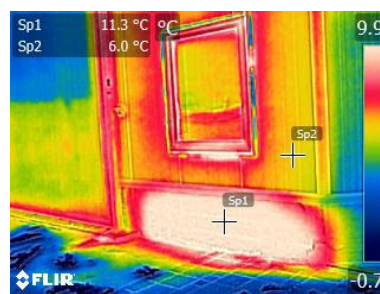
The lack of adequate insulation on the overhead wall of the industrial facility suggests the existence of an omission that resulted in increased thermal loss (Figure 4). The cooler areas on the pavement are the parts covered with water that, by its evaporation, takes away thermal energy and ostensibly represents an area of lower temperature.

**Figure 4.** Lack of insulation of the outer envelope in front of the radiator.

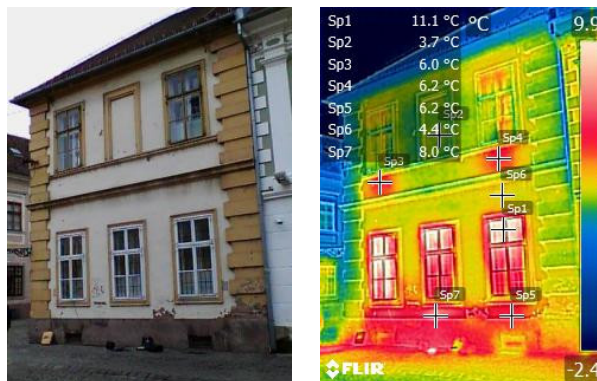
**Figure 16.** Thermogram of the whole building.

The wall thickness of the analyzed building is 74 cm, and the thickness of the parapet below the window, where the heating elements of the city’s central heating are located, is 36 cm. From the thermogram in Figure 16, it can be seen that the building is heated at the project temperature. The thermogram also shows the position of the radiators on parapet walls under the window. In Figure 16, the thermal image shows that the interior windows on the ground floor are open, since the space is used for the post office, and a greater amount of fresh air is required.

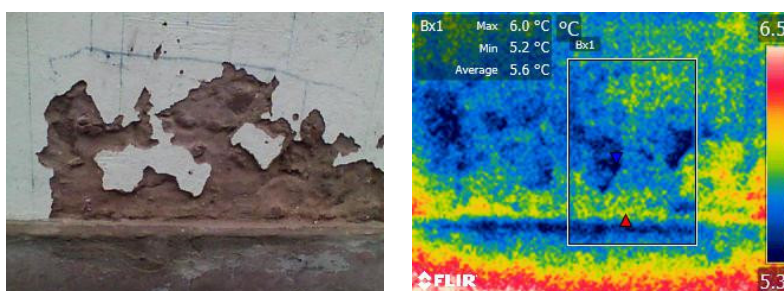
The outer envelope (i.e., the facade) has not been renewed since the 1980s. An additional analysis on the parts of the envelope with visible damage was carried out, but the conclusion that can be provided is that the shape of the damage does not strictly correlate with the thermal pattern (Figure 17).

**Figure 17.** Analysis of facade damage.

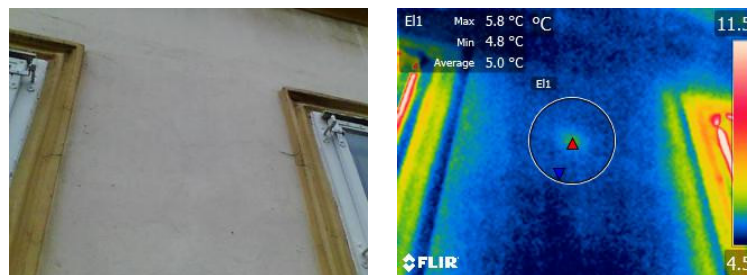
A weak dot heat bridge on the first floor was noticed (Figure 18). This was probably a result of the metallic anchorage (structural element) covered with plaster during the last facade maintenance.

Figure 18. Discovered weak point heat bridge.

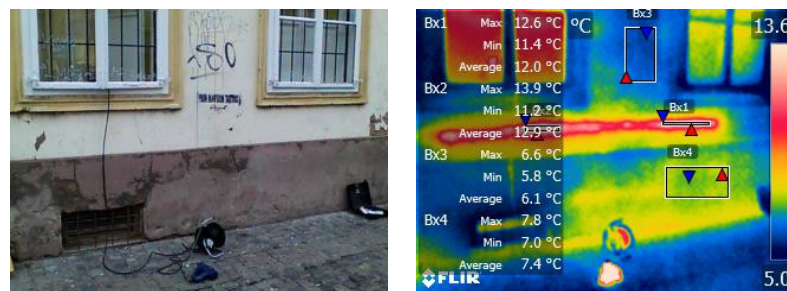
There was not any discontinuity by the analysis of the thermal pattern change. In Figure 20, a linear trace of the heating body, which is continuous and uninterrupted, can be observed.

Figure 20. Homogeneous thermal pattern on excitation along the wall.

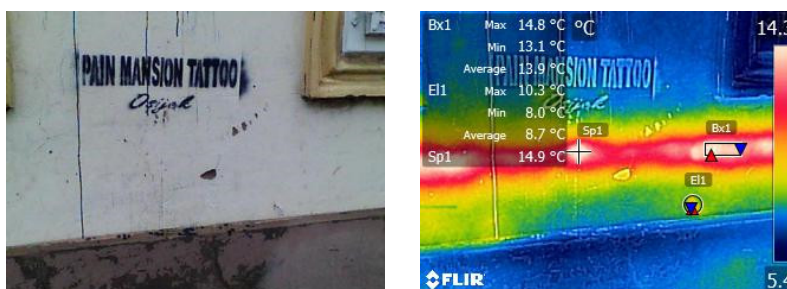
The detail below the left window in the lower left corner of the thermogram reveals that spot facade damage, due to a difference in emissivity, shows a higher apparent temperature (Figure 21).

Figure 21. Influence of damage to the thermal pattern.

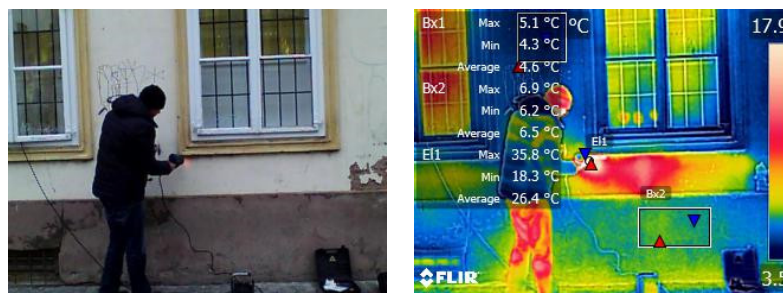
Increasing the area under the thermal excitation did not affect the result. The thermal pattern caused by the excitement was homogenous and uniformly disappeared over time (Figure 22).

Figure 22. Increasing the area of applied thermal excitation.

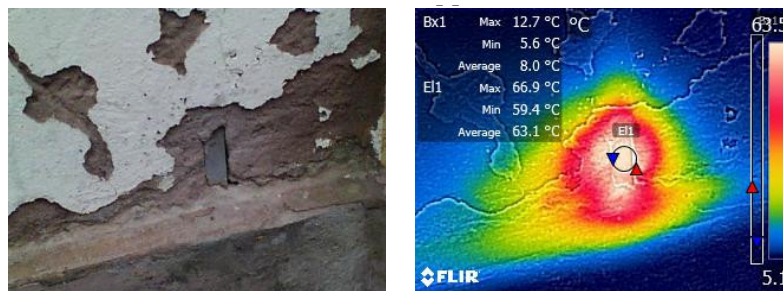
As no discontinuity in structural elements of a building was discovered, the conclusion was that there was no change of the analyzed area, or the method itself is not applicable because of the wall mass and thermal capacity. In the case of heating the lightning protection grounding line, the heating capacity of the wall and the surface character of the applied method were observed (Figure 23).

Figure 23. Thermal excitation of lightning protection installation.

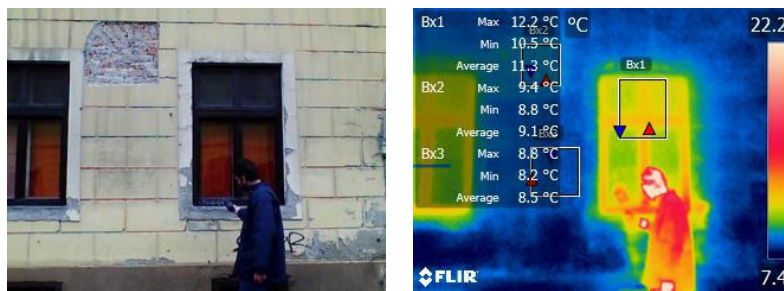
Figure 24. Termogram of Kostić house in 23 Kuhačeva Street.

By analyzing the thermal pattern shown in Figure 24, the difference in the probing area, as a result of the difference in emissivity, is evident. The expected discontinuity observed by probing did not appear during the heat excitation of the parapet wall (Figure 25a). As can be seen from Figure 25b, a further line heating process raised the wall temperature but did not result in a change in the thermal pattern. During the heating and during the time, the thermal pattern seemed to be inhomogeneous, albeit in a manner that corresponds to the presence of moisture, rather than non-discontinuity in the structural elements. By analyzing the smaller parts of the wall, no additional information (as shown in Figure 25c) was obtained.

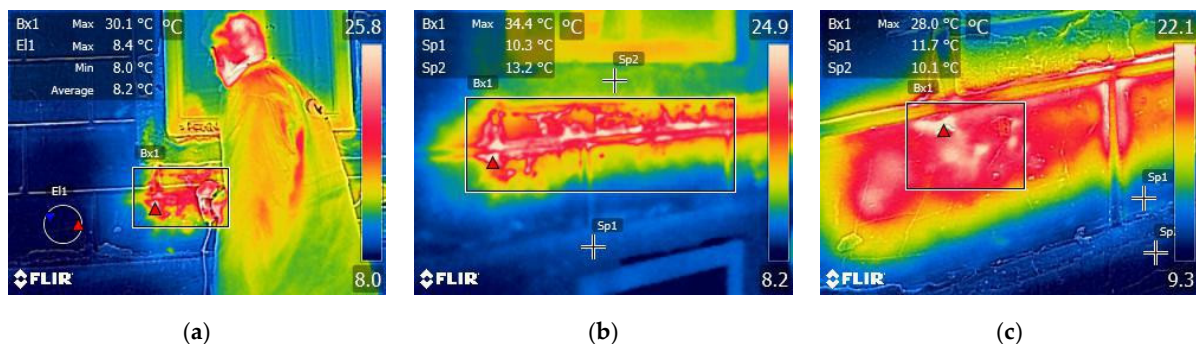
Figure 25. Changing the thermal pattern due to heating.

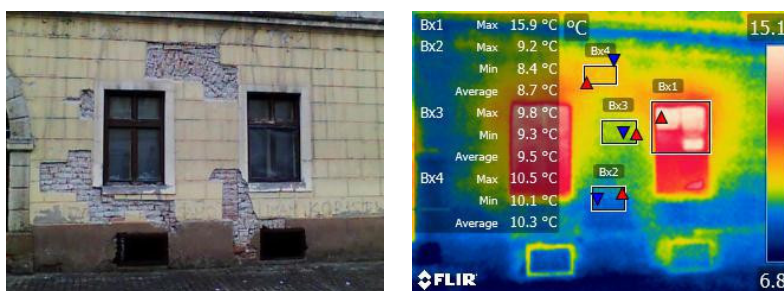
After looking at the bricked up openings as well as wall probing (Figure 26) and the associated thermal pattern, it is obvious that the thermographic analysis was not as effective in finding the bricked up openings in the massive homogeneous structures of the brick wall.

Figure 26. Thermogram of the probing building part of a known wall structure.

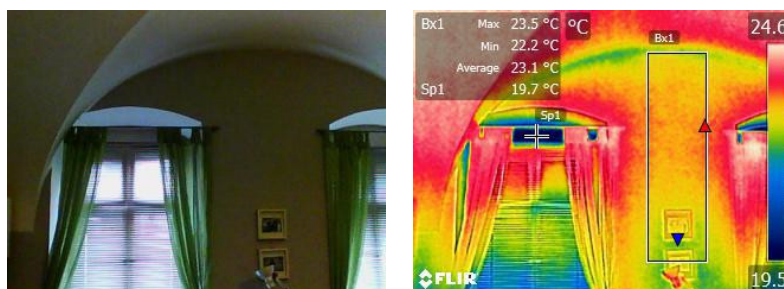
In order to confirm the conclusions, the examined place was checked from the inside of the building. Significant thermal masses and continuous heating have resulted in a constant thermal pattern, presented in Figure 27.

**Figure 27.** Thermal pattern on the inside of the wall.
