# Preliminary Observations on Historical Castle Trakošćan (Croatia) Performance under Recent $ML \geq 5.5$ Earthquakes

**Abstract:** Trakošćan Castle, built on a rocky peak in the late 13th century, is a cultural heritage site protected as a historical entity by the Republic of Croatia. The Castle is constructed as a highly irregular masonry structure with timber or shallow masonry arches, vaults or dome floors. It was substantially renewed, upgraded and partially retrofitted from the 16th century until the year 2000. The M5.5 (VIII EMS) and M6.2 (VIII-IX EMS) earthquakes, which struck the city of Zagreb on 22 March 2020 and the Pokupsko-Petrinja area on 29 December 2020, strongly shook the Castle's structure. Earthquake damage was observed and assessed by visual inspection accompanied by ambient vibration measurements. The slight cracks that appeared on masonry arches were found to be critically positioned, and can likely lead to the arches' collapse if their spreading is not prevented. Ambient vibration measurements, which were compared to pre-earthquake ones, revealed the decrease in the fundamental frequencies of the Castle's central tower unit and the second floor, thus possi

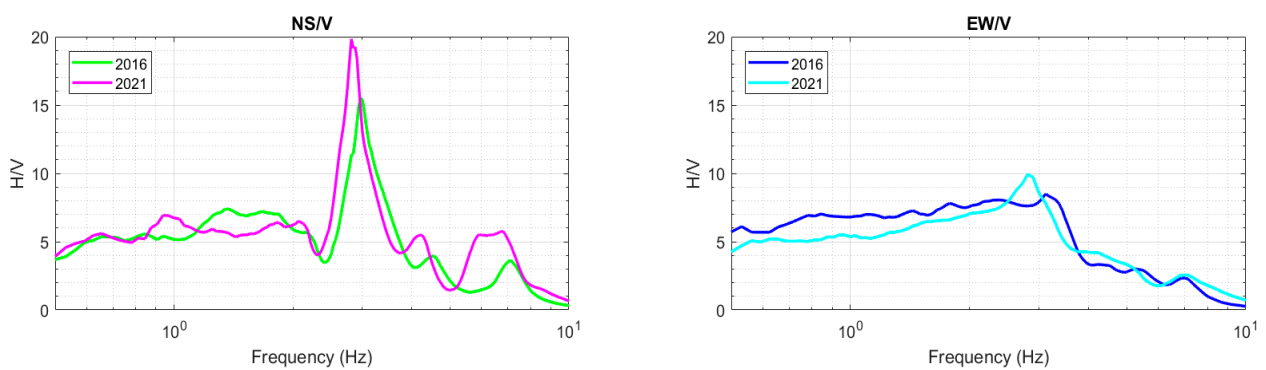
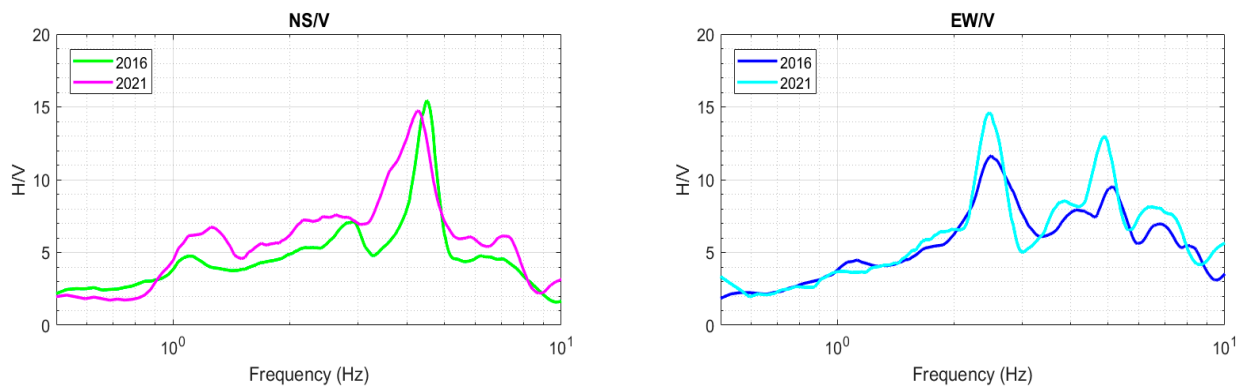
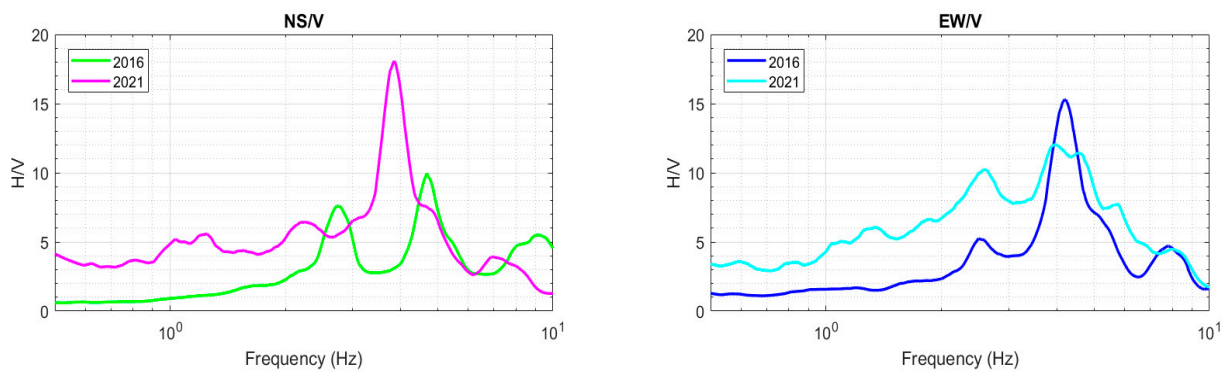
**Figure 6.** Comparison between ambient noise measurements carried out in 2016 and 2021 on the top of the Castle’s tower.

Figure 7. Comparison between ambient noise measurements carried out in 2016 and 2021 on the Castle’s 2nd floor, position 1.

Figure 8. Comparison between ambient noise measurements carried out in 2016 and 2021 on the Castle’s 2nd floor, position 2.

The cracking on the surface of the Castle's structural components indicates no severe or near-collapse structural damage. The measurements of the fundamental period of the structure (Figures 6–8 and Table 1), prior to and after the earthquake events, showed the period increase. This implies that the observed cracking is not related merely to the structural component's plaster coating, but for the structure itself as well. This will require further on-site assessment, as well as numerical and experimental analyses to assess the real condition of the building, which will be the basis for proposing adequate prevention and rehabilitation measures. Rigorous and detailed vulnerability assessment of such historic buildings and the implementation of appropriate retrofitting solutions can help to reduce the levels of physical damage, loss of life and the economic impact of future seismic events. However, we need to note that it is planned to install accelerometers for continuous measurement of microseismic noise and potential earthquakes inside selected buildings (one of them is Trakošćan Castle), which will help us to monitor if estimated dynamic characteristics of buildings and structural building integrity have been affected in the case of an earthquake. This is one of the objectives of the project SeisRICHerCRO.

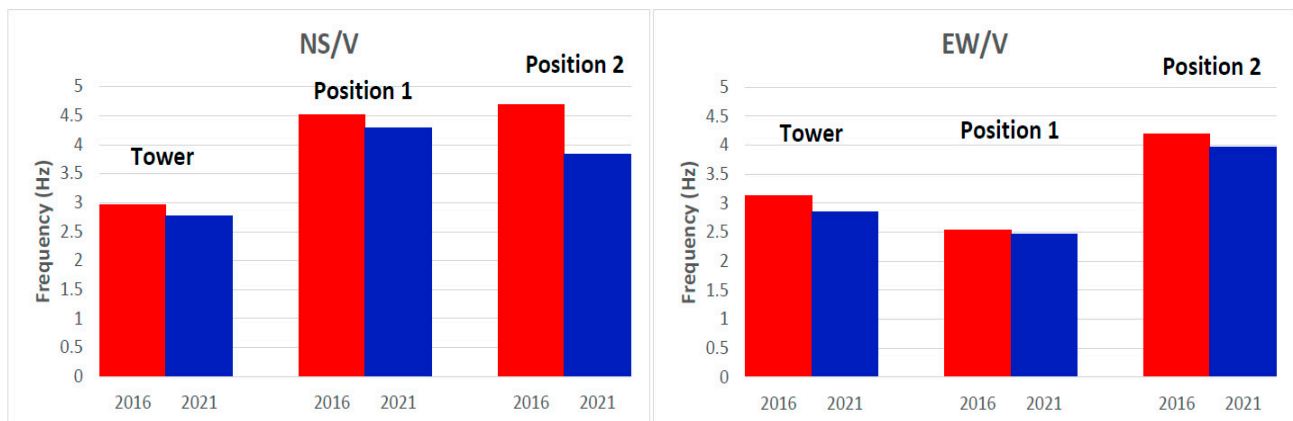
Bar charts in Figure 9 show that the change in fundamental frequency for the tower and 2nd floor (position 1) is not so significant as the change at the other location on the 2nd floor (position 2) for the average N/V component, where visible cracks were observed. Concerning the latter, the Zagreb M5.5 earthquake induced slight cracks that were spread after the Petrinja M6.2 earthquake. Therefore, the decrease in frequency may potentially suggest the loss of structural stiffness as a consequence of the earthquake damage assessed by visual inspection, accompanied by ambient vibration measurements.

**Figure 9.** Bar charts showing change in fundamental frequency on the Castle's tower, and 2nd floor positions 1 and 2.

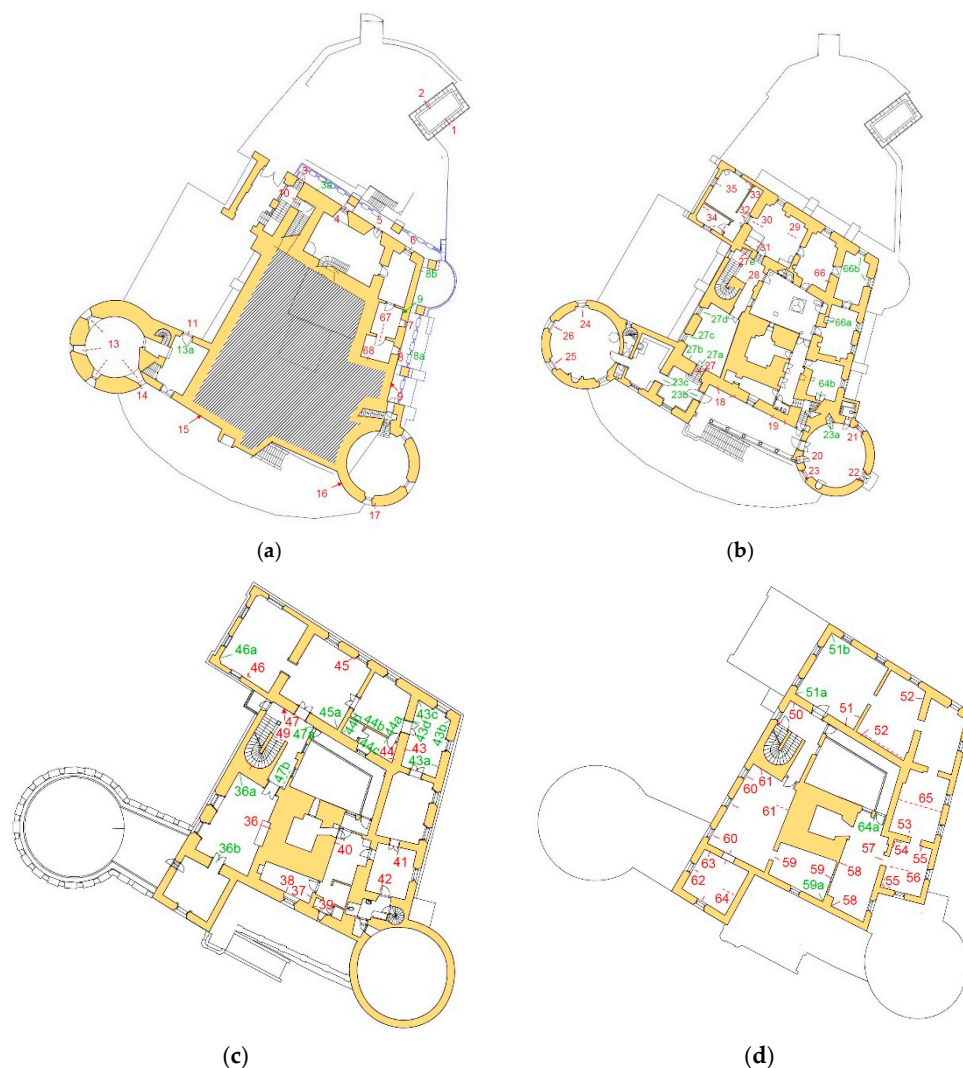
As shown in Figures 10 and 11, cracking was generally initiated in the vicinity of opening corners or wall ends, and spread throughout the building. The cracks in walls were mostly bound by fine oblique shear cracks. Based on the cracking type, distribution and characteristics (width, length, indentation, direction and location), damage to the building shown in Figures 10 and 11 belongs to the class of minor damage (Grade 1: Negligible to slight damage) in compliance with the EMS-98 scale [25]. Therefore, the observed damage does not pose a threat to the load-bearing capacity and usability of the building (see Figures 12–15 for examples).

**Figure 10.** Map of crack positions observed during the in situ visual inspection: (a) Basement; (b) Ground floor; (c) First floor; (d) Second floor (note: red colored marks designate the damage after the Zagreb M5.5 2020 earthquake and green colored marks designate damage after the Petrinja M6.2 2020 earthquake).

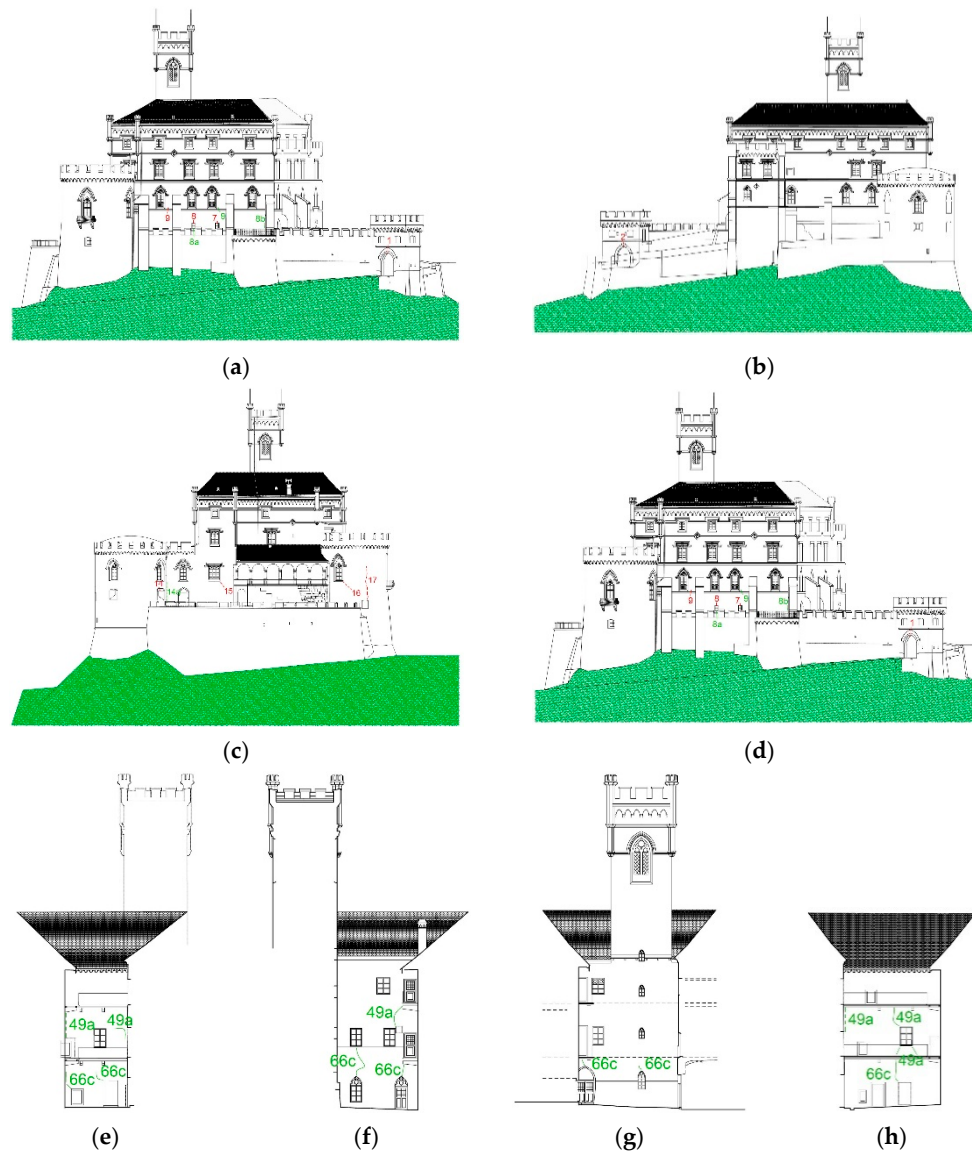
**Figure 11.** Map of crack positions observed during the in situ visual inspection: (a) East façade; (b) West façade; (c) South façade; (d) North façade; (e) Inner east façade; (f) Inner west façade; (g) Inner south façade; (h) Inner north façade.

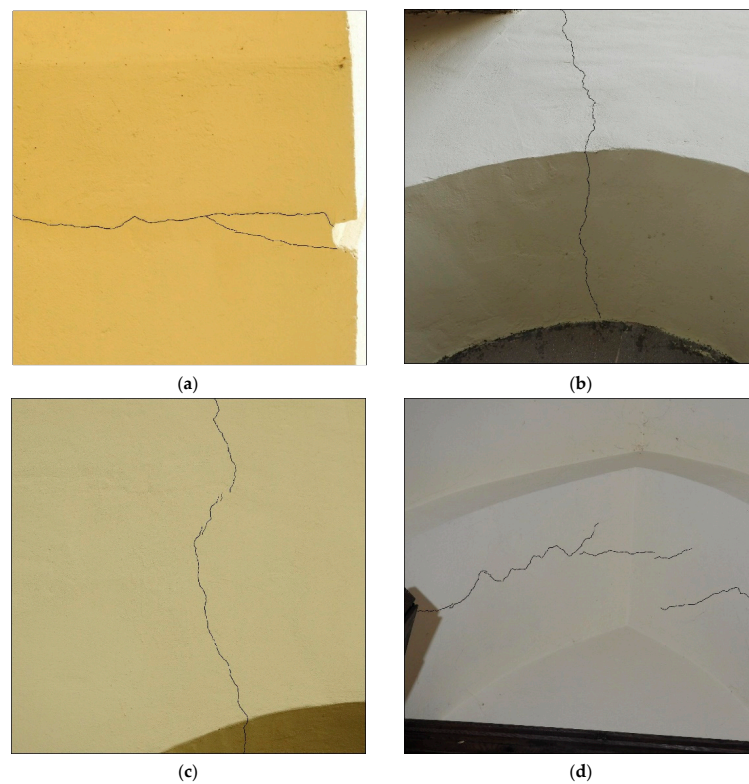
**Figure 12.** Examples of damage on arches and vaults marked on map of cracks: (a) Crack on arch over entrance (ID 2 in Figure 10a); (b) Crack on lintel arch (ID 4 in Figure 10a); (c) Crack stretching across arch and façade wall above it (ID 14 in Figure 10a); (d) Cracking of pointed arch over window (ID 21 in Figure 10b).

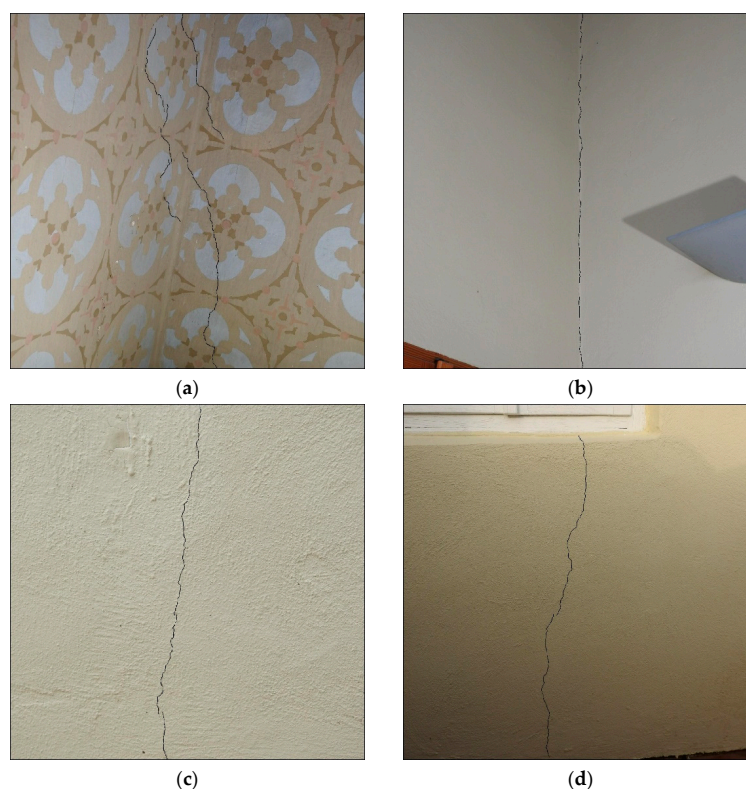
**Figure 14.** Typical damage observed on walls: (a) Oblique cracks at the junction of walls (ID 43 in Figure 10c); (b) Vertical crack at the junction of walls (ID 39 in Figure 10c); (c) Vertical crack on a façade wall (ID 8a in Figure 10a); (d) Vertical crack under window on a façade wall (ID 8b in Figure 10a).
