Preliminary observations on historical castle Trakošćan (Croatia) performance under recent $ML \geq 5.5$ earthquakes

Markušić, Snježana; Stanko, Davor; Penava, Davorin; Trajber, Domagoj; Šalić, Radmila

Source / Izvornik: **Geosciences, 2021, 11**

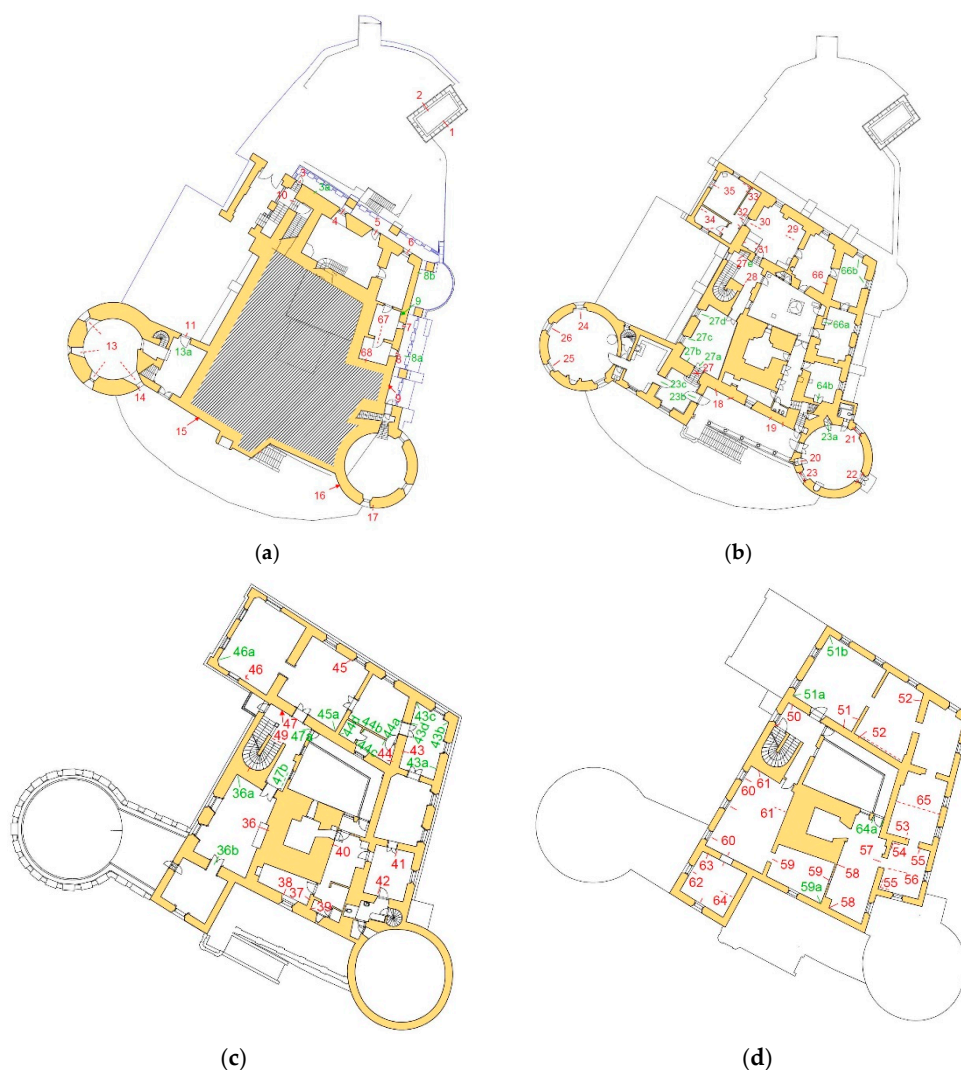
As shown in Figures 10 and 11, cracking was generally initiated in the vicinity of opening corners or wall ends, and spread throughout the building. The cracks in walls were mostly bound by fine oblique shear cracks. Based on the cracking type, distribution and characteristics (width, length, indentation, direction and location), damage to the building shown in Figures 10 and 11 belongs to the class of minor damage (Grade 1: Negligible to slight damage) in compliance with the EMS-98 scale [25]. Therefore, the observed damage does not pose a threat to the load-bearing capacity and usability of the building (see Figures 12–15 for examples).

The damage marked as 12 (see Figures 10 and 11) is a hairline tensile crack < 1 mm wide, formed at the apex of a shallow arch spanning 4.35 m, extending to adjacent arches, from which the arch assumes the corresponding part of the load. Although the crack does not indicate substantial to heavy damage according to the EMS-98 scale, due to the location of its occurrence (arch vertex), proper crack control measures should be taken. The damage marked as 52 (see Figures 10 and 11) is a crack < 3 mm wide, and represents slight damage to the part of the 2nd floor wall perpendicular to the outer wall on which the roof structure rests, and is also further weakened by the presence of chimneys. In the observed portion of the wall, the vertically continuous chimneys are placed within the wall. However, the gross wall thickness was kept the same as in the remaining portion of the wall. Therefore, due to the reduction in the net thickness of the wall, the chimneys represent the intrinsic lack of structural integrity of the particular wall or building itself. Figures 13 and 14 show the

Figure 10. Map of crack positions observed during the in situ visual inspection: (a) Basement; (b) Ground floor; (c) First floor; (d) Second floor (note: red colored marks designate the damage after the Zagreb M5.5 2020 earthquake and green colored marks designate damage after the Petrinja M6.2 2020 earthquake).

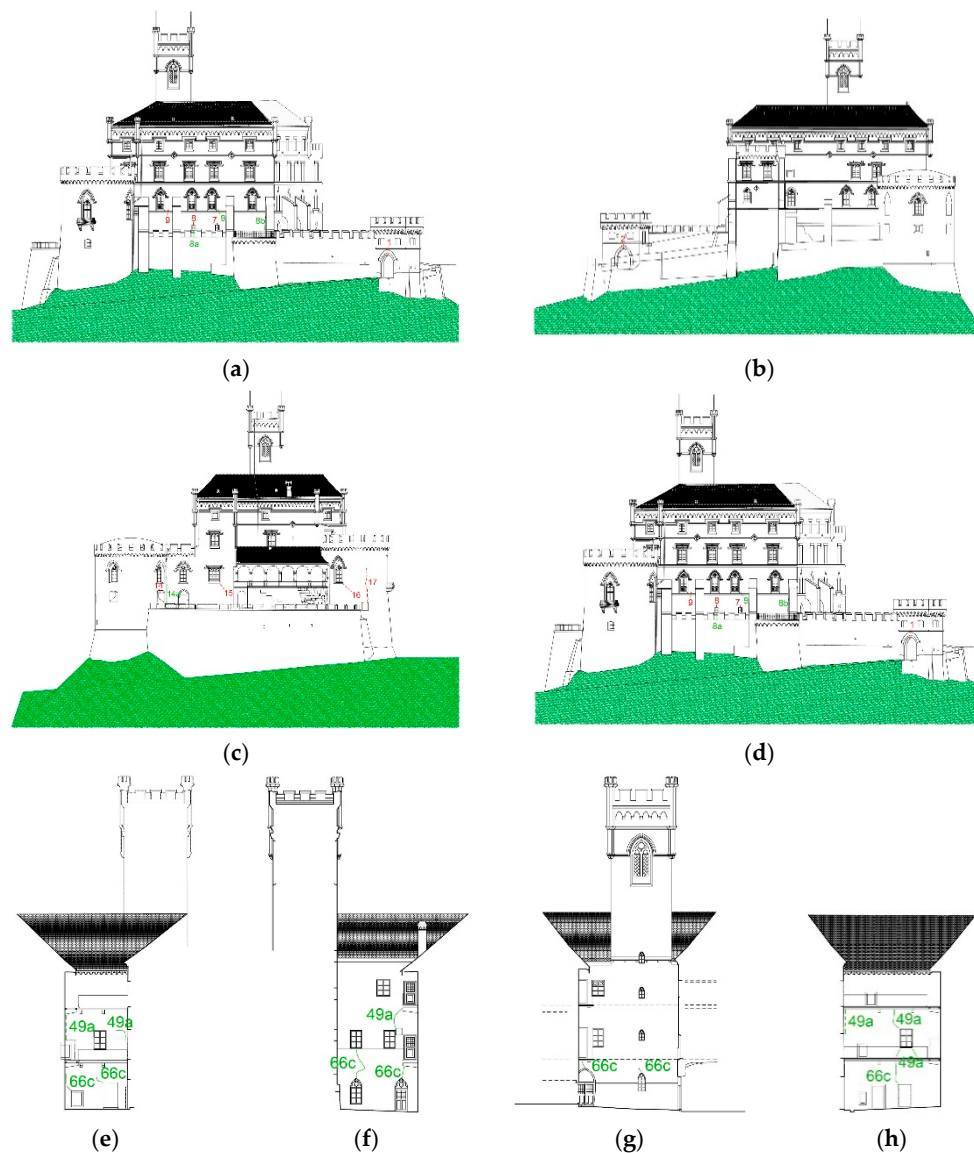
Figure 11. Map of crack positions observed during the in situ visual inspection: (a) East façade; (b) West façade; (c) South façade; (d) North façade; (e) Inner east façade; (f) Inner west façade; (g) Inner south façade; (h) Inner north façade.
