Comparison of Seismic and Structural Parameters of Settlements in the East Anatolian Fault Zone in Light of the 6 February Kahramanmaraş Earthquakes

Işık, Ercan; Hadzima-Nyarko, Marijana; Avcil, Fatih; Büyüksaraç, Aydın; Arkan, Enes; Alkan, Hamdi; Harirchian, Ehsan

Source / Izvornik: **Infrastructures**, 2024, 9

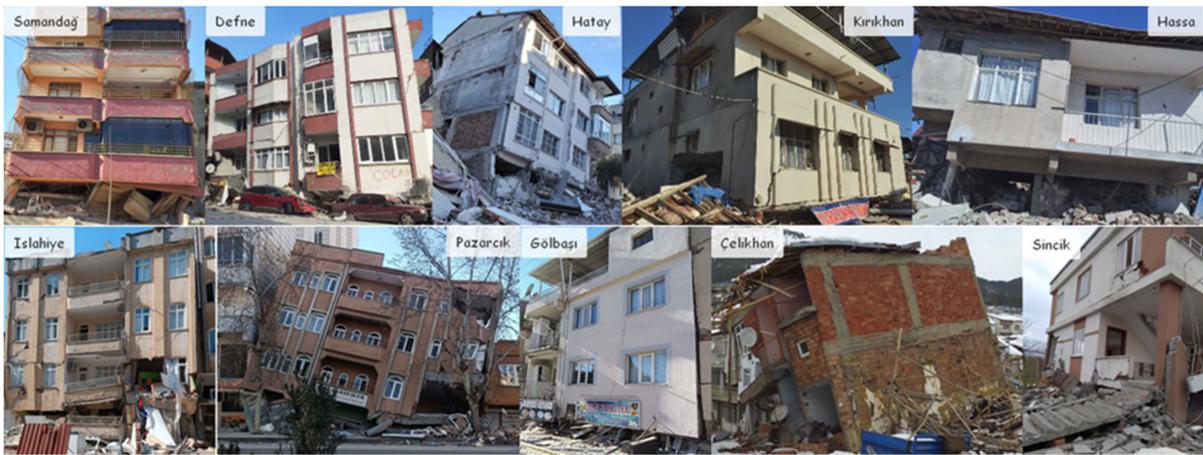
The disaster of the century for Türkiye, the earthquakes centered in Kahramanmaraş on 6 February 2023, caused great destruction in a very large region. In addition to the large-scale loss of life and property resulting from the destruction, there were economic losses that the country could not handle. In addition, the damage to transportation structures caused a loss of time in necessary aid and interventions. However, the interventions made in these structures in a very short time and the rapid establishment of alternative routes solved this problem in a short time. The earthquake caused destruction and structural damage at different levels in different structural systems. In the region, very great destruction also occurred in reinforced concrete buildings, which are the main urban building stock. In this study, RC structures located in the settlements considered and exposed to various levels of structural failure were evaluated observationally by taking into account the damage. Examples of RC buildings that have received various levels of structural damage in different settlements as a consequence of field examinations are shown in Figure 4.

Figure 4. RC structures exposed to various levels of structural damage.

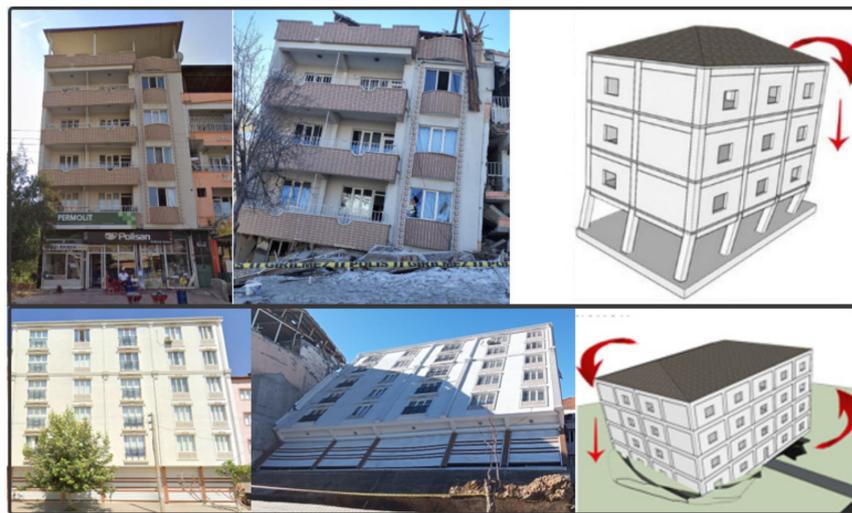
Pre-earthquake and post-earthquake images and schematic representations of this damage for two sample RC buildings are shown in Figure 5. Pre-earthquake images were taken with the help of Google Street View.

Figure 5. Pre-earthquake and post-earthquake images of two sample RC structures.

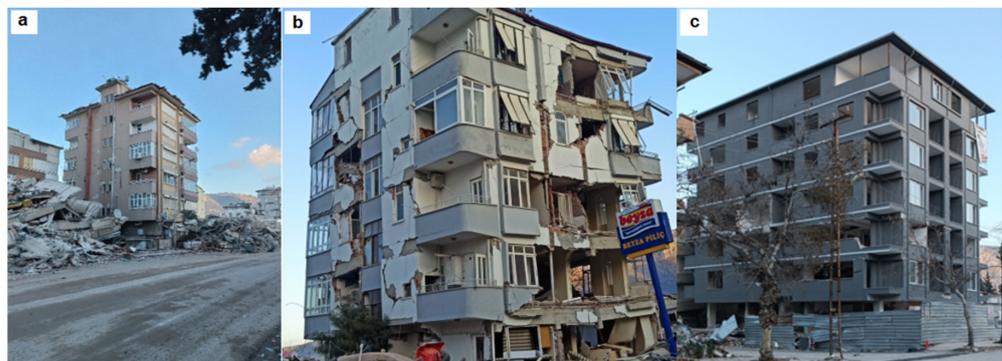
Figure 6. Examples of RC buildings with life safety ensured. (a) RC building standing despite the collapse of neighboring buildings, (b) example of RC building for pre-collapse performance level, and (c) example of a completed but not yet occupied building without damage.
