Source / Izvornik: **Buildings, 2019, 9**

Locating Hidden Elements in Walls of Cultural Heritage Buildings by Using Infrared Thermography

Analyzed Elements of Kostić House

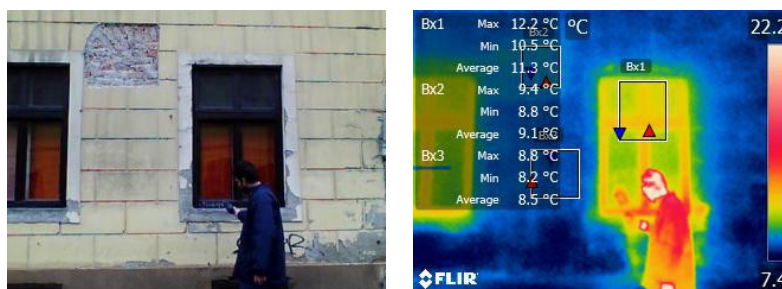
Figure 24. Termogram of Kostić house in 23 Kuhačeva Street.

By analyzing the thermal pattern shown in Figure 24, the difference in the probing area, as a result of the difference in emissivity, is evident. The expected discontinuity observed by probing did not appear during the heat excitation of the parapet wall (Figure 25a). As can be seen from Figure 25b, a further line heating process raised the wall temperature but did not result in a change in the thermal pattern. During the heating and during the time, the thermal pattern seemed to be inhomogeneous, albeit in a manner that corresponds to the presence of moisture, rather than non-discontinuity in the structural elements. By analyzing the smaller parts of the wall, no additional information (as shown in Figure 25c) was obtained.

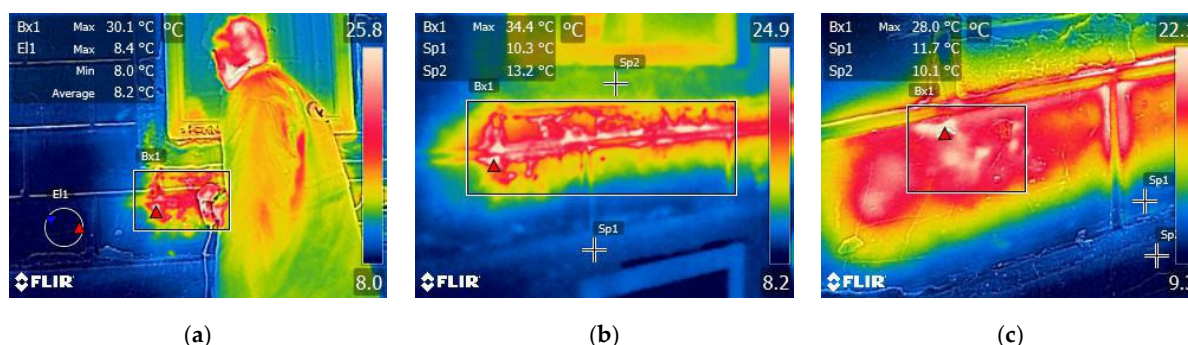
Figure 25. Changing the thermal pattern due to heating.

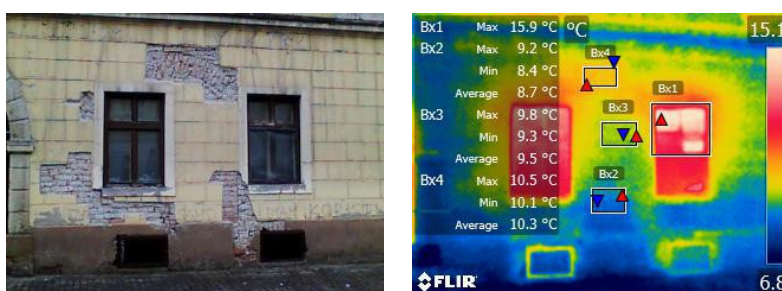
After looking at the bricked up openings as well as wall probing (Figure 26) and the associated thermal pattern, it is obvious that the thermographic analysis was not as effective in finding the bricked up openings in the massive homogeneous structures of the brick wall.

Figure 26. Thermogram of the probing building part of a known wall structure.

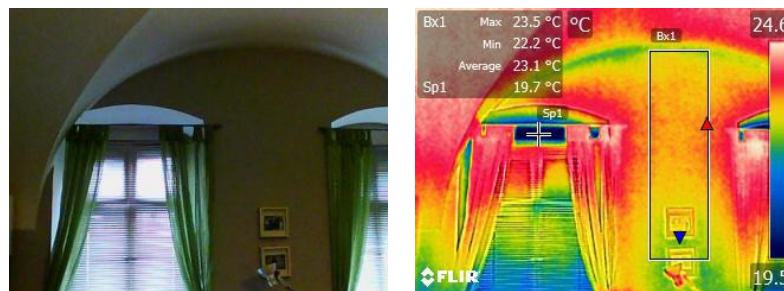
In order to confirm the conclusions, the examined place was checked from the inside of the building. Significant thermal masses and continuous heating have resulted in a constant thermal pattern, presented in Figure 27.

Figure 27. Thermal pattern on the inside of the wall.
