# Locating Hidden Elements in Walls of Cultural Heritage Buildings by Using Infrared Thermography

**Abstract:** The structure of Tvrđa and its buildings date back to the Middle Ages. Tvrđa represents the Old Town of the city of Osijek and the best-preserved and largest ensemble of Baroque buildings in Croatia. After the withdrawal of the Ottomans in 1687, during the 18th century, the Austro-Hungarian administration systematically formed a new fortification system, regulated streets and squares and built a large number of military objects. Tvrđa took its present form in the 19th century and has kept it since then. Investigating the historical development of individual buildings, in addition to archival sources and existing architectural documentation, the obvious source of information are the buildings themselves. The aim of this paper is to explore the possibilities of using infrared thermography to find structural elements and hidden openings in historic buildings in Osijek's Tvrđa. This paper describes the exploration of the 18th century openings on the facades of the former Kostić houses. The facades were bricked into the walls in the 19th century because houses were reused and

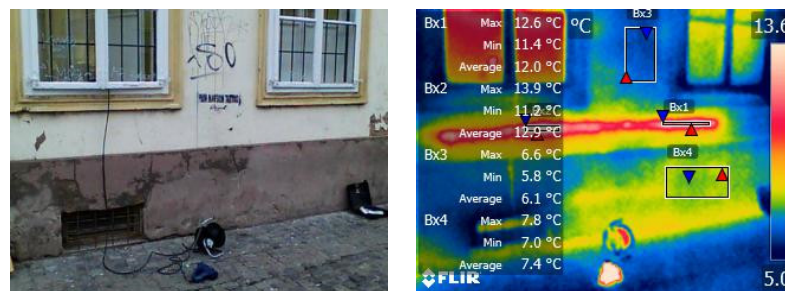
There was not any discontinuity by the analysis of the thermal pattern change. In Figure 20, a linear trace of the heating body, which is continuous and uninterrupted, can be observed.

**Figure 20.** Homogeneous thermal pattern on excitation along the wall.

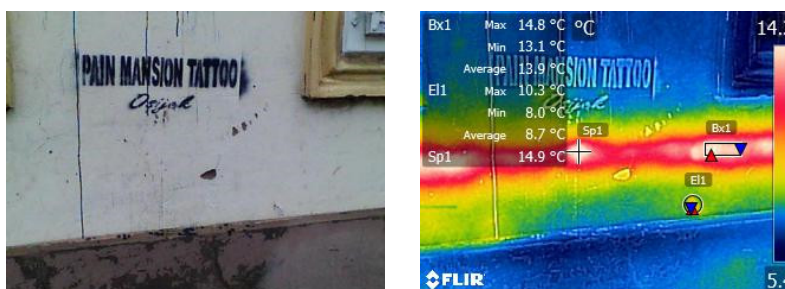
The detail below the left window in the lower left corner of the thermogram reveals that spot facade damage, due to a difference in emissivity, shows a higher apparent temperature (Figure 21).

**Figure 21.** Influence of damage to the thermal pattern.
