Locating Hidden Elements in Walls of Cultural Heritage Buildings by Using Infrared Thermography

Abstract: The structure of Tvrđa and its buildings date back to the Middle Ages. Tvrđa represents the Old Town of the city of Osijek and the best-preserved and largest ensemble of Baroque buildings in Croatia. After the withdrawal of the Ottomans in 1687, during the 18th century, the Austro-Hungarian administration systematically formed a new fortification system, regulated streets and squares and built a large number of military objects. Tvrđa took its present form in the 19th century and has kept it since then. Investigating the historical development of individual buildings, in addition to archival sources and existing architectural documentation, the obvious source of information are the buildings themselves. The aim of this paper is to explore the possibilities of using infrared thermography to find structural elements and hidden openings in historic buildings in Osijek's Tvrđa. This paper describes the exploration of the 18th century openings on the facades of the former Kostić houses. The facades were bricked into the walls in the 19th century because houses were reused and their

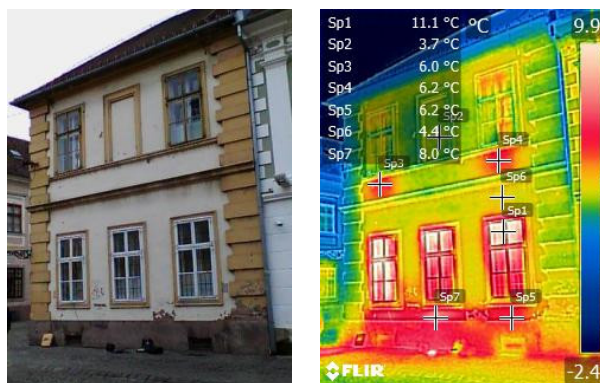
Figure 16. Thermogram of the whole building.

The wall thickness of the analyzed building is 74 cm, and the thickness of the parapet below the window, where the heating elements of the city's central heating are located, is 36 cm. From the thermogram in Figure 16, it can be seen that the building is heated at the project temperature. The thermogram also shows the position of the radiators on parapet walls under the window. In Figure 16, the thermal image shows that the interior windows on the ground floor are open, since the space is used for the post office, and a greater amount of fresh air is required.

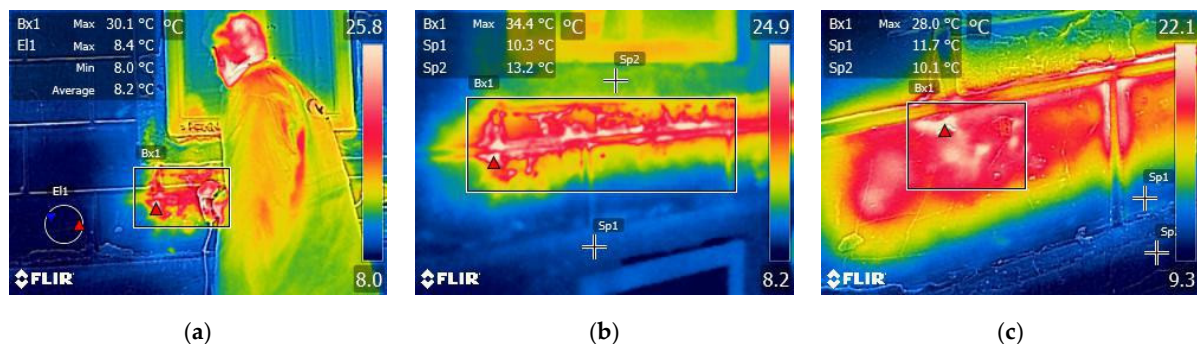
By analyzing the thermal pattern shown in Figure 24, the difference in the probing area, as a result of the difference in emissivity, is evident. The expected discontinuity observed by probing did not appear during the heat excitation of the parapet wall (Figure 25a). As can be seen from Figure 25b, a further line heating process raised the wall temperature but did not result in a change in the thermal pattern. During the heating and during the time, the thermal pattern seemed to be inhomogeneous, albeit in a manner that corresponds to the presence of moisture, rather than non-discontinuity in the structural elements. By analyzing the smaller parts of the wall, no additional information (as shown in Figure 25c) was obtained.

Figure 25. Changing the thermal pattern due to heating.

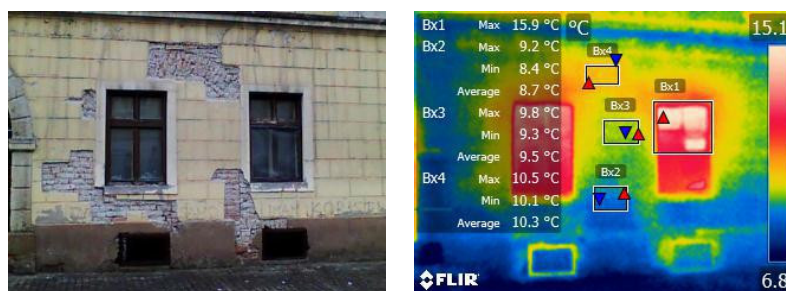
After looking at the bricked up openings as well as wall probing (Figure 26) and the associated thermal pattern, it is obvious that the thermographic analysis was not as effective in finding the bricked up openings in the massive homogeneous structures of the brick wall.

Figure 26. Thermogram of the probing building part of a known wall structure.
