*Source / Izvornik:* **Acta Technica Corviniensis, 2019, XII, 15 - 18**

## A CASE STUDY ON INFLUENCE OF TRAFFIC-INDUCED VIBRATIONS ON BUILDINGS AND RESIDENTS

<sup>1-4</sup>Josip Juraj Strossmayer University of Osijek, Faculty of Civil Engineering and Architecture Osijek, Osijek, CROATIA

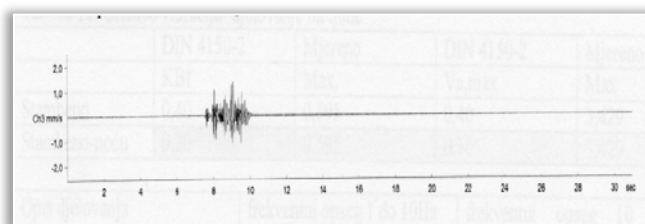
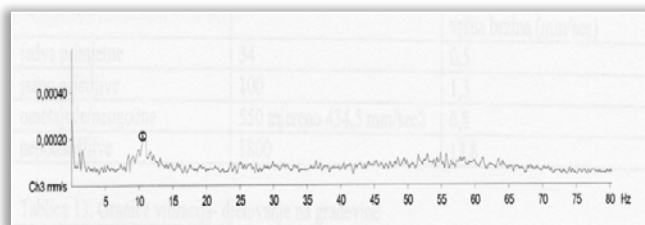
Figure 4. Time history record of vertical velocities (in mm/sec) at foundation (above) and acceleration data (in mm/sec<sup>2</sup>) at various frequencies

SN	DIN 4150-3	Measured
$v_{a,max}$ (mm/sec) sensitive buildings	1.5-2.5	4	3.429

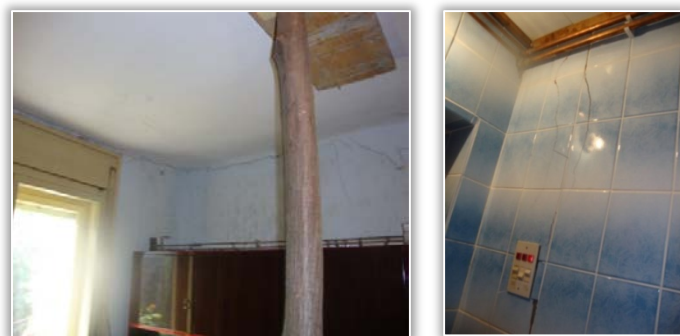
Presented are results for single building that suffered the most of the damage (see Figure 5). The building is a house with basement of dimensions 80 m<sup>2</sup>, built in two parts (50 and 30 m<sup>2</sup>) with solid brick masonry without confining elements. The first, old part, was built 60 years ago, and second part was built several years ago. Due to age it is considered as sensitive building. The building is placed near road with 7 m distance to its closest point, and 19 m to its farthest. The foundation soil is rock. The building experienced both, the structural (collapse of storey slab in older part, cracks in outer and foundation wall) and the non-structural damage (cracking of windows, cracked ceramic tiles, displacement of roof tiles and rain water leakage).

Figure 5. Damage to the ceiling (left) and damage to the ceramic tiles (right)

The increased traffic, and correspondingly the vibrations, including the initial condition of the road, its surroundings, could have led to heavy damage to buildings. In other buildings, the damage level was lower, due to different input parameters.
