A case study on influence of traffic-induced vibrations on buildings and residents

A CASE STUDY ON INFLUENCE OF TRAFFIC-INDUCED VIBRATIONS ON BUILDINGS AND RESIDENTS

In this work elaborated is the case study on the influence of traffic-induced vibrations to buildings and residents that was a subject of a lawsuit [3,4].

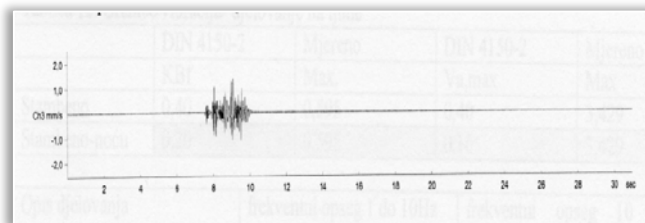
Figure 4. Time history record of vertical velocities (in mm/sec) at foundation (above) and acceleration data (in mm/sec²) at various frequencies

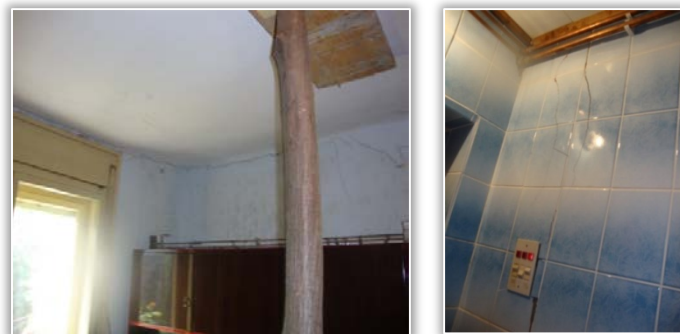
Presented are results for single building that suffered the most of the damage (see Figure 5). The building is a house with basement of dimensions 80 m², built in two parts (50 and 30 m²) with solid brick masonry without confining elements. The first, old part, was built 60 years ago, and second part was built several years ago. Due to age it is considered as sensitive building. The building is placed near road with 7 m distance to its closest point, and 19 m to its farthest. The foundation soil is rock. The building experienced both, the structural (collapse of storey slab in older part, cracks in outer and foundation wall) and the non-structural damage (cracking of windows, cracked ceramic tiles, displacement of roof tiles and rain water leakage).

Figure 5. Damage to the ceiling (left) and damage to the ceramic tiles (right)

The increased traffic, and correspondingly the vibrations, including the initial condition of the road, its surroundings, could have led to heavy damage to buildings. In other buildings, the damage level was lower, due to different input parameters.
