Preliminary observations on historical castle Trakošćan (Croatia) performance under recent $ML \geq 5.5$ earthquakes

Preliminary Observations on Historical Castle Trakošćan (Croatia) Performance under Recent $ML \geq 5.5$ Earthquakes

Keywords: preliminary observations; historical building; Trakošćan Castle; Croatia; building performance; recent earthquakes in 2020

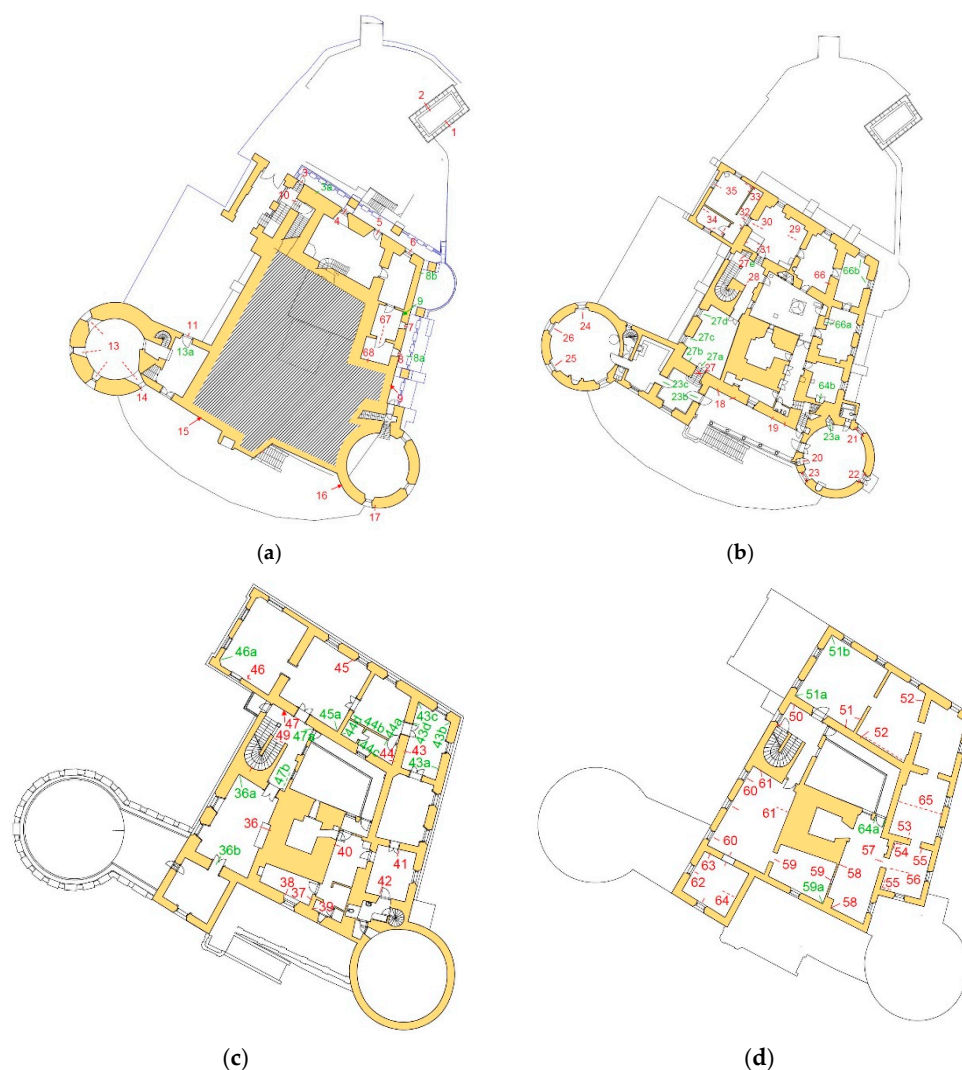
As shown in Figures 10 and 11, cracking was generally initiated in the vicinity of opening corners or wall ends, and spread throughout the building. The cracks in walls were mostly bound by fine oblique shear cracks. Based on the cracking type, distribution and characteristics (width, length, indentation, direction and location), damage to the building shown in Figures 10 and 11 belongs to the class of minor damage (Grade 1: Negligible to slight damage) in compliance with the EMS-98 scale [25]. Therefore, the observed damage does not pose a threat to the load-bearing capacity and usability of the building (see Figures 12–15 for examples).

The damage marked as 12 (see Figures 10 and 11) is a hairline tensile crack < 1 mm wide, formed at the apex of a shallow arch spanning 4.35 m, extending to adjacent arches, from which the arch assumes the corresponding part of the load. Although the crack does not indicate substantial to heavy damage according to the EMS-98 scale, due to the location of its occurrence (arch vertex), proper crack control measures should be taken. The damage marked as 52 (see Figures 10 and 11) is a crack < 3 mm wide, and represents slight damage to the part of the 2nd floor wall perpendicular to the outer wall on which the roof structure rests, and is also further weakened by the presence of chimneys. In the observed portion of the wall, the vertically continuous chimneys are placed within the wall. However, the gross wall thickness was kept the same as in the remaining portion of the wall. Therefore, due to the reduction in the net thickness of the wall, the chimneys represent the intrinsic lack of structural integrity of the particular wall or building itself. Figures 13 and 14 show the

Figure 10. Map of crack positions observed during the in situ visual inspection: (a) Basement; (b) Ground floor; (c) First floor; (d) Second floor (note: red colored marks designate the damage after the Zagreb M5.5 2020 earthquake and green colored marks designate damage after the Petrinja M6.2 2020 earthquake).

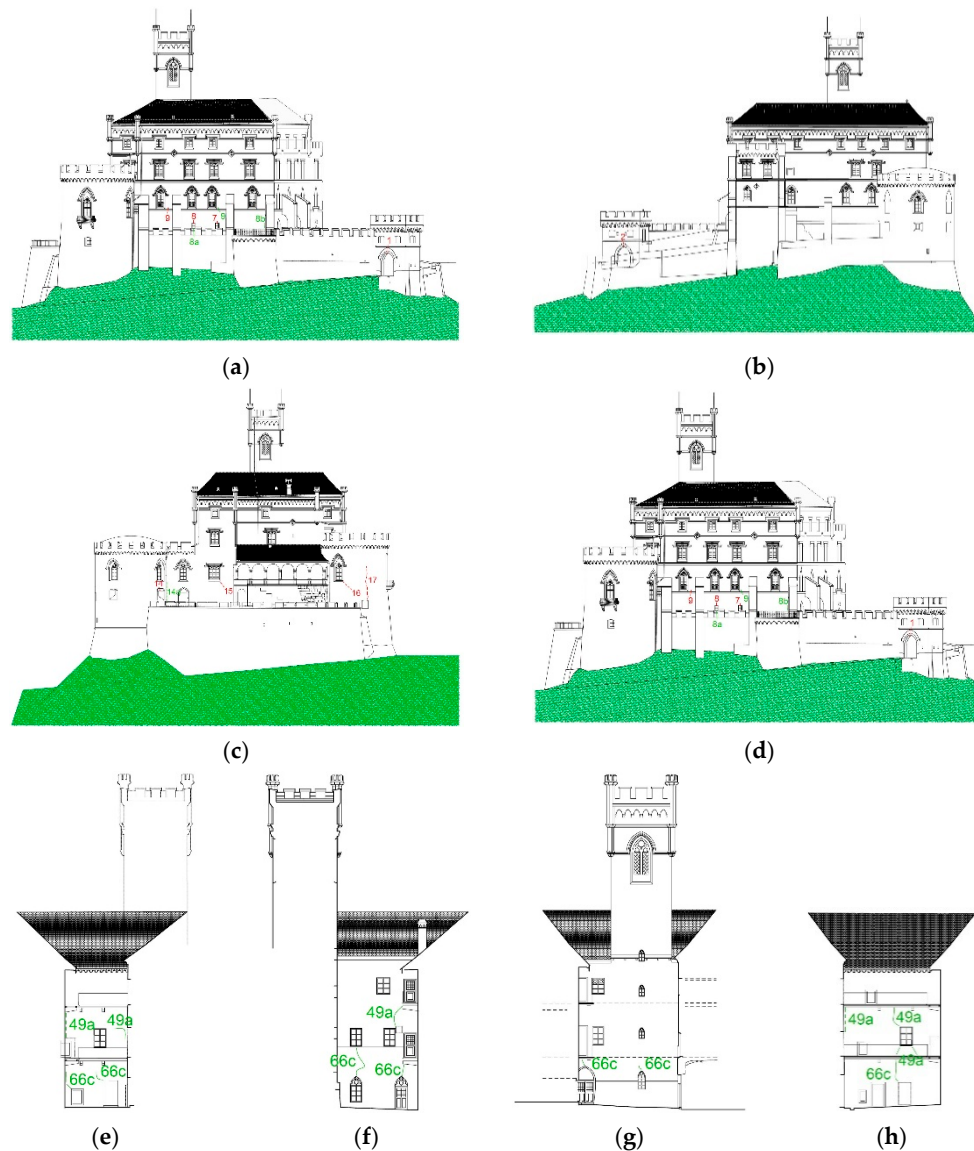
Figure 11. Map of crack positions observed during the in situ visual inspection: (a) East façade; (b) West façade; (c) South façade; (d) North façade; (e) Inner east façade; (f) Inner west façade; (g) Inner south façade; (h) Inner north façade.
