Preliminary Observations on Historical Castle Trakošćan (Croatia) Performance under Recent $ML \geq 5.5$ Earthquakes

Abstract: Trakošćan Castle, built on a rocky peak in the late 13th century, is a cultural heritage site protected as a historical entity by the Republic of Croatia. The Castle is constructed as a highly irregular masonry structure with timber or shallow masonry arches, vaults or dome floors. It was substantially renewed, upgraded and partially retrofitted from the 16th century until the year 2000. The M5.5 (VIII EMS) and M6.2 (VIII-IX EMS) earthquakes, which struck the city of Zagreb on 22 March 2020 and the Pokupsko-Petrinja area on 29 December 2020, strongly shook the Castle's structure. Earthquake damage was observed and assessed by visual inspection accompanied by ambient vibration measurements. The slight cracks that appeared on masonry arches were found to be critically positioned, and can likely lead to the arches' collapse if their spreading is not prevented. Ambient vibration measurements, which were compared to pre-earthquake ones, revealed the decrease in the fundamental frequencies of the Castle's central tower unit and the second floor, thus possibly in

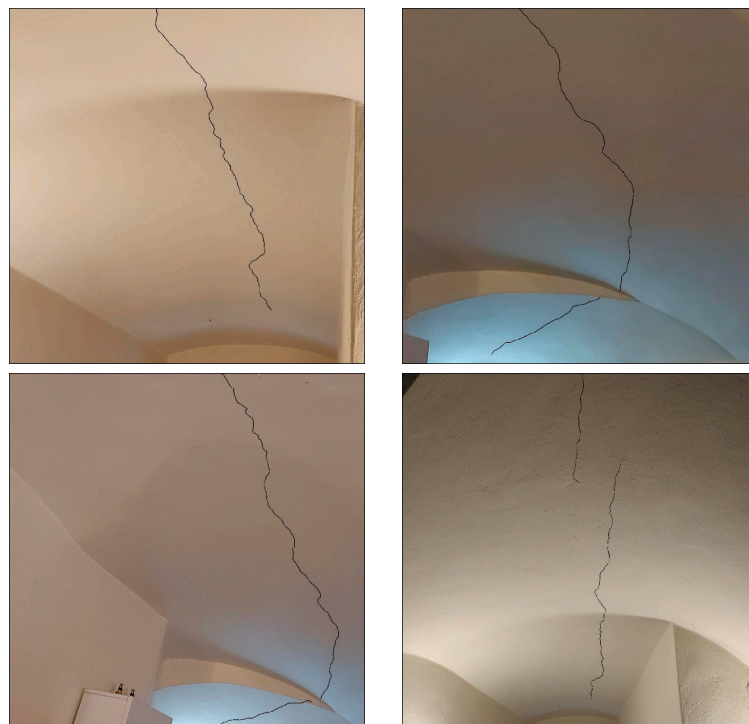
typical damage observed on vaults and arches in the form of sparsely distributed hairline cracks, with length ranging from 2 to 6 m, and in some cases even over 10 m. The majority of cracks are positioned perpendicular across vaults and arches and from there propagate to openings close to them (see Figure 12b,c). Longitudinal cracks on arches and vaults have been observed above openings in the east tower at floor level (cracks IDs 21, 22 and 23 in the damage distribution map in Figure 12d). An interesting spatial crack pattern (Figure 13) has been observed on the ceiling vault of the ground floor (ID 13), where cracks are spread from openings (windows) upwards to the center of the vault. The cracks observed on a vault shown in Figure 10a (crack ID 13) imply the decomposition of the vault load-bearing structural system to an individual arch system, which represents the new equilibrium of the structure. Above the nearby outer wall, retrofitting measures were carried out with reinforced concrete horizontal confining elements (Figure 15). However, these measures were inadequate, since there is an interruption of the confining element that makes it ineffective. For this reason, it is necessary to further monitor the development of this crack.

Figure 13. Damage observed on ceiling vault of the west tower at ground floor (damage ID on all four images is 13 in Figure 10a).

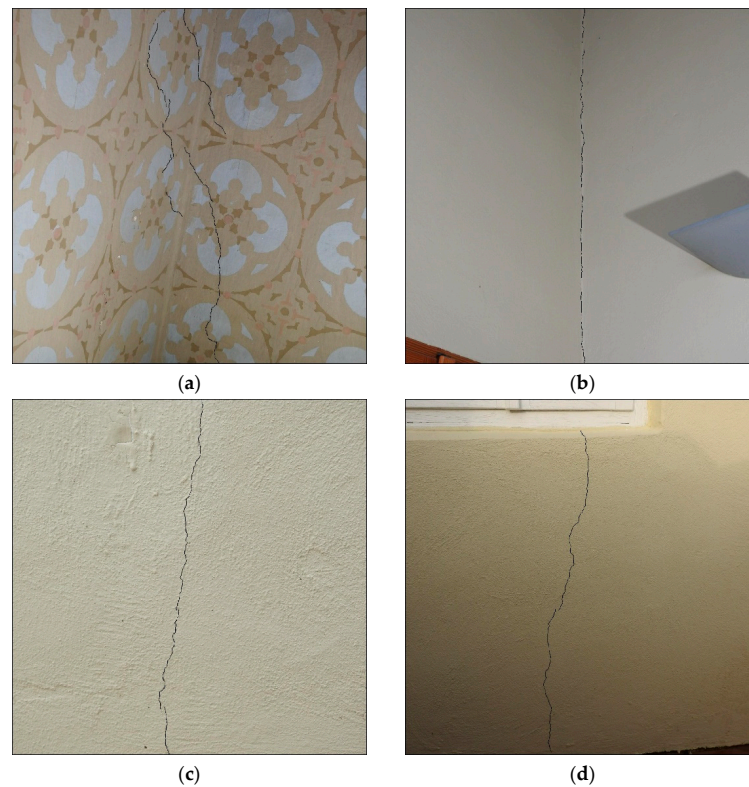
Figure 14. Typical damage observed on walls: (a) Oblique cracks at the junction of walls (ID 43 in Figure 10c); (b) Vertical crack at the junction of walls (ID 39 in Figure 10c); (c) Vertical crack on a façade wall (ID 8a in Figure 10a); (d) Vertical crack under window on a façade wall (ID 8b in Figure 10a).
