Comparison of Seismic and Structural Parameters of Settlements in the East Anatolian Fault Zone in Light of the 6 February Kahramanmaraş Earthquakes

Keywords: Kahramanmaraş; earthquake couple; reinforced concrete; PGA; target displacements

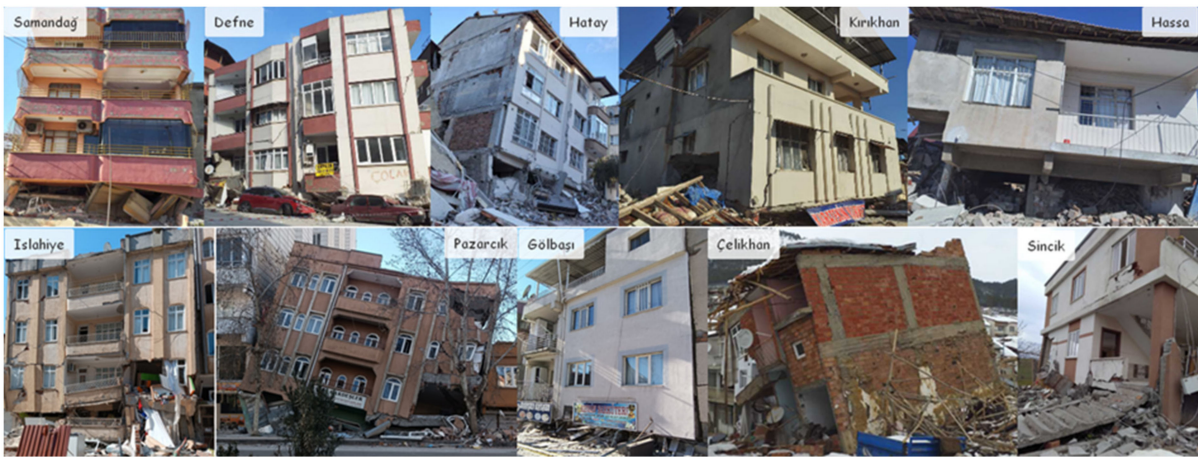
Figure 4. RC structures exposed to various levels of structural damage.

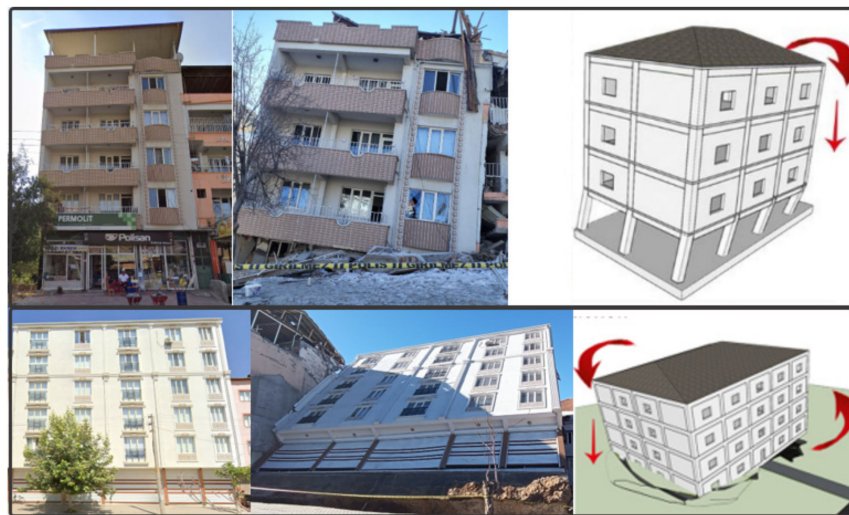
Pre-earthquake and post-earthquake images and schematic representations of this damage for two sample RC buildings are shown in Figure 5. Pre-earthquake images were taken with the help of Google Street View.

Figure 5. Pre-earthquake and post-earthquake images of two sample RC structures.

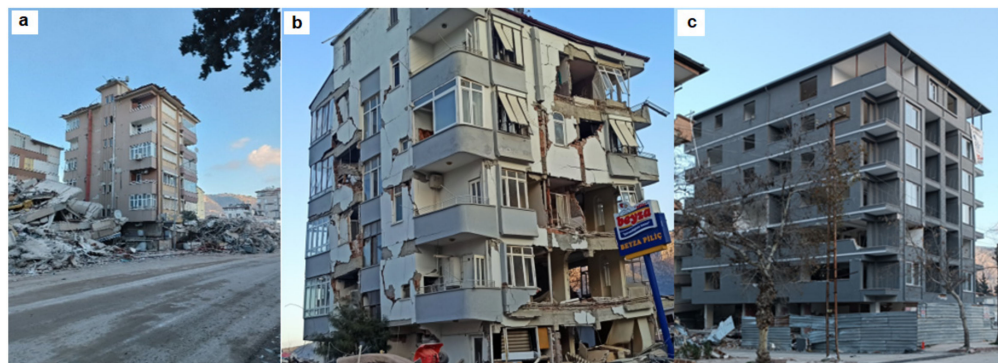
Figure 6. Examples of RC buildings with life safety ensured. (a) RC building standing despite the collapse of neighboring buildings, (b) example of RC building for pre-collapse performance level, and (c) example of a completed but not yet occupied building without damage.
