## Project 3 — Evaluation of seismic performance of a template design RC school building before and after strengthening

### Abstract

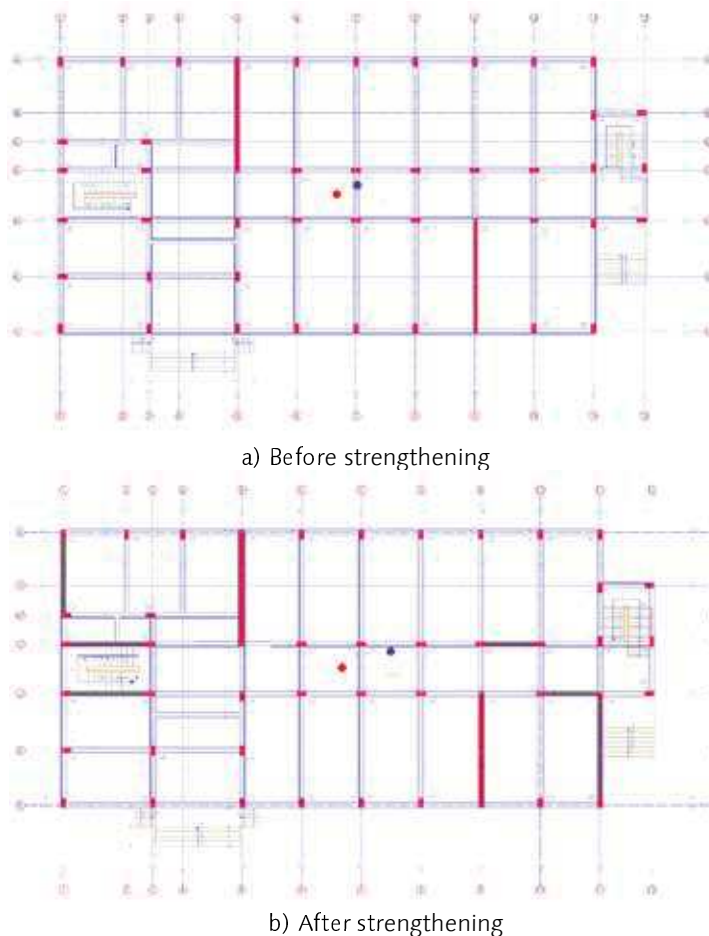
Figure 2 show the modification of the ground plan by the replacement of non-structural masonry infill walls with reinforced concrete structural walls (red walls), which is a common strengthening technique in Turkey to increase the building capacity and to decrease the maximum displacements. The chosen school building is thus representative for a large number of school buildings in whole Turkey before and after strengthening.

Figure 2 — Ground plan of the study object

A first evaluation of the study object before and after strengthening was carried out on the basis of regularity and construction details check. The general layout obeys with the regularity criteria of an earthquake resistant designed structure which will be confirmed by the check of the location of the centre of mass (red point) and rigidity (blue point) in Figure 2.

The location of the centre of mass and rigidity a translational behaviour of the building in both directions can be expected under seismic action due to the quite small distances between as well as the location

of both points. That means in case of the unstrengthened structure only less additional forces can be expected due to torsional behaviour. Due to the retrofitting of the structure the centre of rigidity was shifted, thus a larger distance occurred and the influence of torsional motion will become higher.

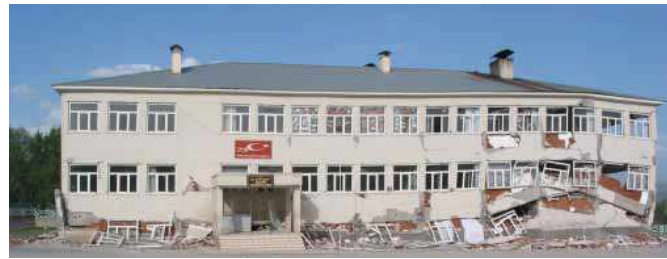
The magnitude 6.6 Bingöl (Türkiye) earthquake on May 1, 2003 caused severe damages and collapse to school buildings (see Figure 3). The comparison of the general layouts from the damage structures and the study object indicates the representativeness of the studied object and provides the opportunity to adopt the experiences from the Bingöl earthquake to the study area Antakya. Thus, the results of the damage prognosis can be compared with the observed damages on school building with a nearly identical (template) design for a known seismic action.

Figure 3 — Damage of a school building caused by the 1st May Bingöl earthquake [2]
