Project 3 - Evaluation of seismic performance of a template design RC school building before and after strengthening

Source / Izvornik: **Model Validation and Simulation, 2013, 309 - 318**

Project 3 — Evaluation of seismic performance of a template design RC school building before and after strengthening

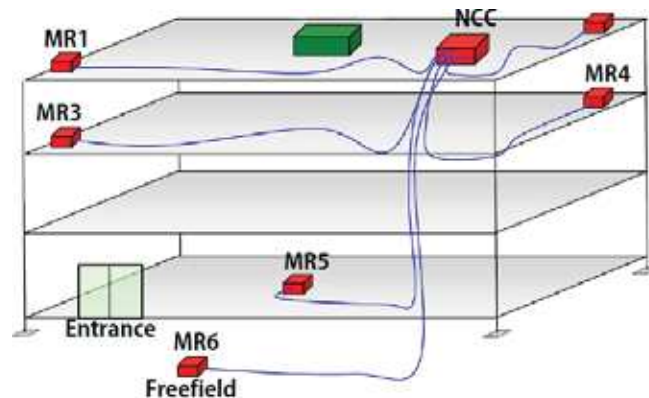
Mustafa Kemal University carried out building response measurements before and after strengthening of the school building in 2011. The building was equipped with five triaxial velocity sensors Type MS2004+ and the corresponding recorder Type MR2002 (SYSCOM Inc.). The sensors are oriented at the main axis of the building. In general, two sensors were installed in two opposite corners on the roof and two sensors in the same corners on a mid-floor story. The fifth sensor was installed in the middle of the ground floor. Sensor number six was installed outside of the building (see scheme in Figure 4).

Figure 4 — Applied instrumentation scheme [1]
