Source / Izvornik: **Buildings, 2019, 9**

Locating Hidden Elements in Walls of Cultural Heritage Buildings by Using Infrared Thermography

Abstract: The structure of Tvrđa and its buildings date back to the Middle Ages. Tvrđa represents the Old Town of the city of Osijek and the best-preserved and largest ensemble of Baroque buildings in Croatia. After the withdrawal of the Ottomans in 1687, during the 18th century, the Austro-Hungarian administration systematically formed a new fortification system, regulated streets and squares and built a large number of military objects. Tvrđa took its present form in the 19th century and has kept it since then. Investigating the historical development of individual buildings, in addition to archival sources and existing architectural documentation, the obvious source of information are the buildings themselves. The aim of this paper is to explore the possibilities of using infrared thermography to find structural elements and hidden openings in historic buildings in Osijek's Tvrđa. This paper describes the exploration of the 18th century openings on the facades of the former Kostić houses. The facades were bricked into the walls in the 19th c

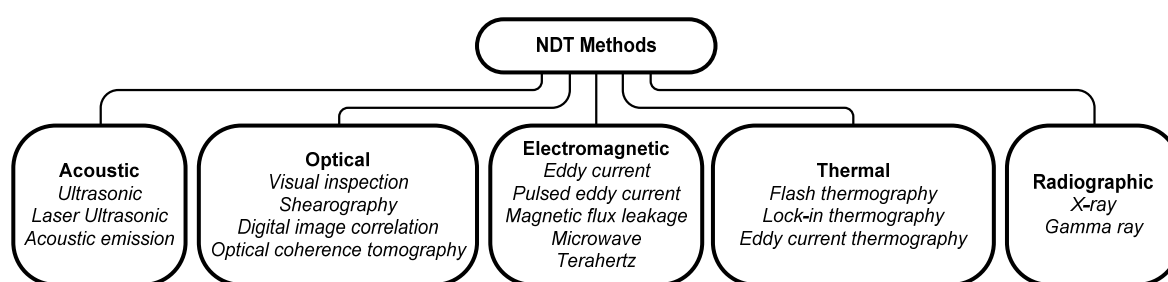
Figure 1. Categories of nondestructive testing (NDT) and evaluation of techniques [5].

The general division of the NDT method shown in Figure 1 can be further expanded, depending on specific applications. Basic nondestructive testing (NDT) methods and techniques, useful in assessing concrete structure durability, were applied for testing concrete structures in the work of [6]. One of the early Laboratory Testing Concrete Elements is available in [7]. The selection of a particular NDT method depends heavily on the object to be tested. In the article of [4], the appropriate methods for each test were provided, as presented in Table 1.

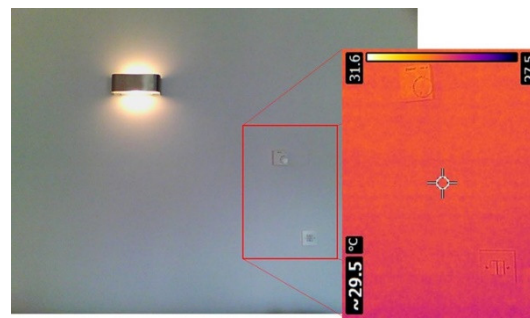
Figure 7. The partition wall and thermogram of the area where the hidden junction box is located.

A third example of passive thermography is shown in Figure 7, illustrating the section of the partition wall in the stationary state the analysis was performed in. The mean measured temperature is 29.6 °C, with a difference of 0.7 °C between the maximum and the minimum reading value being attributed to the difference in the emissivity of the wall, switches and thermostats. Reflection of the surrounding sources exists as well, but to a lesser extent. The partition wall has no heat flow, and therefore, the temperature distribution over the surface is homogeneous. In the case of an inspected body that has the same temperature as the environment, as can be seen in Figure 7, active thermography is needed.

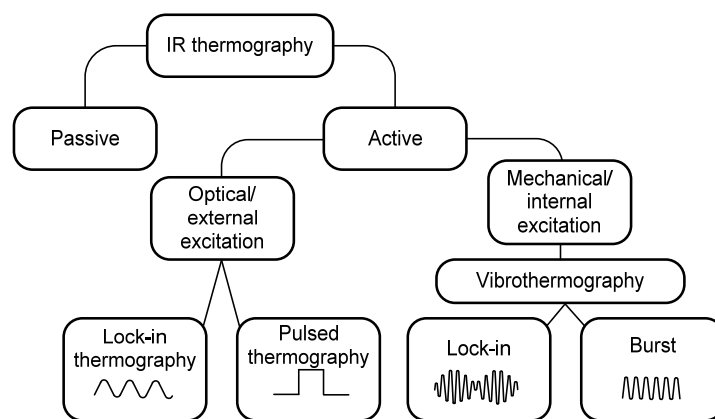
Figure 8. Classification of active thermography.

Infrared thermal measurements, taken by applying thermal excitation to an analyzed object to achieve a temperature difference, are considered as a process of active thermography. Active thermography produces results only if the properties of an analyzed object are different from the properties of the environment where it is located. In the case of active thermography, the excitation can be ultrasonic, electric, thermal and mechanical. Thermographs are recorded in time, and on their basis and with the application of software support, information regarding material properties can be obtained. Figure 8 provides active thermography classification that can be found in [22].

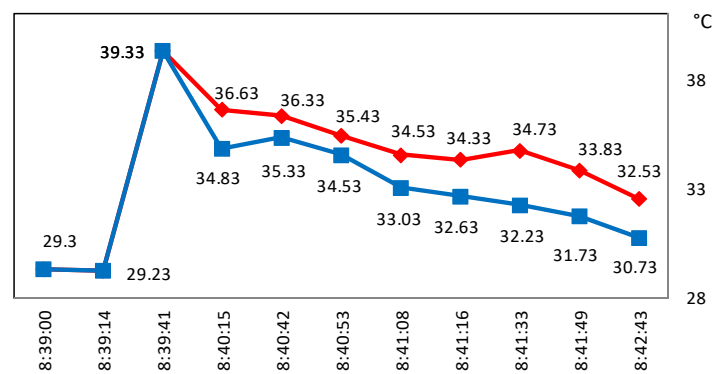
Figure 10. The temperature values in the junction box and its immediate area.

The time duration and the temperature values are shown in Figure 10. The measured values, marked with squares, represent the point which is located between the box and the switch, while the line, marked with diamonds, indicates the temperature in the area of the junction box.

Figure 10 shows the precise temperature values in the analyzed spot point, but not their spatial distribution. Due to camera accuracy and slight camera movement, individual temperature measurement readings over time tend to show variations, although the actual temperature values are continuously falling. This is one of the basic problems associated with classical thermography. The special temperature distribution is presented in Figure 11, where the hidden junction box is located, which clearly illustrates the location of the connection line by which the thermostat is connected to the junction box.

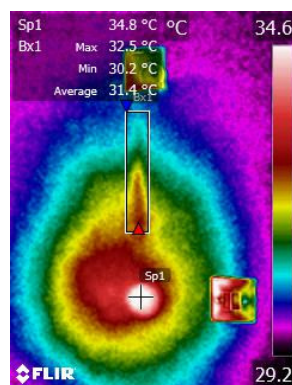
Figure 11. Thermogram of the hidden junction box.

In Figure 11, the position of the conductor under plaster is visible due to the material variation. It should be taken into account that, during the recording, the observed image is monochromatic and that, in most cases, it represents the sum of radiation in the IR spectrum. The advantages of using an IR thermal camera in finding a power supply cable can be seen in Figure 12, where materials of similar characteristics were used, namely plaster and gypsum.

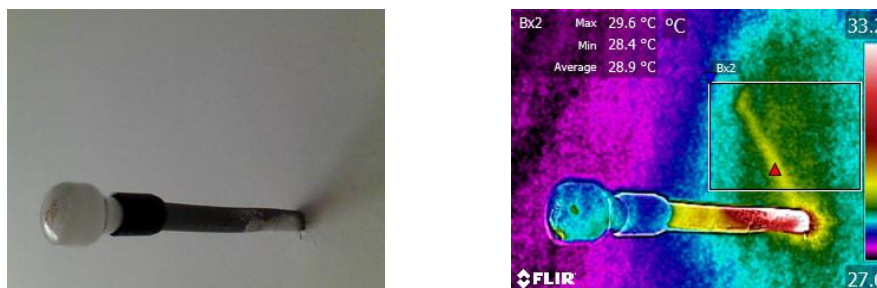
Figure 12. Finding a power supply cable with active thermography.

The position of the power supply cable can be often observed by applying thermal excitation. When installing a lighting fixture, the danger accidental mechanical damage of a power supply cable is, in that case, reduced to a minimum. Encouraged by the previously described experiments with thermal step excitation, the idea for research regarding finding hidden elements in historical buildings was initiated.

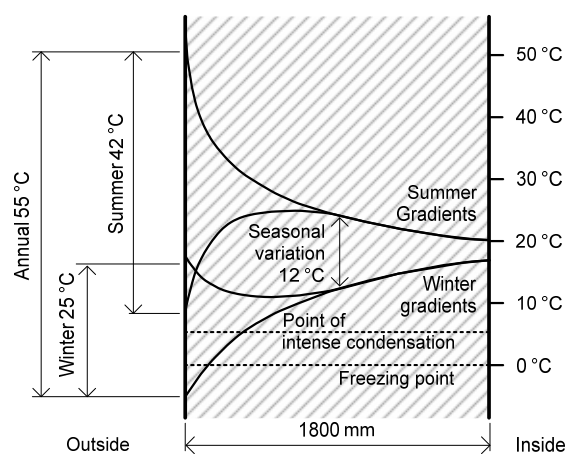
Figure 13. Theoretical temperature changes in a thick wall [25].

As shown in Figure 13, the wall temperatures varied by up to 55 °C or more on the surface, decreasing below freezing on cold winter nights. This wide discrepancy should be compared with a 12 °C seasonal variation in the wall center and 2 °C in the interior the latter, which probably receives some heating in winter. Daily variations of the surface temperature will be greater in summer, e.g., 42 °C, compared with winter, e.g. 25 °C. The dew point for interstitial condensation is located near the outer surface. Consequently, this can result in freezing in the outer layers, since a great deal of heat is required to raise the temperature of a heavy building with thick walls by even 1 °C, i.e., it takes time for the heat to flow through the brick and mortar. There is a tendency for the outer face to be heated up prior to a response the core can provide and long before the inner face is affected. This time lag would affect the theoretical temperature gradient.

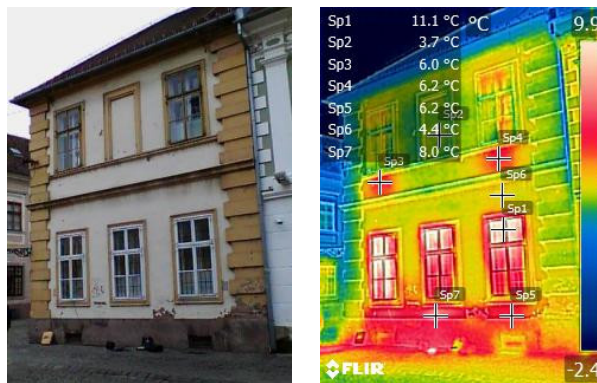
Figure 16. Thermogram of the whole building.

A thermographic diagnosis of historical buildings requires a multidisciplinary approach. For a high quality thermographic analysis of the buildings, it was necessary to carry out a survey of the building of interest. The complexity of the thermographic analysis process is highlighted in the provided investigation of the older buildings [17]. So far, the presence of concrete deterioration, water seepage, cover delamination and significant cracks was investigated in the work of [9]. In addition, the existence of delamination and detachments of the murals were performed as well. The thermographic analysis of Kostić house on the corner of Marković and Kuhačeva Street was carried out on 19th December 2017 between 2:15 PM and 2:45 PM. The outer temperature ranged from 1.7 °C to 1.5 °C with a relative humidity ranging from 63% to 75%. Figure 16 shows a thermogram of the outer envelope. The analysis was performed with the setting of the emissivity 0.9 according to the proposition put forward in [28]. When the exact temperature value of the analyzed thermal radiation

has to be determined, the important factor is emissivity. But, in this case, that was the aim of the analysis. For the purpose of finding discontinuity in building elements, the temperature difference is important. Although some basic guidelines for emissivity values are given in Table 2, more detailed data can be found in Table 3. Table 3 shows typical emission values of building materials.

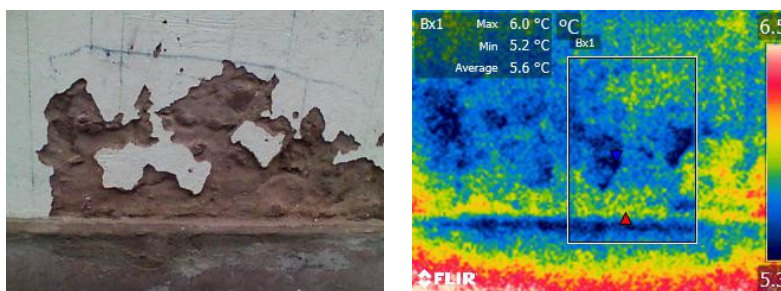
Figure 17. Analysis of facade damage.

The outer envelope (i.e., the facade) has not been renewed since the 1980s. An additional analysis on the parts of the envelope with visible damage was carried out, but the conclusion that can be provided is that the shape of the damage does not strictly correlate with the thermal pattern (Figure 17).
