Source / Izvornik: **Geosciences, 2020, 10**

The Zagreb (Croatia) M5.5 Earthquake on 22 March 2020

Keywords: Zagreb earthquake; Medvednica Mountains; seismicity; amplification; structural modeling; building damage

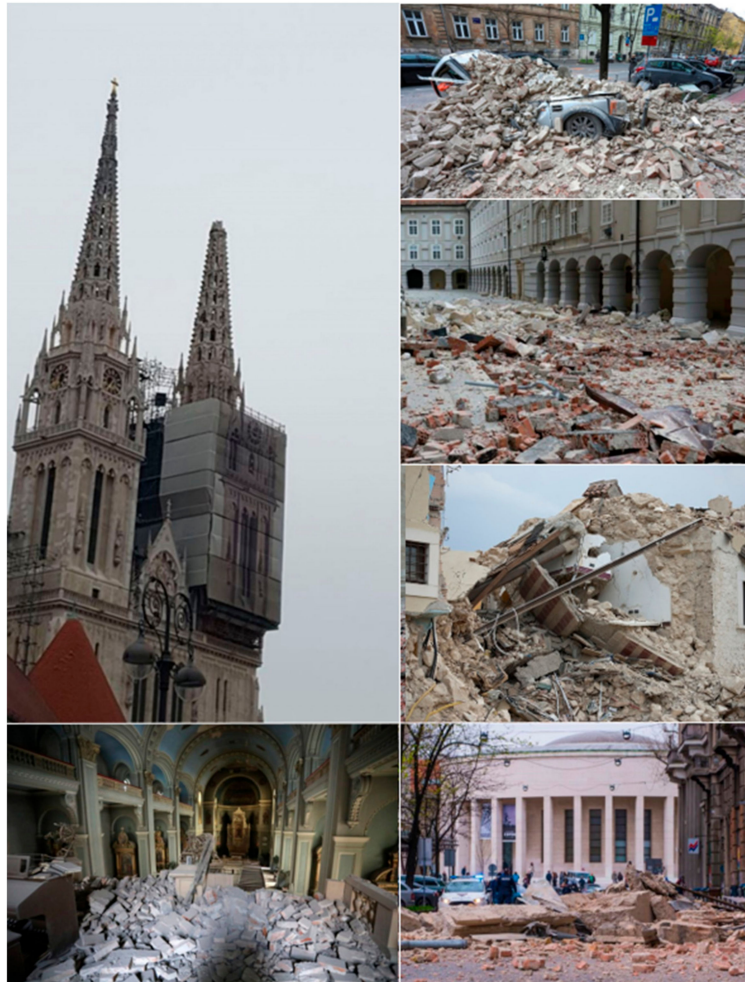
The earthquake hit the city center hardest, and the initial information indicated that the damage was great. Much damage to the cultural and historical architectural heritage of the city of Zagreb was reported, with severe damage to the south tower of Zagreb Cathedral. About 16,555 residential, public and monumental buildings were damaged (Figure 6) as declared by [21,22].

Figure 6. Photos of damage in Zagreb caused by the 22 March 2020 earthquake.

Figure 6 illustrates that in the old city center, three- to five-story masonry buildings, constructed from the time period of the Austro-Hungarian monarchy to 1920, sustained very heavy damage or were destroyed due to the M5.5 Zagreb earthquake on 22 March 2020. There were 26,197 damaged buildings in total (approximately 1900 uninhabitable), among which 9642 were family houses (as declared by [21,22]). As stated in the Disaster Risk Assessment for the Republic of Croatia [24], before 1920, masonry buildings used wooden slab construction, while reinforced concrete (RC) slabs were introduced in the period from 1920 to 1945. Before 1945, buildings possessed only initial earthquake resistance, and earthquake load was not considered in design (up to 5% of relevant peak ground acceleration-PGA was considered in design due to wind load). In compliance with Earthquake Hazard Map of Republic of Croatia [25], the relevant PGA based on 10% exceedance in 50 years, i.e., a return period of 475 years in the Zagreb area goes up to 0.28 g. The consideration of earthquake action in the design of buildings dates from 1946; however, the designs provided inadequate solutions. From 1945 to 1964, earthquake load was considered in the design of buildings by using simplified methodologies (the horizontal force at the top of the building); however, only up to 10% of the relevant PGA was considered in design. In 1964, as a result of the M6.9 Skopje (North Macedonia) earthquake in 1963, the Ordinance on Temporary Technical Regulations for Construction in Seismic Areas (Federal Republic of Yugoslavia (FRY) Official Journal, [26]) was issued. The ordinance required the construction of vertical or horizontal confining elements in masonry buildings, but it provided low earthquake resistance in general. In 1981, it was replaced by the Ordinance on Technical Standards for the Construction of High-Rise Buildings in Seismic Areas (FRY Official Journal, [27]), which provided moderate resistance. Between the years 1964 and 1998, 30–50% of the relevant PGA was considered in the building earthquake resistance design, and 70–100% was considered between 1998 and 2013. The aforementioned regulations were completely replaced by the contemporary standard EN 1998-1 [28] in 2013, which ensured high earthquake resistance (i.e., the earthquake load considered equals 100% of the relevant PGA).

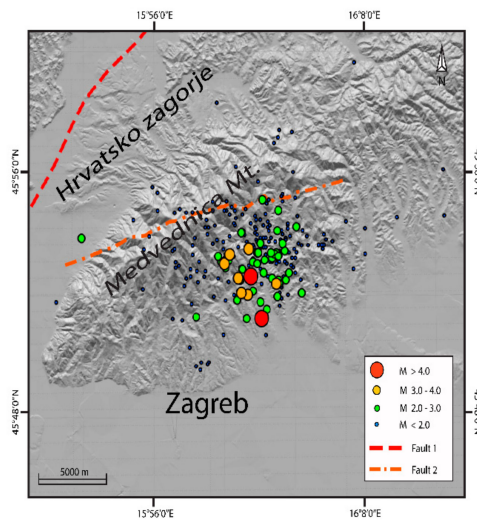
Figure 12. Spatial distribution of earthquake epicenter locations in the period from 22 March to 1 April 2020 (the Zagreb 2020 earthquake sequence). Fault lines are simple projections of the two modeled fault plains from the deep subsurface of the Medvednica Mountains to the surface (see Supplement 1 and Figure 13).

A set of 257 measurements was analyzed both spatially and temporally and processed for import into geological 3D modeling software. To achieve better visual insight, the hypocenters were scaled based on magnitude values (M_L) into four intervals: <2.0, 2.0–3.0, 3.0–4.0 and >4.0 (Figure 12).

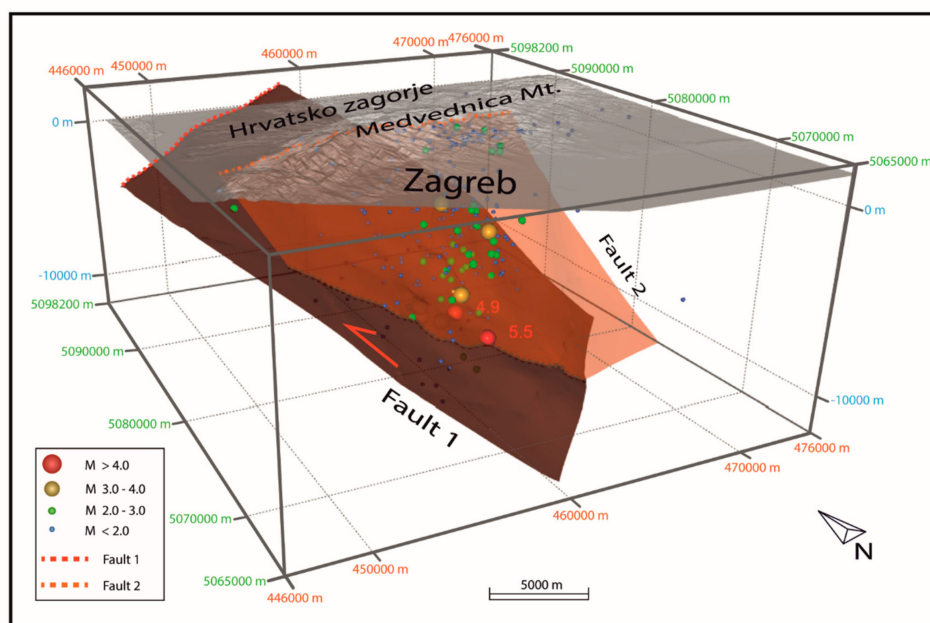
Figure 13. Preliminary structural 3D model of the Zagreb 2020 earthquake sequence. Coordinates are shown in HTRS96/TM coordinate system, and the elevation is in meters (no vertical exaggeration). Fault 1 is interpreted as a primary thrust fault, and Fault 2 is interpreted as a secondary (reverse?) fault.

Using the previously described methodology, a primary fault plane was modeled (Fault 1) based on the dataset containing 45 hypocenters, including most of the highest magnitude events in the Zagreb 2020 earthquake sequence. The fault is characterized by an orientation similar to the southeast-dipping instrumentally calculated fault-plane solutions of the main shock and the strongest aftershock (Figure 4). The rupture along Fault 1 propagated towards the northwest, apparently along a deep-rooted southeast-dipping thrust fault (125/31, dip direction/dip angle). The thrust fault can be projected to the surface where it virtually appears in the central part of the Hrvatsko Zagorje basin (Figures 1b and 13).

A system of south-dipping longitudinal reverse faults has been mapped on the surface along the Medvednica Mountains [15] and interpreted in one of the latest tectonic models as the youngest (Pliocene to Quaternary) system of reverse faults ([11]; Figure 1) that are probably still active [7]. The reverse slip of the primary ruptured fault (Fault 1) of the Zagreb 2020 earthquake sequence (Figure 13; Supplement 1) generally corresponds to the frontal reverse fault striking along the northern foothills of the mountain (Figure 1b). However, the interpreted steep frontal reverse fault does not match the modeled gently inclined primary fault that is here interpreted as a thrust fault (Figure 13). Thus, a fault that could accommodate such a movement is probably a southeast-dipping thrust fault that completely dissects the basement of the central part of the Medvednica Mountains. This master thrust could represent a basal detachment (décollement) of the system of steeper reverse faults striking along the Medvednica Mountains. It could be steeper in the frontal part and thus could match the North Medvednica reverse fault, or it could be buried below the Neogene Hrvatsko Zagorje basin (Figure 1b; Figures 12 and 13).
