# The Zagreb (Croatia) M5.5 Earthquake on 22 March 2020

**Abstract:** On 22 March 2020, Zagreb was struck by an M5.5 earthquake that had been expected for more than 100 years and revealed all the failures in the construction of residential buildings in the Croatian capital, especially those built in the first half of the 20th century. Because of that, extensive seismological, geological, geodetic and structural engineering surveys were conducted immediately after the main shock. This study provides descriptions of damage, specifying the building performances and their correlation with the local soil characteristics, i.e., seismic motion amplification. Co-seismic vertical ground displacement was estimated, and the most affected area is identified according to Sentinel-1 interferometric wide-swath data. Finally, preliminary 3D structural modeling of the earthquake sequence was performed, and two major faults were modeled using inverse distance weight (IDW) interpolation of the grouped hypocenters. The first-order assessment of seismic amplification (due to site conditions) in the Zagreb area for the M5.5 earthquake shows that ground motions of approximately 0.16–0.19 g were amplifie

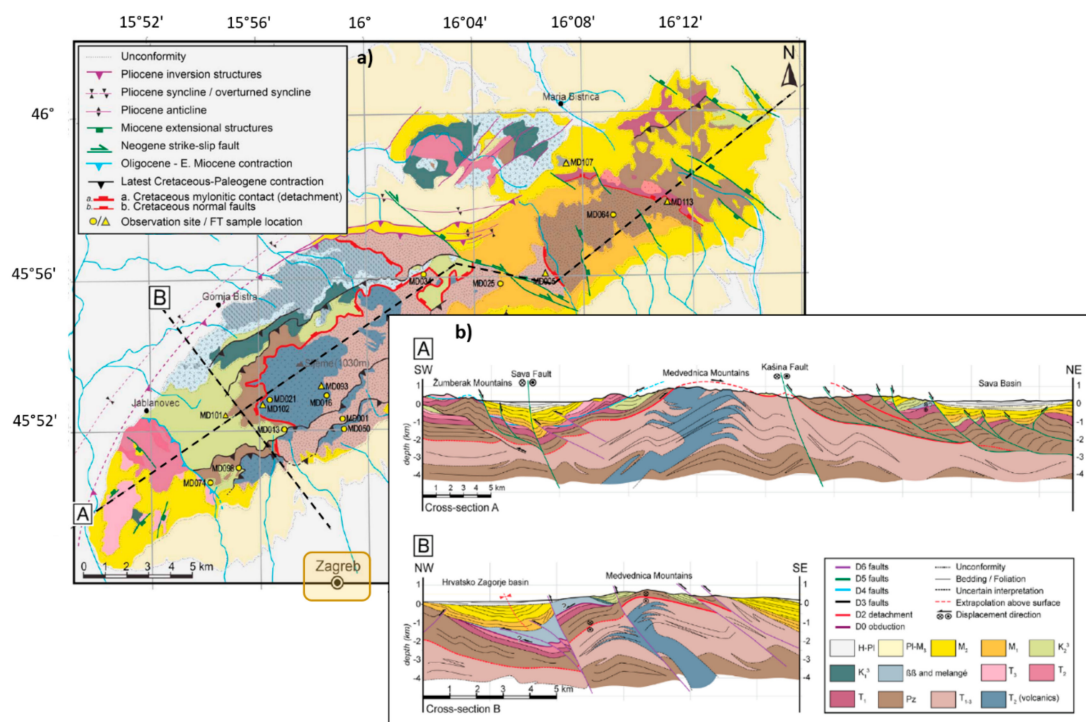
The Medvednica Mountains are composed of a Paleozoic to Mesozoic metamorphic core overlain by non-metamorphic Mesozoic and Cenozoic rocks ([13–15]; Figure 1a). All units are truncated by normal and reverse faults and are surrounded by the Miocene–Quaternary deposits of the Pannonian Basin.

**Figure 1.** (a) Geological map of the Medvednica Mountains. The map shows the location of the cross-sections A and B; (b) Cross-sections across the Medvednica Mountains: (A) longitudinal (SW–NE) and (B) transversal (NW–SE) (after [11]).

Using the previously described methodology, a primary fault plane was modeled (Fault 1) based on the dataset containing 45 hypocenters, including most of the highest magnitude events in the Zagreb 2020 earthquake sequence. The fault is characterized by an orientation similar to the southeast-dipping instrumentally calculated fault-plane solutions of the main shock and the strongest aftershock (Figure 4). The rupture along Fault 1 propagated towards the northwest, apparently along a deep-rooted southeast-dipping thrust fault (125/31, dip direction/dip angle). The thrust fault can be projected to the surface where it virtually appears in the central part of the Hrvatsko Zagorje basin (Figures 1b and 13).

A system of south-dipping longitudinal reverse faults has been mapped on the surface along the Medvednica Mountains [15] and interpreted in one of the latest tectonic models as the youngest (Pliocene to Quaternary) system of reverse faults ([11]; Figure 1) that are probably still active [7]. The reverse slip of the primary ruptured fault (Fault 1) of the Zagreb 2020 earthquake sequence (Figure 13; Supplement 1) generally corresponds to the frontal reverse fault striking along the northern foothills of the mountain (Figure 1b). However, the interpreted steep frontal reverse fault does not match the modeled gently inclined primary fault that is here interpreted as a thrust fault (Figure 13). Thus, a fault that could accommodate such a movement is probably a southeast-dipping thrust fault that completely dissects the basement of the central part of the Medvednica Mountains. This master thrust could represent a basal detachment (décollement) of the system of steeper reverse faults striking along the Medvednica Mountains. It could be steeper in the frontal part and thus could match the North Medvednica reverse fault, or it could be buried below the Neogene Hrvatsko Zagorje basin (Figure 1b; Figures 12 and 13).

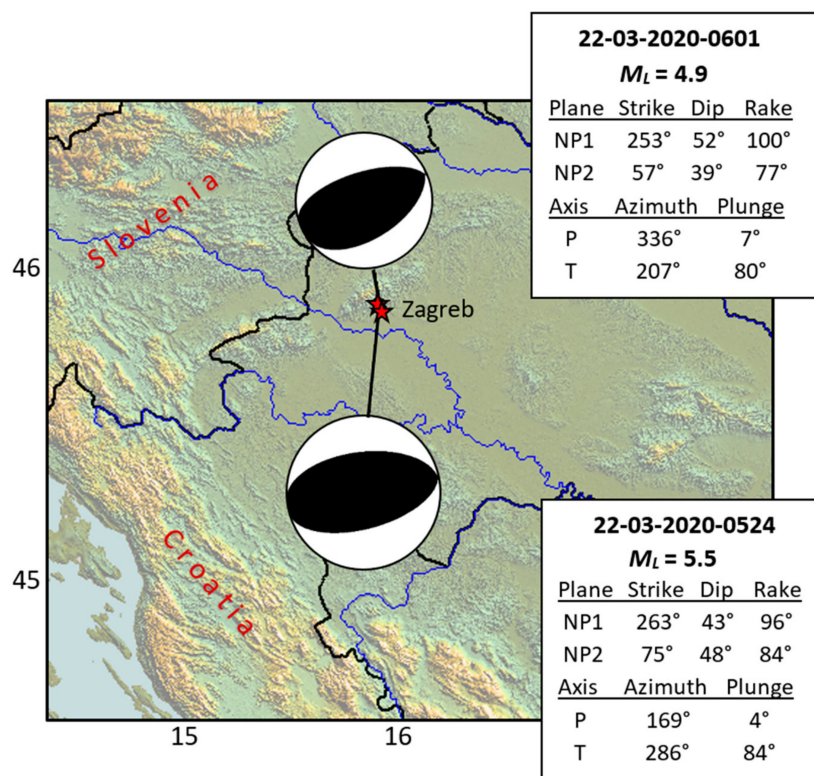
Based on the analysis of data recorded in Croatia and around the world (waveform data taken from the USGS National Earthquake Information Center [20]), the focal mechanisms of the main earthquake and the strongest aftershock were calculated (Figure 4).

The fault-plane solution of the main shock indicates that the earthquake occurred on a reverse fault whose fault plane dips at an angle of  $43^\circ$  to the south-southeast or at an angle of  $48^\circ$  to the north-northwest. The axis of maximum tectonic pressure (P) was horizontal and in the SSE-NNW direction, while the axis of maximum tension (T) was almost vertical. The calculated fault mechanisms will be described in greater detail in Section 4.5 and linked to the geological features of the study area.

**Figure 4.** Fault-plane solutions of 22 March 2020 earthquakes at 05:24 UTC and 06:01 UTC. The focal sphere is shown in stereographic projection.

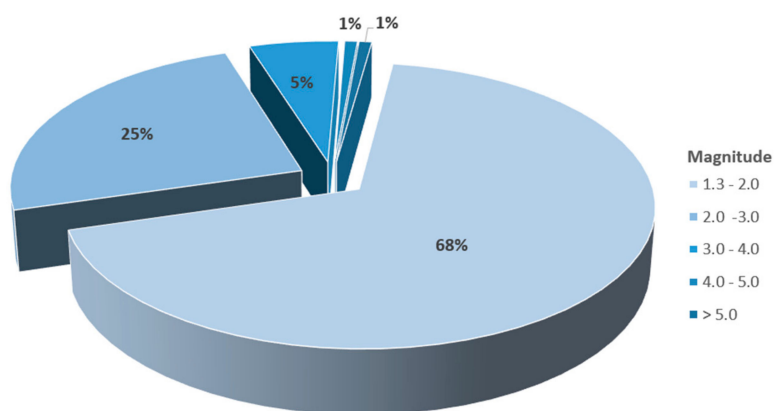
Since no one knows how much accumulated energy is released through a main earthquake, the aftershock activity is normal and not uncommon. Figure 5 presents the number of earthquakes of a certain magnitude (greater than 1.3) that occurred after the main earthquake of 22 March 2020 at 05:24 UTC.

**Figure 5.** Percentage of earthquakes of each magnitude interval that occurred in the epicentral area of the Zagreb earthquake in the period from 22 March to 1 April 2020.
