# The Zagreb (Croatia) M5.5 Earthquake on 22 March 2020

**Keywords:** Zagreb earthquake; Medvednica Mountains; seismicity; amplification; structural modeling; building damage

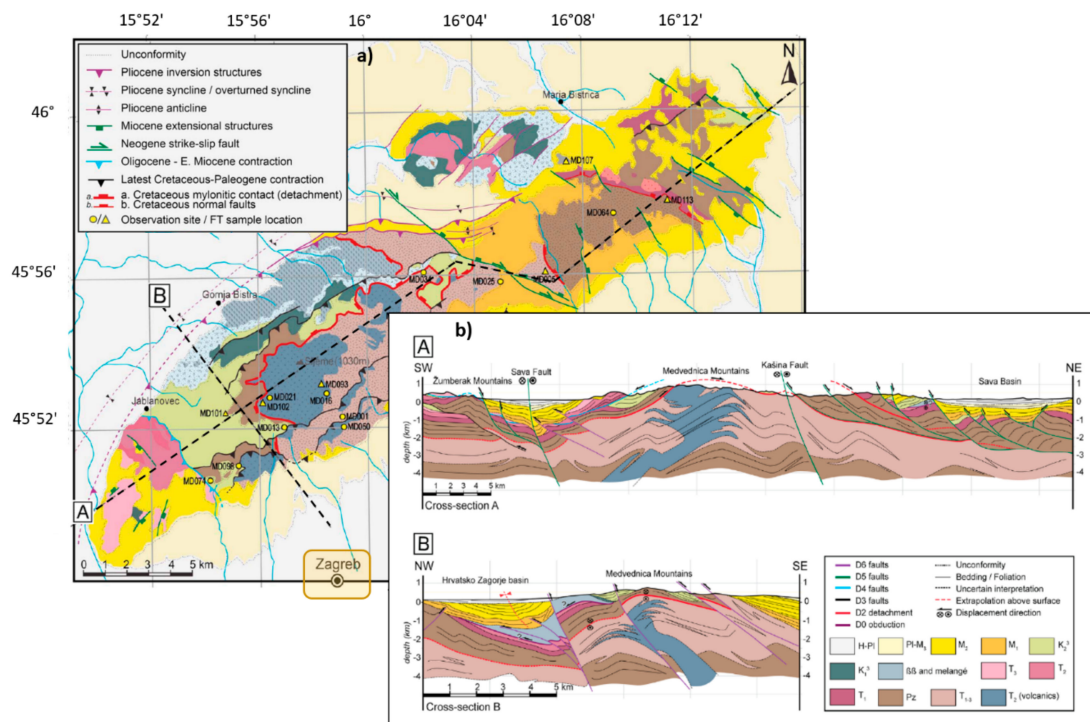
**Figure 1.** (a) Geological map of the Medvednica Mountains. The map shows the location of the cross-sections A and B; (b) Cross-sections across the Medvednica Mountains: (A) longitudinal (SW–NE) and (B) transversal (NW–SE) (after [11]).

The Medvednica Mountains are composed of a Paleozoic to Mesozoic metamorphic core overlain by non-metamorphic Mesozoic and Cenozoic rocks ([13–15]; Figure 1a). All units are truncated by normal and reverse faults and are surrounded by the Miocene–Quaternary deposits of the Pannonian Basin.

Using the previously described methodology, a primary fault plane was modeled (Fault 1) based on the dataset containing 45 hypocenters, including most of the highest magnitude events in the Zagreb 2020 earthquake sequence. The fault is characterized by an orientation similar to the southeast-dipping instrumentally calculated fault-plane solutions of the main shock and the strongest aftershock (Figure 4). The rupture along Fault 1 propagated towards the northwest, apparently along a deep-rooted southeast-dipping thrust fault (125/31, dip direction/dip angle). The thrust fault can be projected to the surface where it virtually appears in the central part of the Hrvatsko Zagorje basin (Figures 1b and 13).

A system of south-dipping longitudinal reverse faults has been mapped on the surface along the Medvednica Mountains [15] and interpreted in one of the latest tectonic models as the youngest (Pliocene to Quaternary) system of reverse faults ([11]; Figure 1) that are probably still active [7]. The reverse slip of the primary ruptured fault (Fault 1) of the Zagreb 2020 earthquake sequence (Figure 13; Supplement 1) generally corresponds to the frontal reverse fault striking along the northern foothills of the mountain (Figure 1b). However, the interpreted steep frontal reverse fault does not match the modeled gently inclined primary fault that is here interpreted as a thrust fault (Figure 13). Thus, a fault that could accommodate such a movement is probably a southeast-dipping thrust fault that completely dissects the basement of the central part of the Medvednica Mountains. This master thrust could represent a basal detachment (décollement) of the system of steeper reverse faults striking along the Medvednica Mountains. It could be steeper in the frontal part and thus could match the North Medvednica reverse fault, or it could be buried below the Neogene Hrvatsko Zagorje basin (Figure 1b; Figures 12 and 13).

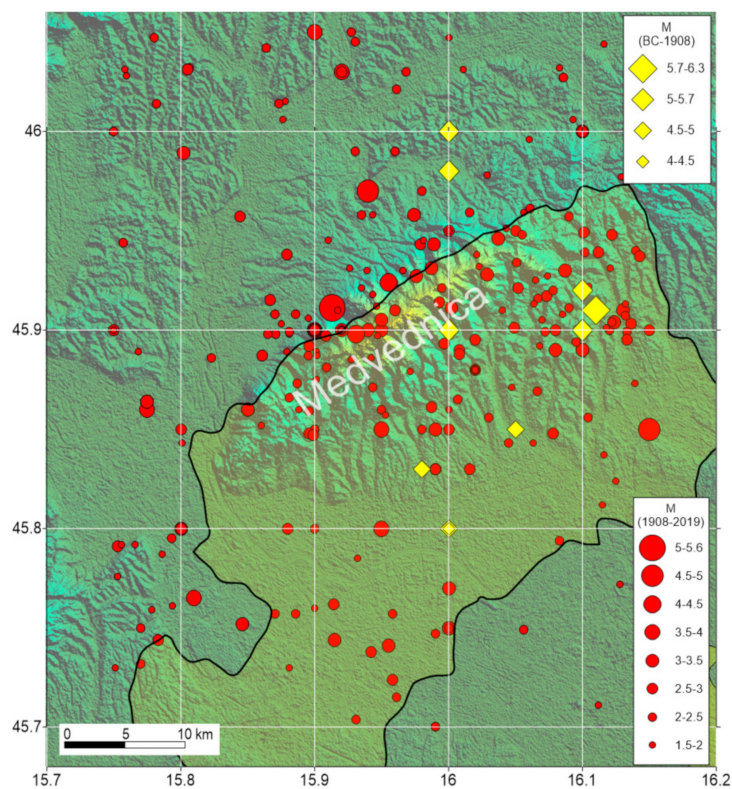
**Figure 2.** Spatial distribution of earthquakes with locations in the wider Zagreb area from BC to 2019 (according to the updated version of the Croatian Earthquake Catalogue, first described in [18]). The urbanized Zagreb city area is displayed with yellow shadowing.

Figure 2 displays the locations of the epicenters of all earthquakes that have occurred in the wider Zagreb area (BC to 2019).

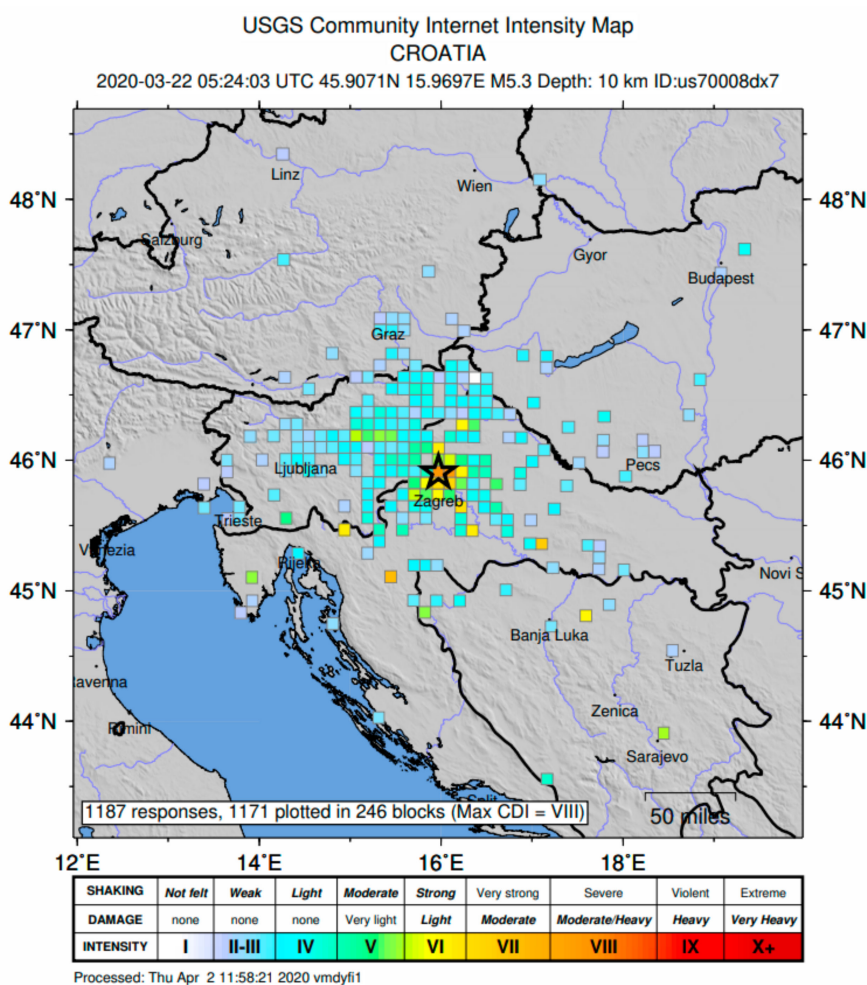
Figure 3. Intensity map according to data collected by USGS [19].

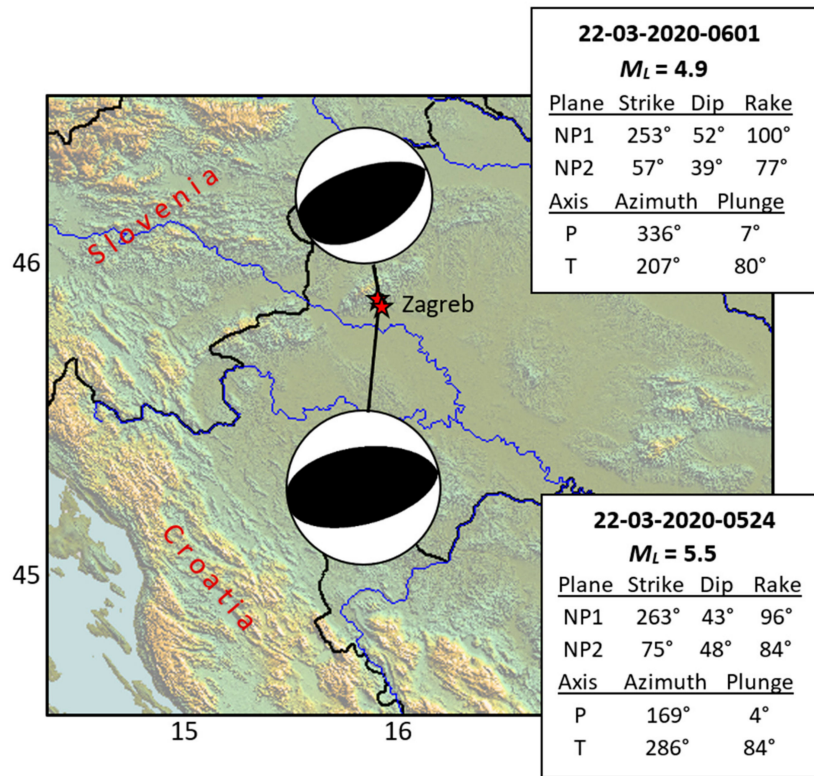
The fault-plane solution of the main shock indicates that the earthquake occurred on a reverse fault whose fault plane dips at an angle of  $43^\circ$  to the south-southeast or at an angle of  $48^\circ$  to the north-northwest. The axis of maximum tectonic pressure (P) was horizontal and in the SSE-NNW direction, while the axis of maximum tension (T) was almost vertical. The calculated fault mechanisms will be described in greater detail in Section 4.5 and linked to the geological features of the study area.

**Figure 4.** Fault-plane solutions of 22 March 2020 earthquakes at 05:24 UTC and 06:01 UTC. The focal sphere is shown in stereographic projection.

Based on the analysis of data recorded in Croatia and around the world (waveform data taken from the USGS National Earthquake Information Center [20]), the focal mechanisms of the main earthquake and the strongest aftershock were calculated (Figure 4).

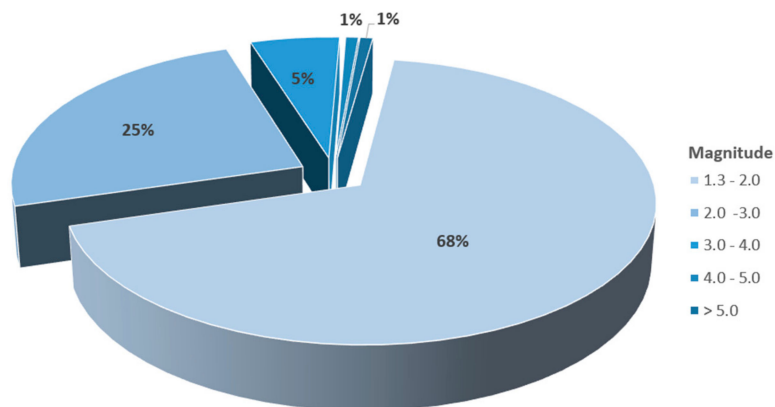
**Figure 5.** Percentage of earthquakes of each magnitude interval that occurred in the epicentral area of the Zagreb earthquake in the period from 22 March to 1 April 2020.

Since no one knows how much accumulated energy is released through a main earthquake, the aftershock activity is normal and not uncommon. Figure 5 presents the number of earthquakes of a certain magnitude (greater than 1.3) that occurred after the main earthquake of 22 March 2020 at 05:24 UTC.

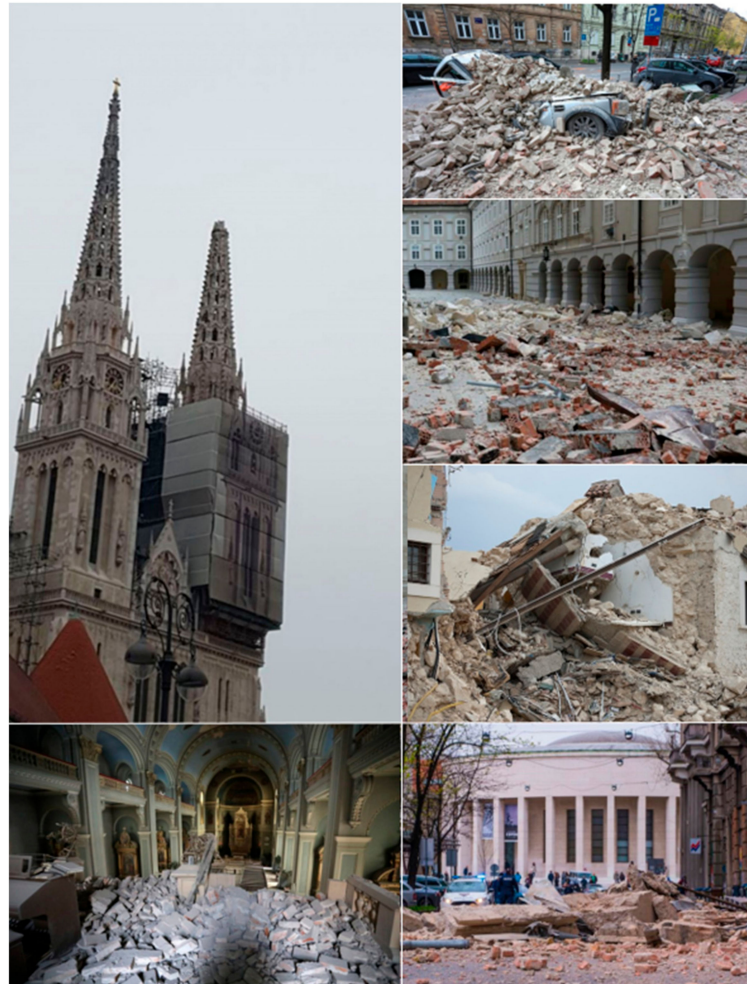
The earthquake hit the city center hardest, and the initial information indicated that the damage was great. Much damage to the cultural and historical architectural heritage of the city of Zagreb was reported, with severe damage to the south tower of Zagreb Cathedral. About 16,555 residential, public and monumental buildings were damaged (Figure 6) as declared by [21,22].

**Figure 6.** Photos of damage in Zagreb caused by the 22 March 2020 earthquake.

Figure 6 illustrates that in the old city center, three- to five-story masonry buildings, constructed from the time period of the Austro-Hungarian monarchy to 1920, sustained very heavy damage or were destroyed due to the M5.5 Zagreb earthquake on 22 March 2020. There were 26,197 damaged buildings in total (approximately 1900 uninhabitable), among which 9642 were family houses (as declared by [21,22]). As stated in the Disaster Risk Assessment for the Republic of Croatia [24], before 1920, masonry buildings used wooden slab construction, while reinforced concrete (RC) slabs were introduced in the period from 1920 to 1945. Before 1945, buildings possessed only initial earthquake resistance, and earthquake load was not considered in design (up to 5% of relevant peak ground acceleration-PGA was considered in design due to wind load). In compliance with Earthquake Hazard Map of Republic of Croatia [25], the relevant PGA based on 10% exceedance in 50 years, i.e., a return period of 475 years in the Zagreb area goes up to 0.28 g. The consideration of earthquake action in the design of buildings dates from 1946; however, the designs provided inadequate solutions. From 1945 to 1964, earthquake load was considered in the design of buildings by using simplified methodologies (the horizontal force at the top of the building); however, only up to 10% of the relevant PGA was considered in design. In 1964, as a result of the M6.9 Skopje (North Macedonia) earthquake in 1963, the Ordinance on Temporary Technical Regulations for Construction in Seismic Areas (Federal Republic of Yugoslavia (FRY) Official Journal, [26]) was issued. The ordinance required the construction of vertical or horizontal confining elements in masonry buildings, but it provided low earthquake resistance in general. In 1981, it was replaced by the Ordinance on Technical Standards for the Construction of High-Rise Buildings in Seismic Areas (FRY Official Journal, [27]), which provided moderate resistance. Between the years 1964 and 1998, 30–50% of the relevant PGA was considered in the building earthquake resistance design, and 70–100% was considered between 1998 and 2013. The aforementioned regulations were completely replaced by the contemporary standard EN 1998-1 [28] in 2013, which ensured high earthquake resistance (i.e., the earthquake load considered equals 100% of the relevant PGA).

On the basis of the observed building damage, a subsequent retrofitting of the most sensitive and dangerous buildings (e.g., city center URM family houses, URM city center residential three- to five-story buildings and cultural heritage buildings) to reduce their vulnerability in compliance with the EN 1998-3 [31] provisions is required, particularly when an earthquake with M6.5 (MMI 8–9) is likely to occur (e.g., once every 475 years, [32]). Considering the structural weaknesses of the damaged buildings, especially those in pre-1964 structures, attention should be given to local and global strengthening and stiffening and unnecessary mass removal. In general, based on recommendations from [30], pre-1964 URM buildings can be retrofitted by, e.g., spraying concrete on the walls from inside to protect the outward appearance. However, heritage buildings require special attention due to their cultural significance and heritage conservancy requirements. An additional way to improve the performance of URM family houses is to insert confining elements into their structural wall intersections. The costs of building repair, estimated to be 6 billion US dollars, should also cover building performance improvement, at least for the most sensitive and dangerous buildings. Considering the case of the recent and nearby M6.4 Durres, Albania, 26 November 2019 earthquake [33] as an example, buildings with moderate and high levels of earthquake-resistant design experienced negligible to slight and moderate damage to RC components (DG 1 and 2). However, they also experienced substantial to heavy damage, including very heavy damage and destruction of URM components (DG 3, 4 and 5). The damage resulting from the Durres, Albania, earthquake could be easily related to laboratory experiments, as described in [34,35]. If such an event affects Zagreb, it could have high social and economic consequences (human casualties, i.e., deaths and injuries, and financial costs) due to buildings collapsing or becoming mostly unserviceable.

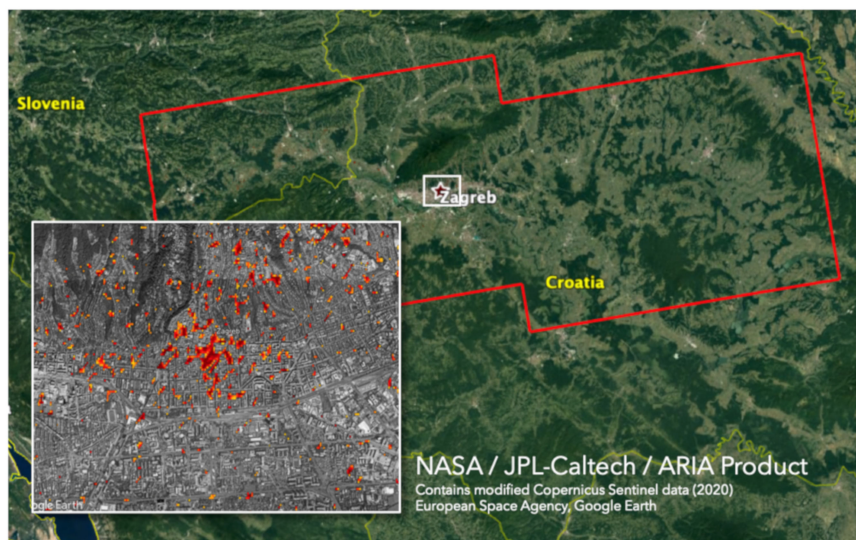
The extent of the damage is also visible on the damage proxy map (DPM) (Figure 7), which was created by the Advanced Rapid Imaging and Analysis (ARIA) team at NASA's Jet Propulsion Laboratory and the California Institute of Technology, both in Pasadena, California. The map depicts areas that were likely damaged. The map was derived from synthetic aperture radar (SAR) images from the Copernicus Sentinel-1 satellites, operated by the European Space Agency (ESA). The team compared a post-event image acquired on 23 March 2020 with pre-event images taken since January 2020. The image covers an area of 166 by 56 km (103 by 35 miles), shown by the large red polygon. Each pixel measures approximately 30 m across. The color variations from yellow to red indicate increasingly significant surface changes. Preliminary validation was performed by using photographs from various sources, including news media. This damage proxy map should be used as a guide to identify damaged areas. The full map is available online at [23].

**Figure 7.** Damage proxy map created by the Advanced Rapid Imaging and Analysis (ARIA) team at NASA's Jet Propulsion Laboratory (JPL) and the California Institute of Technology. This map contains modified Copernicus Sentinel data, processed by the ESA and analyzed by the NASA JPL/Caltech ARIA team. This task was carried out at the JPL, funded by NASA. [23].

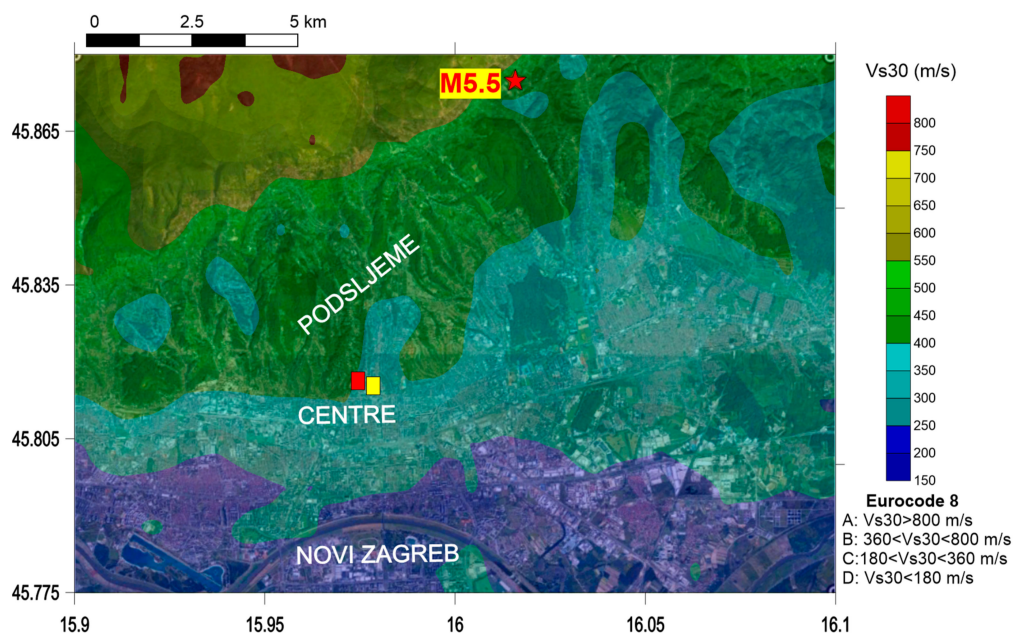
Interestingly, the first scientifically explained observation of the local soil amplification effects and variable earthquake damage due to different local geological units during shaking was presented by Stur [44], who analyzed the Klana (Croatia) earthquake sequence with the main shock on 1 March 1870 ( $I_{max} = VIII$  °MSK), presenting a detailed report on building construction and observations of the unequal distribution of earthquake damage related to soil conditions with geological sketches, damage locations of objects and a map of the shaken area. Herak et al. [45] presented their macroseismic study of this earthquake sequence and measured the horizontal-to-vertical spectral ratios (HVSRS) of ambient noise at six locations to compare estimates of soil response in the epicentral area with observations of site effects [44] during the Klana earthquake. Presented findings and observations from [45] are similar to the observations of [44] about local site effects in Klana and Studena. Similarly, we attempted to assess the seismic site amplification distribution that occurred during the Zagreb M5.5 earthquake to possibly correlate it with observed damage in the city area and local site effects. For the first-order assessment of seismic site conditions, we used maps of the average shear velocity down to 30 m ( $V_{S30}$ ), which is correlated with topographic slope [46], as displayed in Figure 8.

**Figure 8.**  $V_{S30}$  map of the Zagreb area obtained based on approximation via correlation to topographic slope ([46]; source: [47]). Locations of Zagreb Cathedral (yellow square) and Croatian Parliament (red square) are shown. The M5.5 epicenter location is marked with a red star.

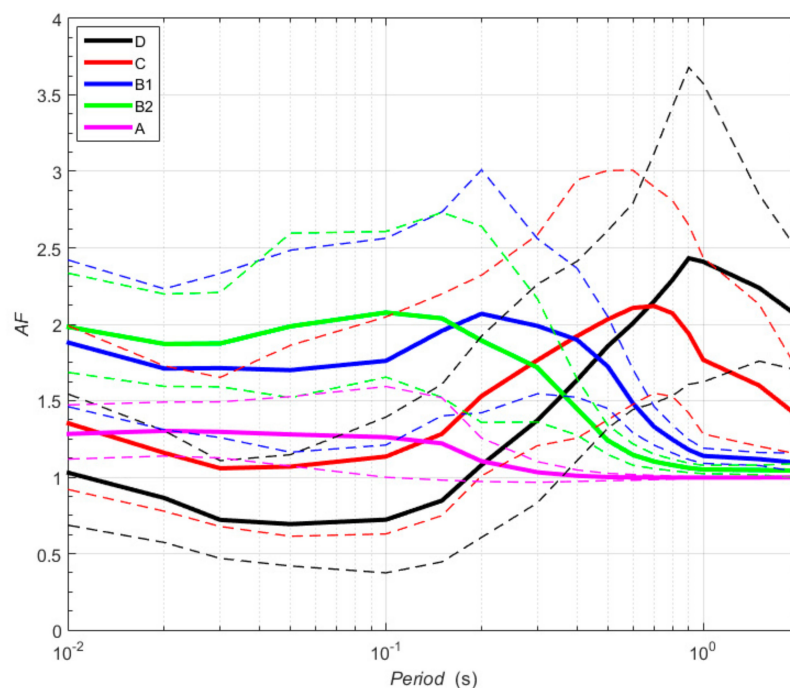
**Figure 9.** Median site amplification factors [41] for  $V_{S30}$  site classes based on Eurocode 8 with ( $\pm 1$  standard deviation (dashed lines) for the  $PGA_{ROCK}$  in the range of 0.159–0.185 g.

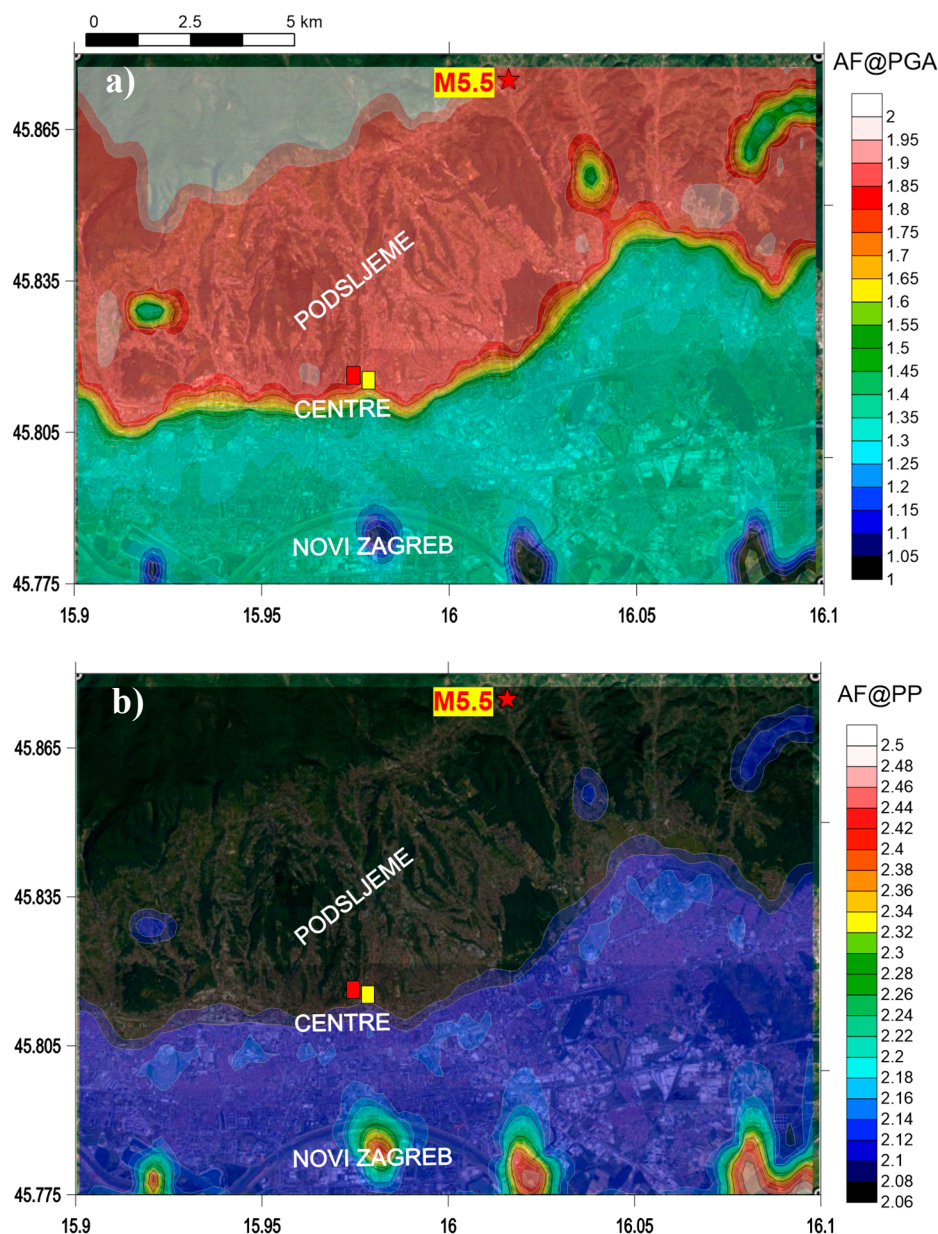
Figure 10 shows two site amplification maps for the PGA at the surface (AF@PGA) and for the predominant amplification peak period (AF@PP) for estimated  $PGA_{ROCK}$ . The amplification factor at the surface (AF@PGA) of the input M5.5 event seismic motion (approximately estimated between 0.16–0.19 g) tends to be 1.6–1.8 in the Podsljeme zone, approximately 1.4–1.6 in the city center and approximately 1.3 in the alluvial Sava zone (Novi Zagreb) due to the nonlinear effects of strong shaking [42]. At the resonant period (AF@PP), the observed amplification factor varies from 2.1 in the Podsljeme zone to 2.2 in city center and 2.4 in the Sava alluvial zone. Observed amplifications probably can also be correlated with ground motion polarization and directionality at sites with pronounced topography [60].

**Figure 10.** (a) Site amplification map for the  $PGA$  at surface (AF@PGA) and (b) the predominant amplification peak period (AF@PP) for estimated  $PGA_{ROCK}$ .

The first-order assessment of seismic amplification (due to site conditions) in the Zagreb area for the M5.5 earthquake shows that ground motions of approximately 0.16–0.19 g were amplified at least twice (if the standard deviation is taken into account, they can be amplified by a factor of 3.0 at some locations) in the Podsljeme and city center zones where the greatest extent of the damage is reported. Damage is most prominent in older buildings built before 1964, while newer buildings that were built using Eurocode 8 sustained very little or no damage, particularly in the Novi Zagreb area where the amplification factor at the resonant period is up to 2.4 (with standard deviation, it can be up to 3.6). Severe damage to the south tower of the Zagreb Cathedral (yellow square) could likely be the result of old construction and resonance effects; for category C, AF@PP = 2.2 at the period of 0.8–0.9 s (1.1–1.25 Hz), which corresponds closely to the Cathedral period of 0.71–0.92 s (1.08–1.4 Hz) [61]. Similar results are observed for the Croatian Parliament (also an old building that suffered considerable damage), where the soil category is B1 with estimated AF@PP = 2.08 at a period 0.31 s (3.16 Hz).

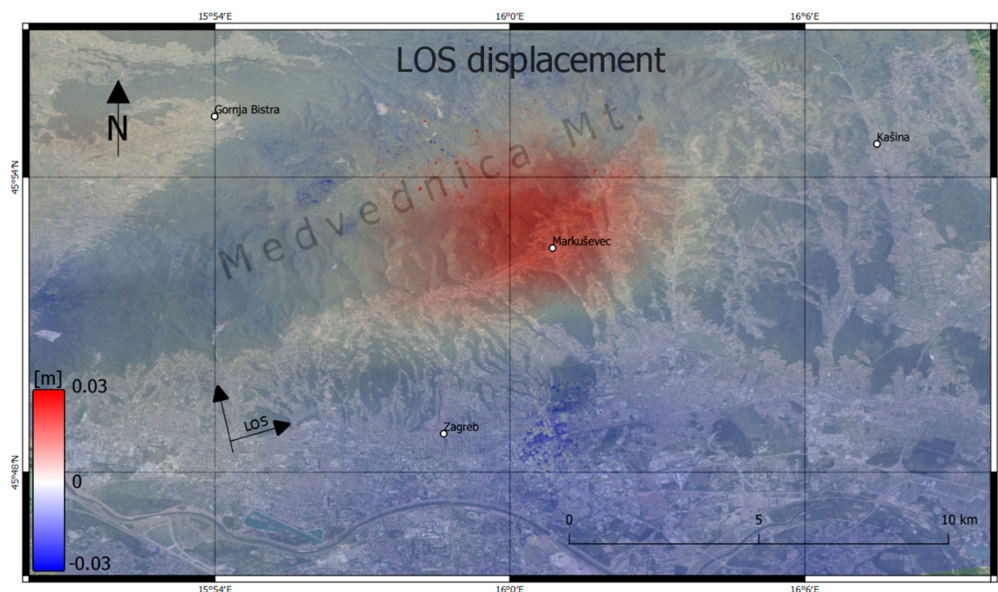
**Figure 11.** Unwrapped interferogram map indicating co-seismic line-of-sight (LOS) deformation of the 22 March 2020 earthquake.

The observed co-seismic deformation implies an approximately 3 cm uplift of the epicentral area that covers approximately 20 km<sup>2</sup>.

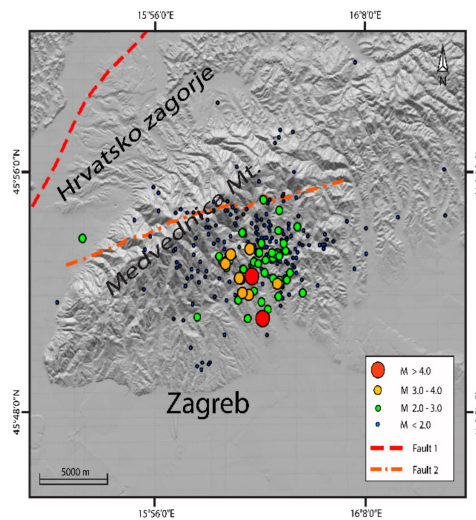
A set of 257 measurements was analyzed both spatially and temporally and processed for import into geological 3D modeling software. To achieve better visual insight, the hypocenters were scaled based on magnitude values ( $M_L$ ) into four intervals: <2.0, 2.0–3.0, 3.0–4.0 and >4.0 (Figure 12).

**Figure 12.** Spatial distribution of earthquake epicenter locations in the period from 22 March to 1 April 2020 (the Zagreb 2020 earthquake sequence). Fault lines are simple projections of the two modeled fault plains from the deep subsurface of the Medvednica Mountains to the surface (see Supplement 1 and Figure 13).

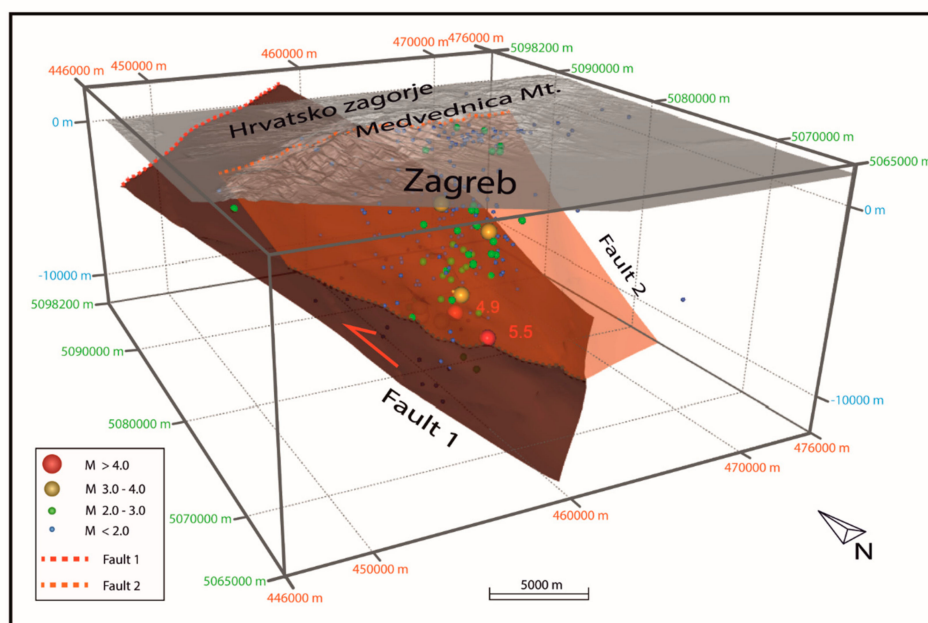
**Figure 13.** Preliminary structural 3D model of the Zagreb 2020 earthquake sequence. Coordinates are shown in HTRS96/TM coordinate system, and the elevation is in meters (no vertical exaggeration). Fault 1 is interpreted as a primary thrust fault, and Fault 2 is interpreted as a secondary (reverse?) fault.
