Locating Hidden Elements in Walls of Cultural Heritage Buildings by Using Infrared Thermography

Abstract: The structure of Tvrđa and its buildings date back to the Middle Ages. Tvrđa represents the Old Town of the city of Osijek and the best-preserved and largest ensemble of Baroque buildings in Croatia. After the withdrawal of the Ottomans in 1687, during the 18th century, the Austro-Hungarian administration systematically formed a new fortification system, regulated streets and squares and built a large number of military objects. Tvrđa took its present form in the 19th century and has kept it since then. Investigating the historical development of individual buildings, in addition to archival sources and existing architectural documentation, the obvious source of information are the buildings themselves. The aim of this paper is to explore the possibilities of using infrared thermography to find structural elements and hidden openings in historic buildings in Osijek's Tvrđa. This paper describes the exploration of the 18th century openings on the facades of the former Kostić houses. The facades were bricked into the walls in the 19th century because houses were reused and their

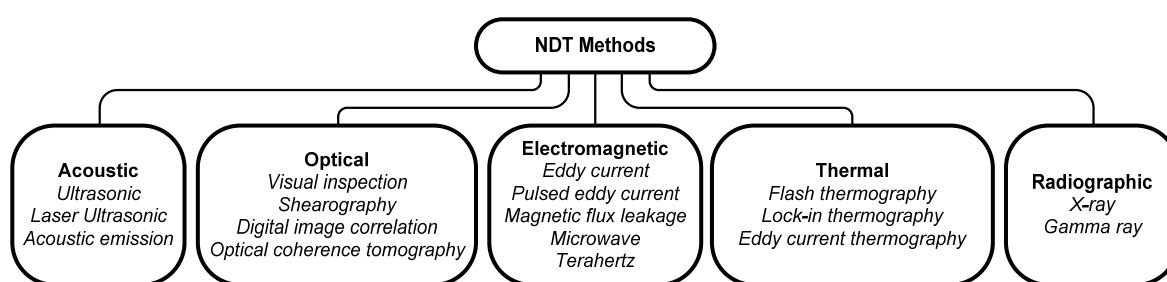
Figure 1. Categories of nondestructive testing (NDT) and evaluation of techniques [5].

The general division of the NDT method shown in Figure 1 can be further expanded, depending on specific applications. Basic nondestructive testing (NDT) methods and techniques, useful in assessing concrete structure durability, were applied for testing concrete structures in the work of [6]. One of the early Laboratory Testing Concrete Elements is available in [7]. The selection of a particular NDT method depends heavily on the object to be tested. In the article of [4], the appropriate methods for each test were provided, as presented in Table 1.

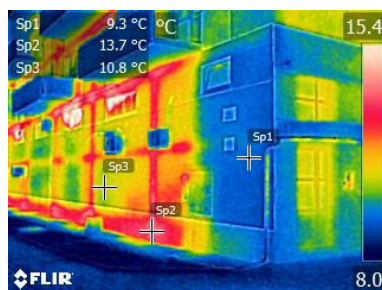
Qualitative thermography provides basic information about the temperature distribution on the surface of analyzed structures. The actual temperature values may differ significantly from those read on the camera. Figure 2 shows a residential building with the areas for commercial usage on the ground floor, where horizontal ties and structural elements are clearly visible, as well as a part of the staircase (bottom right corner of the building) which is not a heated space.

Figure 2. An example of highly-visible structural elements as well as a heated and an unheated space.

Based on the thermogram, it is possible to install new openings without jeopardizing the loadbearing static of the structure. Compliance with the requirements of the Technical Regulation on Rational Use of Energy and Thermal Protection in Buildings can be analyzed by infrared thermography.

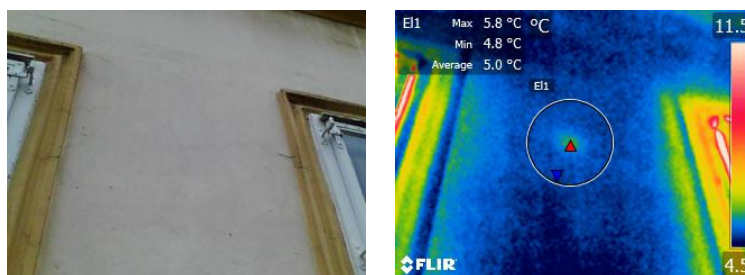
A weak dot heat bridge on the first floor was noticed (Figure 18). This was probably a result of the metallic anchorage (structural element) covered with plaster during the last facade maintenance.

Figure 18. Discovered weak point heat bridge.

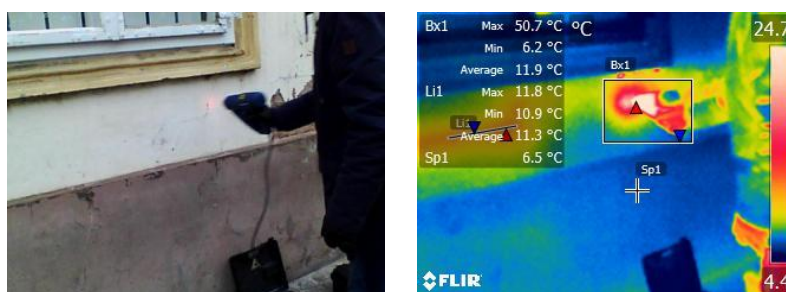
In order to determine the existence of discontinuity in the outer envelope, heating was applied, as is shown in Figure 19.

Figure 19. Initial application moment of thermal excitation.

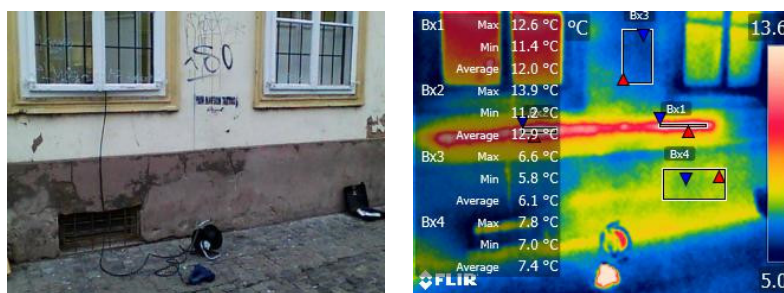
There was not any discontinuity by the analysis of the thermal pattern change. In Figure 20, a linear trace of the heating body, which is continuous and uninterrupted, can be observed.

Figure 20. Homogeneous thermal pattern on excitation along the wall.

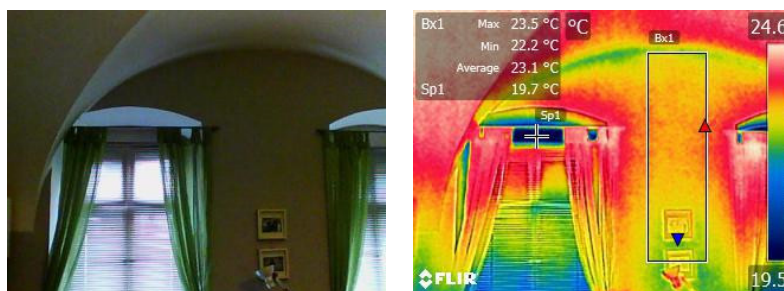
In order to confirm the conclusions, the examined place was checked from the inside of the building. Significant thermal masses and continuous heating have resulted in a constant thermal pattern, presented in Figure 27.

Figure 27. Thermal pattern on the inside of the wall.
