Destructive M6.2 Petrinja Earthquake (Croatia) in 2020—Preliminary Multidisciplinary Research

Abstract: On 28 December 2020, seismic activity in the wider Petrinja area strongly intensified after a period of relative seismological quiescence that had lasted more than 100 years (since the well-known M5.8 Kupa Valley earthquake of 1909, which is known based on the discovery of the Mohorovičić discontinuity). The day after the M5 foreshock, a destructive M6.2 mainshock occurred. Outcomes of preliminary seismological, geological and SAR image analyses indicate that the foreshocks, mainshock and aftershocks were generated due to the (re)activation of a complex fault system—the intersection of longitudinal NW–SE right-lateral and transverse NE–SW left-lateral faults along the transitional contact zone of the Dinarides and the Pannonian Basin. According to a survey of damage to buildings, approximately 15% of buildings were very heavily damaged or collapsed. Buildings of special or outstanding historical or cultural heritage significance mostly collapsed or became unserviceable. A preliminary analysis of the earthquake ground motion showed that in the epicentral area, the estimated peak

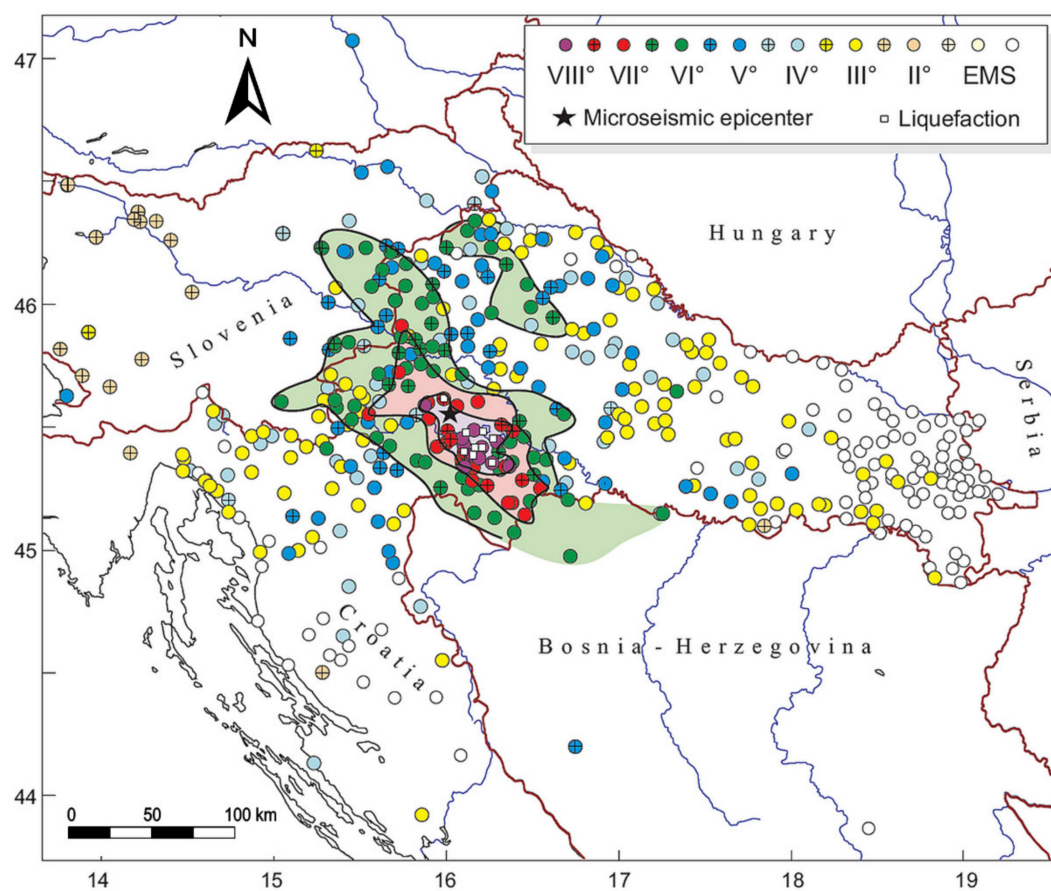
Figure 2. Isoseismal map of the Kupa Valley earthquake on 8 October 1909—macro seismic intensities were assessed according to the European Macroseismic Scale (EMS) [7].

In contrast to the macroseismic isoseismal map of the 1909 event (Figure 2), the highest intensities extend in the NE–SW direction (Figure 3). This direction is almost perpendicular to the direction of the maximal intensity isoseist (pleistoseist) in the case of the Kupa Valley 1909 earthquake.

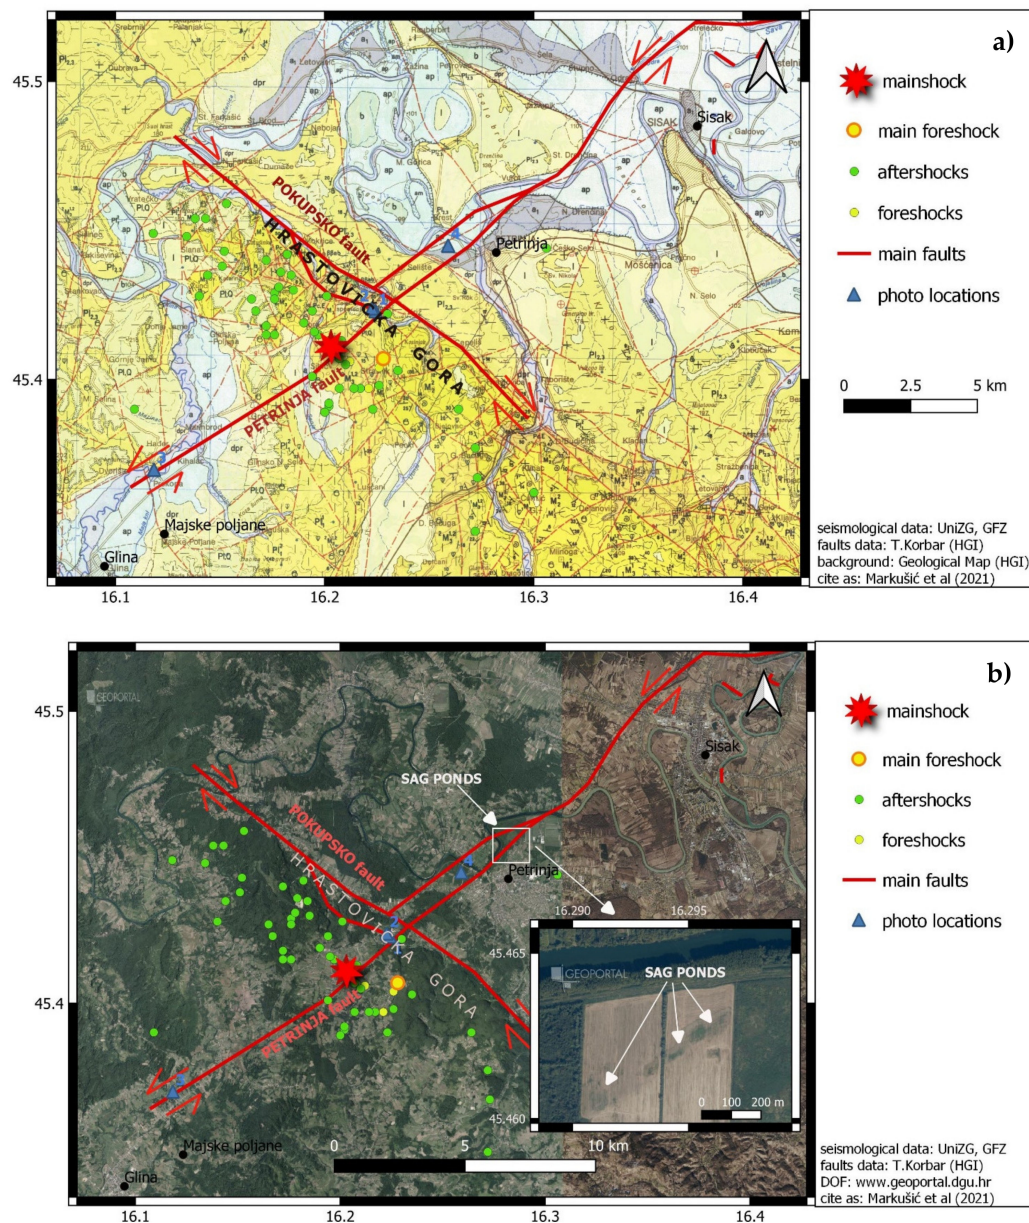
Figure 5. (a) A geological map of the Sisak, Petrinja and Glina areas in Croatia [14] with main faults (thick red lines) of the activated fault system highlighted, the activation of which caused earthquakes on 28 and 29 December 2020 (orange units = Paleogene (Pc, E), yellow units = Neogene (M), light yellow units = Quaternary loess (l) and colluvium (dpr), gray and light blue units = Quaternary alluvium (a, ap), light green units = palustrine); and (b) An interpreted orthophoto image [13] of the activated fault system that was captured a few years before the 2020 earthquakes. Numbers and blue triangles mark the positions of the field photographs that are shown in Figure 6: 1–6A, 2–6B, 3–6C, 4–6D. The inset shows sag ponds along the main creeping sinistral fault line, appearing on an active agricultural land (the orthophoto image is taken in 2018).

The intersection of two faults (longitudinal and transverse faults) on the extension of the Dinarides (NW–SE) can be identified (Figures 5, 7 and 8). Both faults consist of multiple faults with horizontal strike-slip block movements. The transverse fault is a less known, nearly aseismic creeping fault, which is referred to as the sinistral Petrinja Fault. The longitudinal fault is the well-known regional dextral Pokupsko Fault. This fault system is a textbook example of deformations that occur in rock due to compressional stress along the generally north–south axis (Figure 4) and the pre-existing fault net (Figure 5).

An orthophoto image (which was captured a few years before the 2020 earthquakes) of a section of the Petrinja Fault that strikes NE–SW and crosses the Kupa Valley (Figure 5) shows typical strike-slip sag ponds, which were created due to probably continuous movements along the creeping Petrinja Fault. The sag ponds are clear evidence of the fault

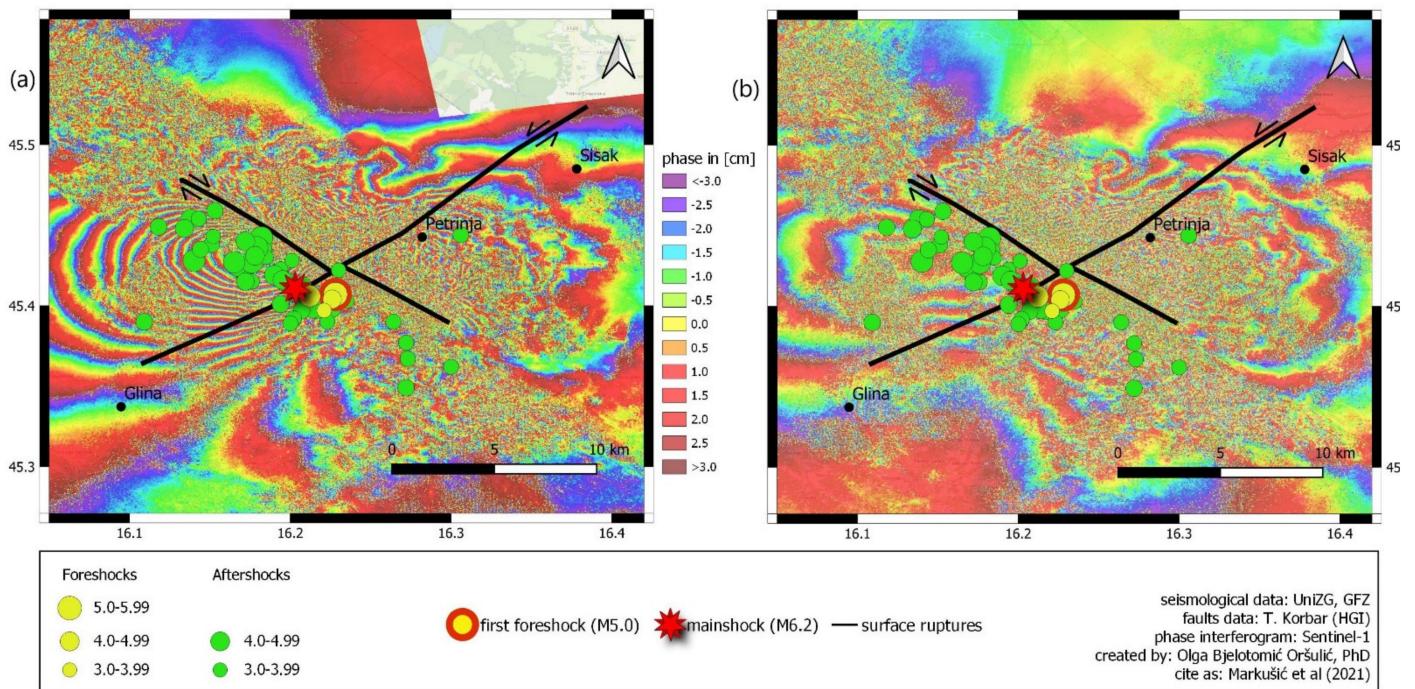
Figure 7. Interferogram of the (a) Sentinel-1A ascending orbit T146 and (b) Sentinel 1-B descending orbit T124. Each colour fringe corresponds to 2.8 cm of ground displacement (corresponding to a displacement of half of a wavelength of 5.6 cm, since the origin of the data is C-band radar).

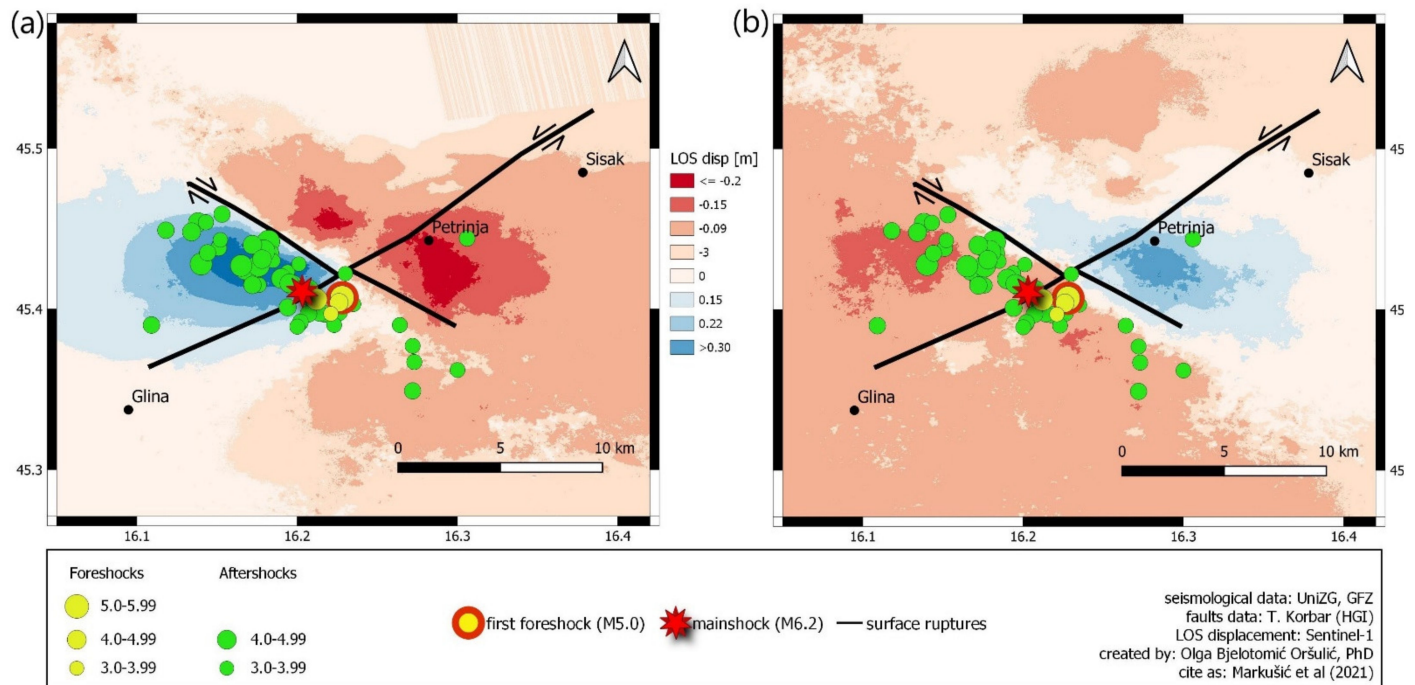
Figure 8. Line of sight (LOS) displacements for (a) Sentinel-1A ascending orbit T146, which has an amplitude of 74 cm and (b) Sentinel-1B descending orbit T124, which has an amplitude of 53 cm.

The results of the SAR analysis (Figure 8) clearly show a fault zone that stretches from NW to SE, which is identified as the Pokupsko Fault, and it corresponds entirely to the geological data. The SE extension of the fault, which is not marked by clear surface ruptures, is also visible. In addition, the strike of the Petrinja Fault (NE to SW) is also recognized although it cannot be clearly identified by SAR analysis, which is likely due to the resultant vector of the dextral and sinistral movements along the fault system. The resultant vector is the largest in the eastern and western quadrants of the fault system; thus, the Petrinja earthquake 2020 resulted in clear east–west lateral extrusion of the faulted blocks that were delineated by the activated faults.

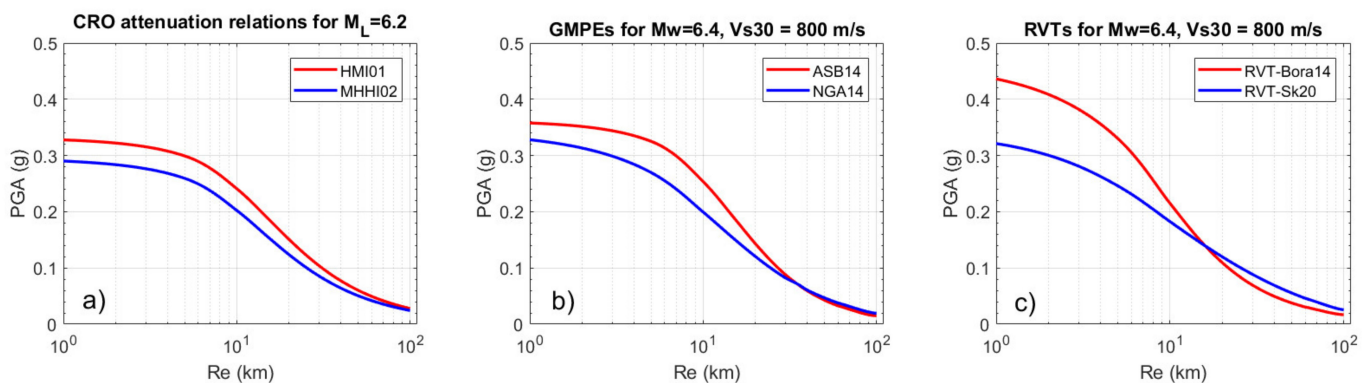
Figure 13. Estimation of the distance scaling PGA for rock ($V_{S30} = 800$ m/s) based on (a) available Croatian attenuation relations HMI02 and MHHI02, (b) GMPEs from ASB14 that were derived for Pan-European sites and NGA14 (NGA West-2 GMPEs) from BSSA14 and CY14 (with weights of 0.5 for each), and (c) Random Vibration Theory models that were derived by Bora14 for the RESORCE-2012 database and RVT-Sk20 for the BSHAP database.

We tested USGS ShakeMap using the attenuation of the peak horizontal acceleration in the Dinarides area relations that were developed by Herak et al. ([60], HMI01) and Markušić et al. ([61], MHHI02) to the level of the average rock or very stiff soil sites (Figure 13a). We also selected three global, empirical ground-motion equations (GMPEs) that might be applicable to this region: (1) the hypocentral distance model of Akkar et al. ([62], ASB14), which was derived using pan-European datasets and two NGA-WEST 2 models (referred to as NGA14) with weights of 0.5; (2) the model of Boore et al. ([63], BSSA14) and (3) the model of Chiou and Youngs ([64], CY14), which was tested by Šalić et al. [65] for the Western Balkan BSHAP strong motion dataset (Figure 13b). Additionally, we tested the Bora et al. ([66], RVT-Bora14) model, which uses random vibration theory (RVT) to predict Fourier amplitude spectra and the duration of ground motion to estimate the response spectra from the RESORCE-2012 strong motion database of the SIGMA project. The same RVT method was used by Skendrović ([67], RVT-Sk20) on the analogue recordings in the BSHAP strong motion database [65,68] and was used in this preliminary analysis, together with the Bora14 model, for comparison (Figure 13c). Since this is a preliminary analysis and we do not have a full seismotectonic analysis of the fault mechanism, GMPE estimations were made for a strike-slip fault with a 90-degree dip using a point source distance model ($R_e = R_{JB}$ and $R_{hyp} = R_{rup}$), similar to [65]. For consistency and comparison, all PGA-distance models in Figure 13 are scaled to the epicentral distance R_e .

The preliminary analysis showed that for the $M_{6.2}$ (or $M_w6.4$) earthquake in the epicentral area (1 km) for the rock site ($V_{S30} = 800$ m/s), the estimated PGA values from the Croatian attenuation relations are 0.327 g (HMI01) and 0.290 g (MHHI02), those from the GMPE models are 0.317 g (ASB14) and 0.298 g (NGA14), and those from the RVT models are 0.436 g (Bora14) and 0.321 g (Sk20). These values are reasonably comparable with USGS ShakeMap rock predictions in the epicentre [59], namely 0.3 g. However, in comparison to Figure 12, site effects significantly influence the amplification of seismic ground motion. According to the Croatian Seismic Hazard Map [32] for the 95- and 475-year return periods (accepted as a part of the National Annex to Eurocode 8), the Petrinja area is located in a relatively moderate seismic hazard zone: 0.08 g (95 yrp) and 0.16 g (475 yrp) peak ground accelerations. The estimated PGA values in Figure 13 for $M_w6.4$ and for the close epicentral area (up to 10 km) substantially exceed the seismic hazard 95- and 475-yrp values. However, they are comparable with 0.33 g for 1000 yrp. This proves the significance of this earthquake within the known historical seismicity in this area. More important is the question of what type of impact this earthquake will have on future seismic hazard calculations not only for the epicentral area but also for the Zagreb city area, within which over 1 million people live.

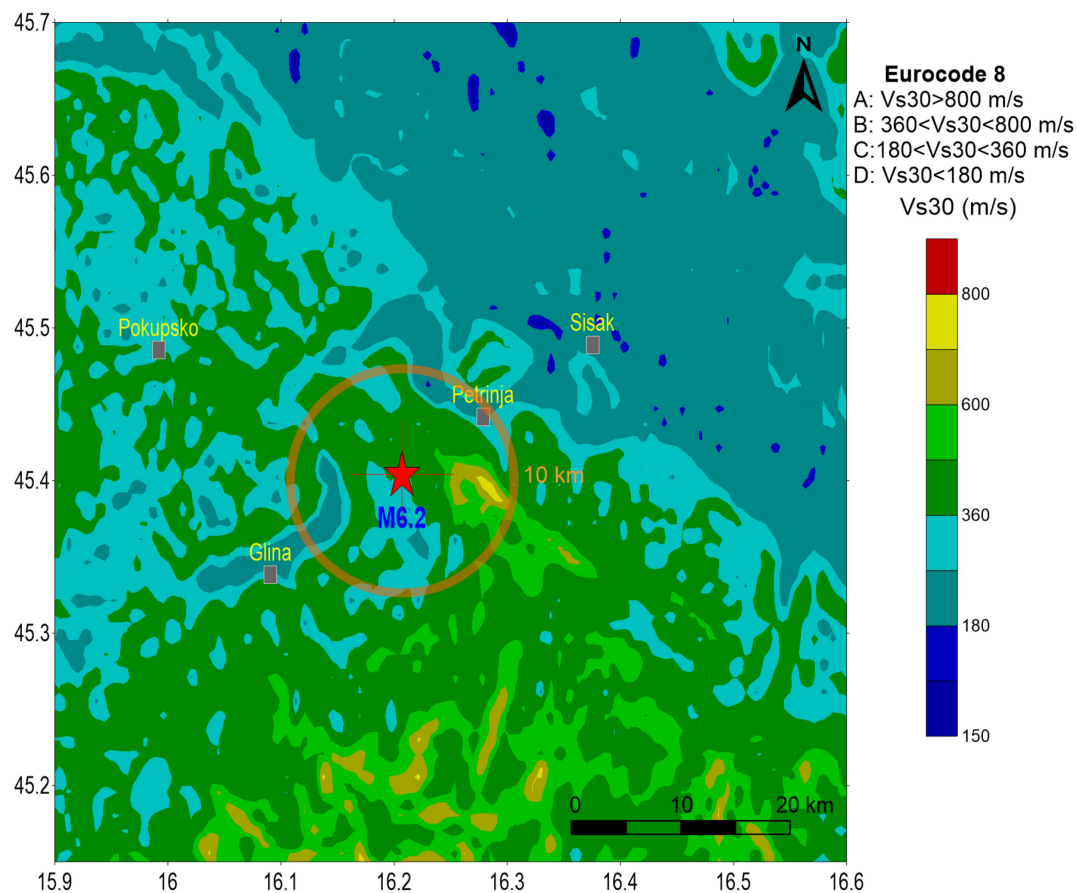
Figure 14. Available V_{S30} map that is based on topographic slope [69]. The red star represents the location of the M6.2 Petrinja 2020 earthquake (M_w 6.4 by USGS). The orange circle represents a 10 km distance from the epicentre.
