Residential building stock in Serbia: classification and vulnerability for seismic risk studies

Source / Izvornik: **Bulletin of earthquake engineering, 2023, 21, 4315 - 4383**

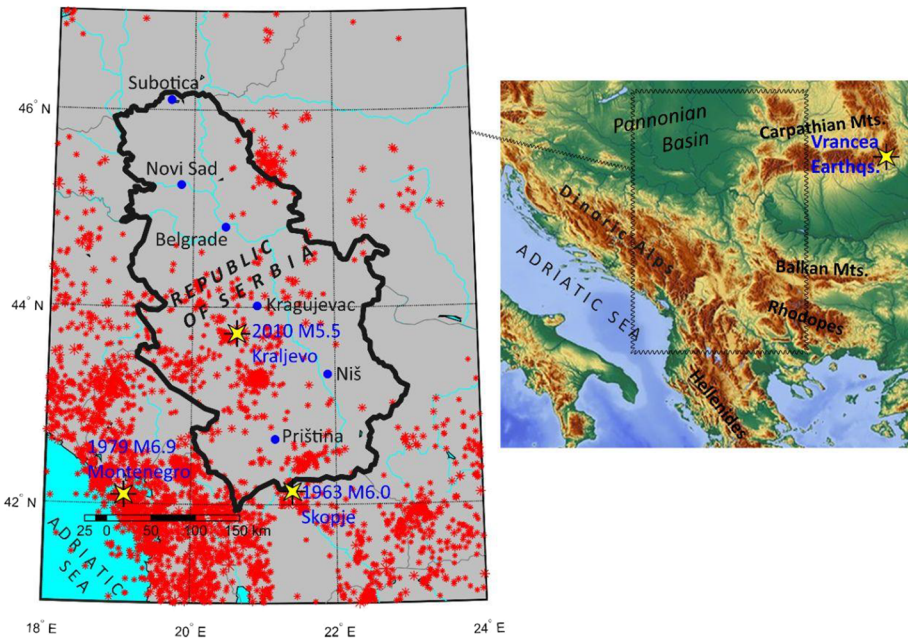
Fig. 1 Earthquakes in Serbia and the region. **a** Epicenters of the regional earthquakes with $M_w \geq 3.0$, recorded between 1900 and 2021 (USGS 2021), including the epicenters of the most significant seismic events from 1963-present, and **b** a geographic map of Serbia (shown within the frame) and the Balkan region, showing the location of the Vrancea, Romania seismic source zone

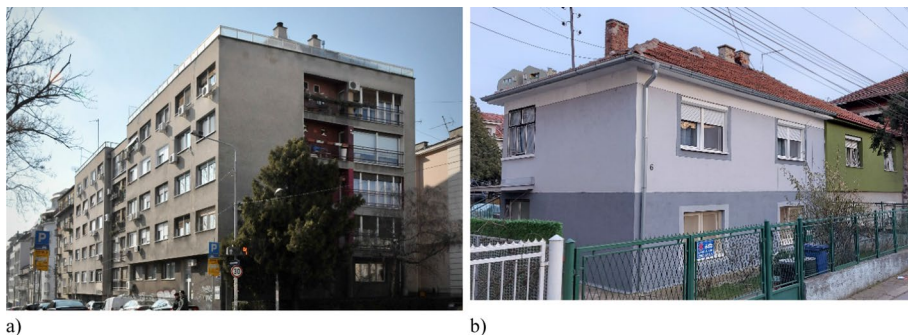
Fig. 11 URM buildings with rigid diaphragms: **a** type M3-M: a typical 5-storey multi-family residential building in Belgrade (post-WWII construction) and **b** type M3-S: a single-family residential building of the 1960 vintage in Niš

Masonry buildings of type M3-M were constructed from the end of WWI until the beginning of the 1970s. These are multi-family apartment buildings found in Serbian urban centres and usually have 3 to 6 floor levels (Fig. 11a). These buildings are regular in plan and elevation, their wall layout is relatively symmetrical, and there are no elevators (only staircases). Load-bearing masonry walls were typically constructed using solid clay bricks and cement:lime:sand mortar. Typical wall thickness is 38–51 cm and 25–30 cm for exterior and interior walls respectively.

Masonry buildings of type M3-S were constructed from the 1950s until the present time. These are low-rise single-family residential buildings found both in suburban areas of urban centres and rural areas (Fig. 11b). Load-bearing masonry walls were typically constructed using modular (multi-perforated) clay blocks or solid clay bricks and

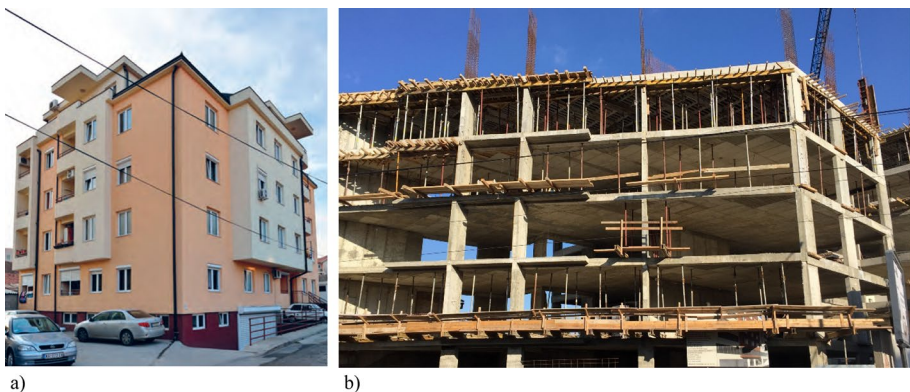
Fig. 14 Cast-in-situ RC frame-wall building typology—type RC2: **a** a 4-storey multi-family residential building in Belgrade (Jovanović Popović et al. 2013c) and **b** an RC2 building under construction in Belgrade

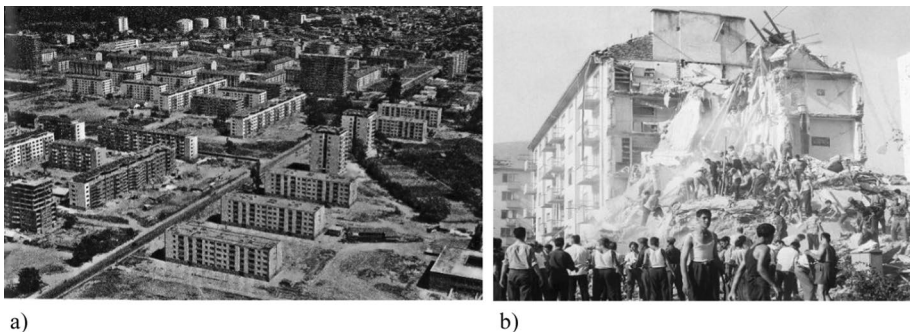
Fig. 17 Damage of masonry buildings (type M3) in the 1963 Skopje earthquake: **a** Karpoš building complex with 40 3–5 storey URM apartment buildings, and **b** a partially collapsed building No.13. (Source: Milutinovic 2022)

Performance of type M3 buildings in the earthquake can be illustrated on the example of the Karpoš residential complex in the western part of Skopje, which was constructed in the 1950s (Berg 1964), Fig. 17a. The complex comprised of 40 buildings, with the height ranging from 3 to 5 floors. The buildings were designed according to standardized designs, with load-bearing walls provided only in one direction (either longitudinal or transverse). One of the densely populated 5-storey buildings (labelled No. 13) partially collapsed and caused 159 fatalities (Fig. 17b). Various damage patterns were observed in these buildings, ranging from in-plane shear cracks to horizontal offset at floor levels (Berg 1964). Detailed reports on post-earthquake surveys of these buildings are available (Milutinović 2022).

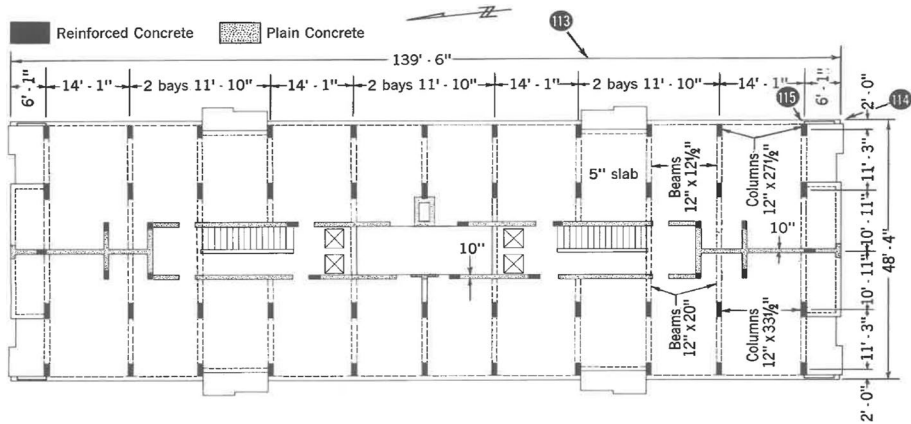
Fig. 18 Floor plan of Karpoš Tower, Skopje (Berg 1964)

Three 14-storey RC apartment buildings in the Karpoš residential complex (called the Karpoš Towers) were also exposed to the 1963 Skopje earthquake (Berg 1964). The buildings had a cast-in-situ RC frame system with RC floors and can be classified as RC1-type buildings according to the proposed classification. The buildings had a rectangular plan, 43 m long and 15 m wide (Fig. 18). Lateral load-resisting system in the transverse direction consisted of parallel RC frames, at approximately 4.0 m spacing. The frames were discontinued at the stairwells. Plain concrete structural walls were provided in the longitudinal direction along two interior gridlines and around the stairwells. Rectangular RC columns had 70 cm by 35 cm cross-sectional dimensions, 6 longitudinal reinforcing bars

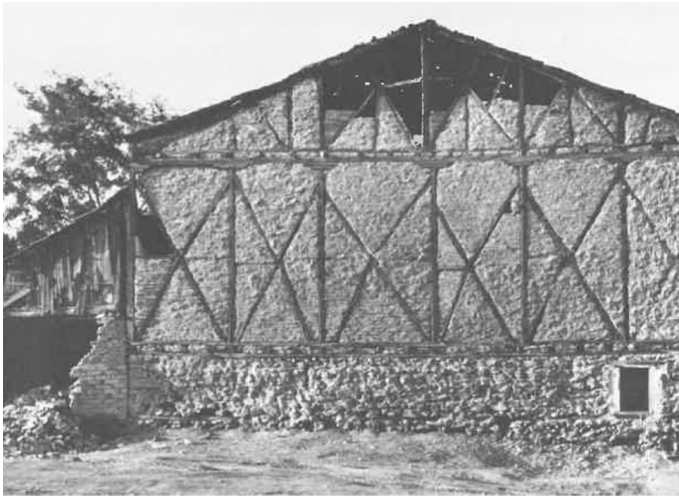
Fig. 20 Minor damage of a timber-framed house (type W) in the centre of Skopje due to the 1963 earthquake (Berg 1964)

At the time of the earthquake, several older timber-framed houses infilled with adobe bricks (*bondruk*) existed in Skopje (type W according to the proposed classification). A type W building shown in Fig. 20 was located close to the Karpoš residential complex and experienced only a minor damage, as opposed to severe damage and destruction of modern masonry buildings (Berg 1964).

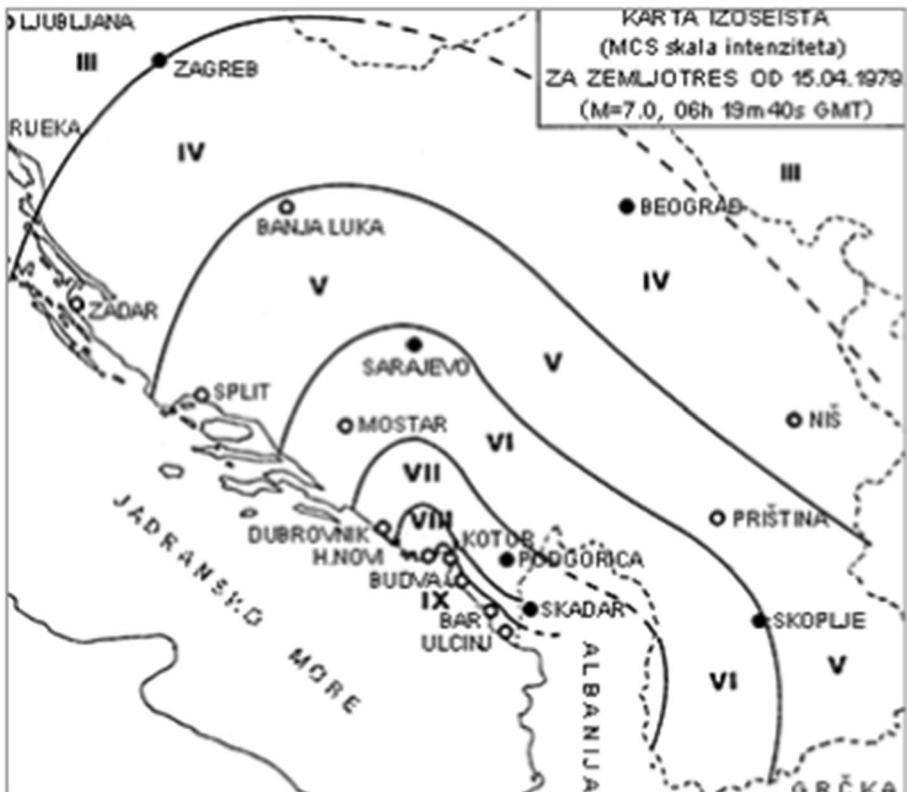
Fig. 23 Intensity map for the 1979 Montenegro earthquake (ZHMS 2013)

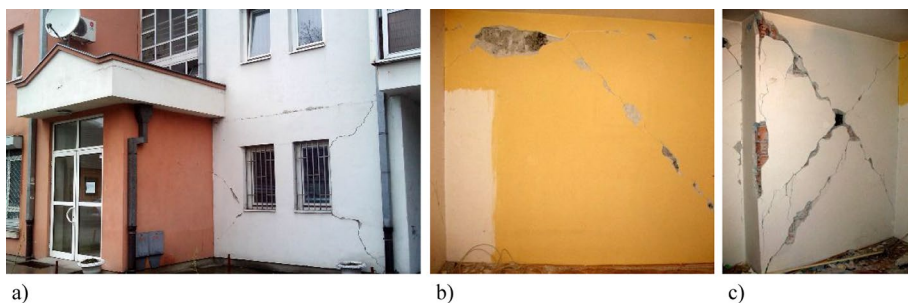
Fig. 30 Performance of type M3-M multi-family residential buildings in the 2010 Kraljevo, Serbia earthquake: **a** diagonal and horizontal cracks in an exterior wall; **b** in-plane damage of a load-bearing interior wall (solid clay bricks), and **c** extensive cracking in a partition wall (multi-perforated clay blocks) (Blagojević 2022)

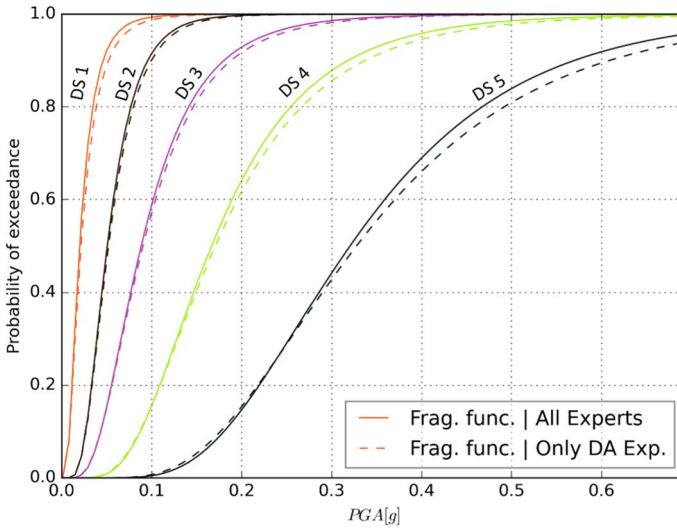
Fig. 35 Fragility functions for the URM building with rigid floors (type M3-M) derived from expert judgement for different DSs. Solid lines are the DS fragility functions derived based on the opinion of all 40 experts that filled the questionnaire (“All Experts”), while dashed lines are the DS fragility functions derived based only on the opinion of experts with post-earthquake damage assessment experience (“Only DA Exp.”)

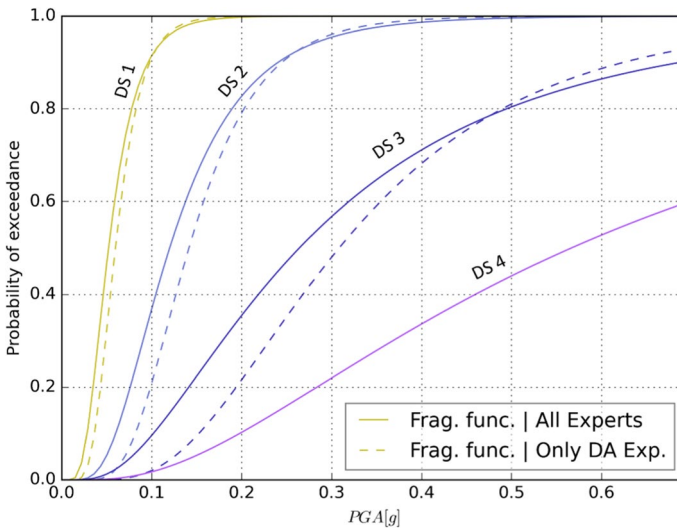
Fig. 36 Fragility functions for the three-story reinforced concrete frame with infills typology (RC1) from the survey form. The fragility functions are derived from expert judgement for different DSs. Solid lines represent the DS fragility function derived based on the opinion of all 40 experts that filled the questionnaire (“All Experts”), while dashed lines are the DS fragility functions derived based only on the opinion of experts with post-earthquake damage assessment experience (“Only DA Exp.”)
