Seismic Performance Assessment of the 18th Century Jesuit College in Dubrovnik's Old City

Journal article, Published version

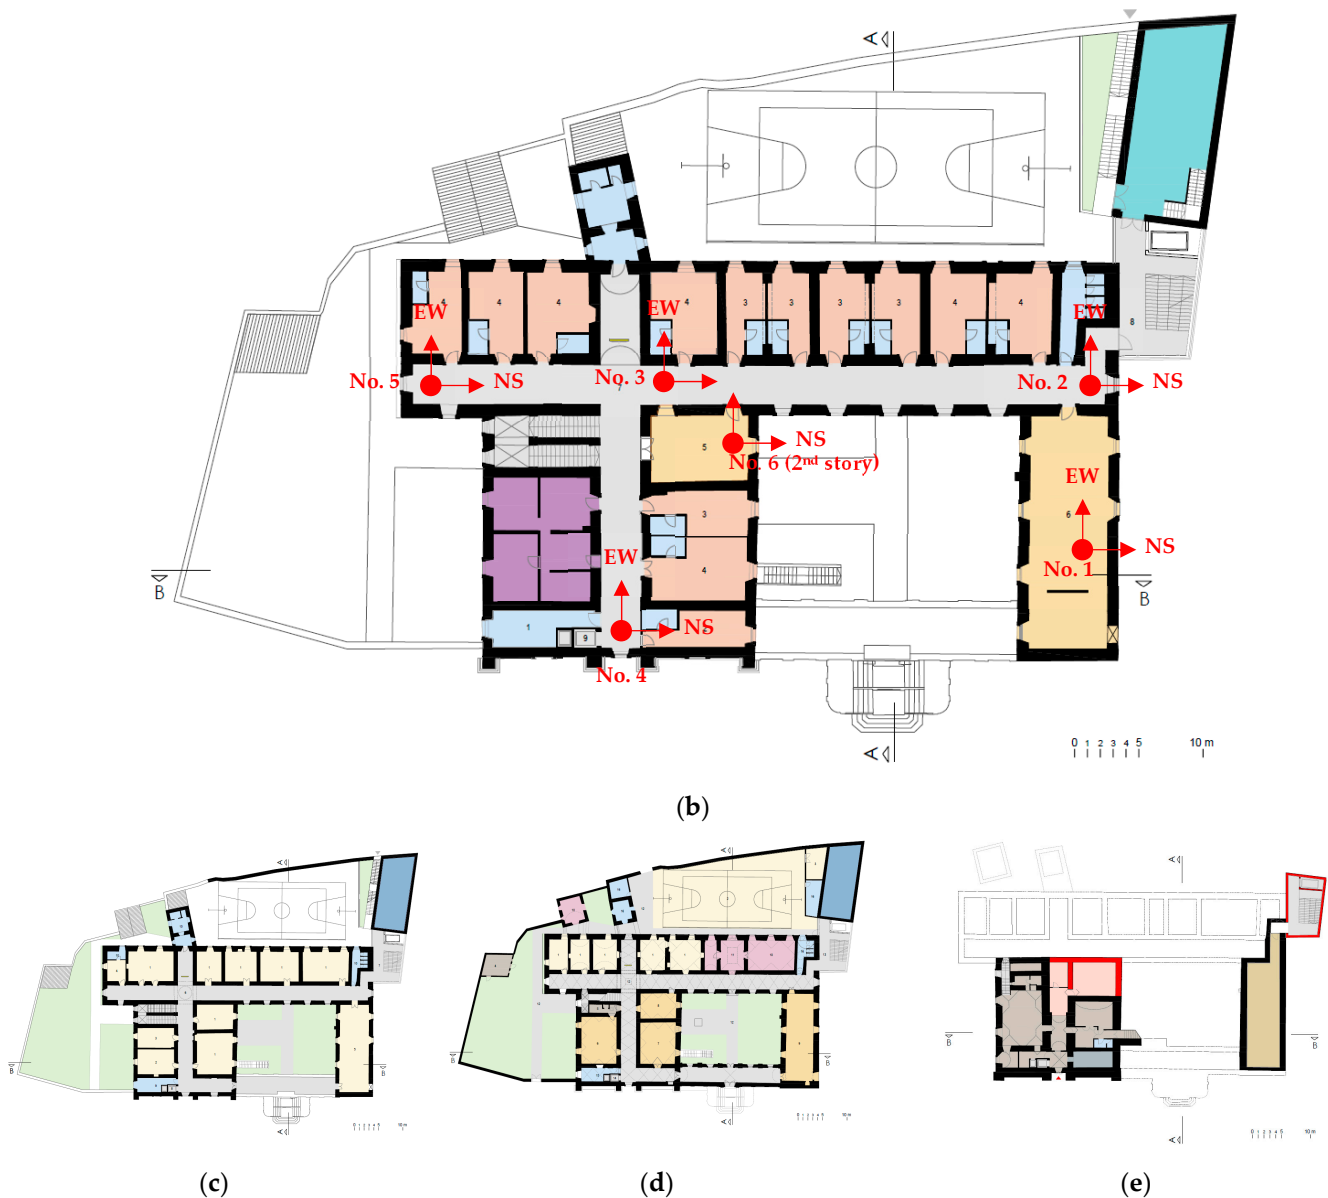
Figure 5. Cont.

Figure 5. Building plan with an overview of the sensor layout and direction (red): (a) 3rd story (attic); (b) 2nd story; (c) 1st story; (d) ground story; (e) basement.

In assessing the seismic performance of the cultural heritage building, the determination of the stiffness of the structure (or individual structural elements) is an important task, often made difficult due to various influencing parameters, such as non-uniform quality of masonry workmanship (see Section 2.1), unknowns within or above the structural elements (thick walls, vaults, etc.), interconnectivity, and damage. The optimal solution in such cases is the calibration of a structural model utilizing vibrational characteristics of the building (natural frequencies), where the geometrical properties are known, and the material characteristics are determined by a trial-and-error process. To identify the natural frequencies, ambient vibration (noise) measurements were collected within the Jesuit College building in two ways: (1) Up to 20 min long (interim) at the 2nd and 3rd story (attic) using HVSr instruments (at five different locations per story); (2) Continuous over 3 days in the 2nd story using a SARA instrument (at one location). The north-south (NS), i.e., the longer direction of the building's south wing (see Figure 5a,b), and east-west (EW) response components were simultaneously measured at a sampling rate of 128 Hz. The fundamental frequencies in NS and EW directions were determined from the Fourier amplitude spectrum of the two recorded horizontal components (see Table 1 and Figure 6). Since no experimental modes were identified, it is not possible to correlate the frequencies with structural mode shapes. Therefore, the measured frequencies are referred to as f_{NS} and f_{EW} for the measurements recorded in the NS and EW directions, respectively. The mean frequency is used as a reference for the calibration of the finite element structural model. The standard deviation (St. dev.), variance (Var.), and variation coefficient (Var. coeff.) indicate the range of variability in the measured response.

In addition to an overview of the sensor layout, Figure 5c–e provides an insight into the structural (stone) masonry wall disposition and irregularity of the building construction. The positions for the measurements were selected across the building to possibly verify the interconnectivity between different wings of the building (structural wholeness). The calculated coefficient of variation is approximately 34% for the 2nd story and 12.5% for the 3rd story (EW and NS) (see Table 1). The overall variation coefficient is approximately 30% for the EW direction and approximately 20% for the NS direction, which indicates irregular behavior of different parts of the building, variation in material properties, structural weaknesses, and material degradation. The natural periods of the building, based on the overall average frequencies, are 0.16 s in EW, and 0.13 s in NS, i.e., longer direction, respectively.

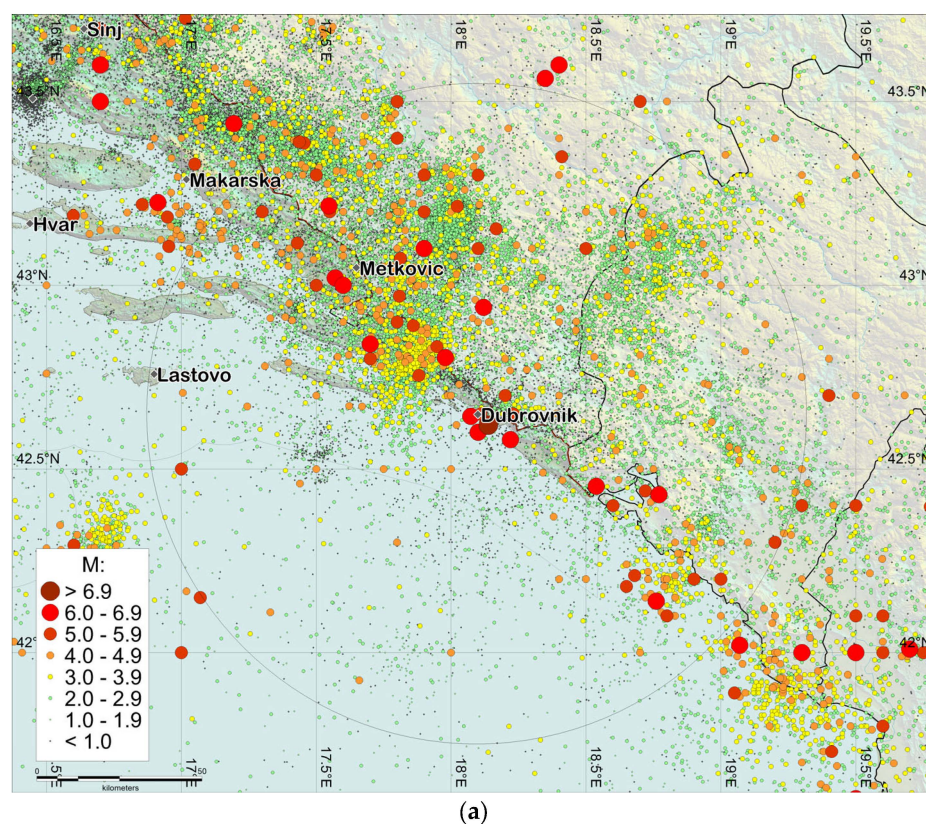
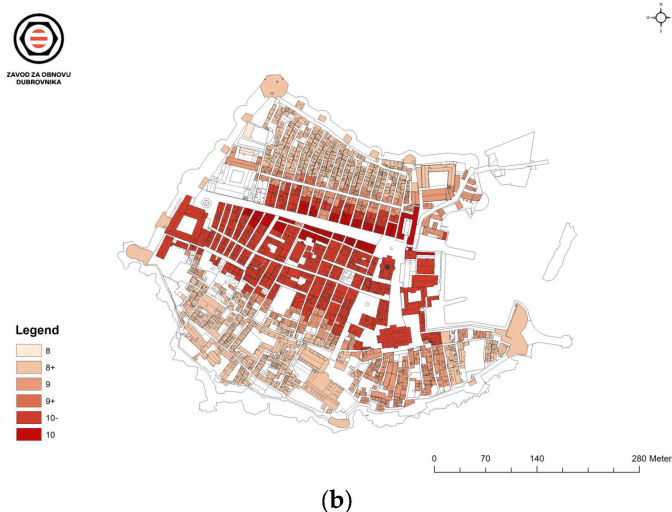
Figure 9. Cont.

Figure 9. (a) Spatial distribution of earthquake locations around the Dubrovnik area based on data from the Croatian Earthquake Catalogue (updated and continuously supplemented version first described in [43] for the period BC–2021. Circle marks the area inside 100 km from Dubrovnik); (b) seismic micro-zoning in compliance with MCS scale available at [46].

The City of Dubrovnik is located on the coast of the Adriatic Sea in the southern part of Croatia and on the boundary between the African and Eurasian tectonic plates which move towards each other causing high seismic/tectonic activity in the region. This region is the most threatened area in Croatia with the highest expected earthquake magnitude of M7.5. According to geological classifications, the area is located at the contact between the Adriatic and Dinaric regional structural units, defined by karstic terrain and porous limestone bedrock. The immediate border of these units is the Ploče–Dubrovnik fault. Between Mljet and the Dubrovnik submarine, the Adriatic unit borders the Adriatic microplate [41]. Earthquakes are a major concern of the region due to the high concentration of cultural heritage buildings of outstanding historical significance. Since the 1979 M7.0 Montenegro Earthquake, the Old City of Dubrovnik is enlisted in the UNESCO World Heritage List [42]. Historic data for the period BC–2021 (see Figure 9), according to the Croatian Earthquake Catalogue—CEC [43], note about ten earthquakes in the region with intensity VIII or more ($^{\circ}$ MCS) out of which the most significant is the 1667 earthquake of intensity X ($^{\circ}$ MCS) [44,45]. Before the Great Dubrovnik Earthquake of 1667, strong earthquakes from 373 BC, 376, 1471, 1482, 1504, 1516, and 1520 are mentioned, which caused damage to the area. Of the very strong or severe earthquakes from the recent past, there are those from 1850 and 1869 with an intensity of VII on the $^{\circ}$ MCS scale; however, the M7 earthquake in Montenegro from 1979 is particularly highlighted. In Dubrovnik, it manifested itself as an earthquake of intensity VII ($^{\circ}$ MCS) with structural damage to numerous buildings in the Old City, including the Jesuit College (see Figure 10a).

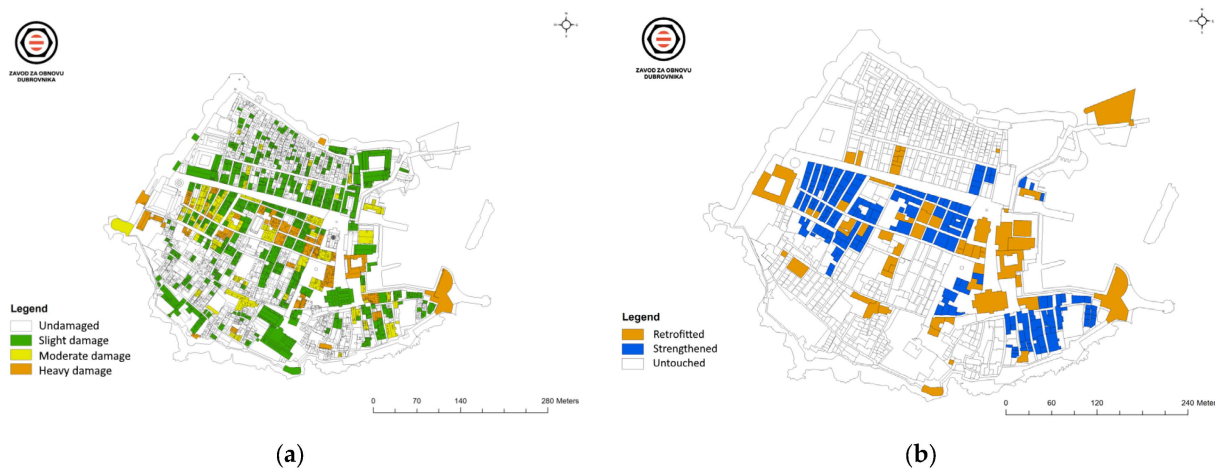
Figure 10. The Old City of Dubrovnik following the 1979 M7 Montenegro earthquake: (a) state of damage to buildings; (b) seismic intervention to buildings available at [46].

To mitigate the effect of earthquakes, retrofitting programs were initiated in the 1980s to repair and strengthen the heritage buildings in Dubrovnik (see Figure 10b). The last significant earthquake in the region occurred in 1996 near Ston VIII–IX (°MCS), and in Dubrovnik it manifested itself with an intensity of V–VI (°MCS) [47], causing minor damage to buildings in the Old City. The region remains an area of high earthquake risk (see Figure 11), emphasizing the importance of a continuous effort toward strengthening cultural heritage assets.

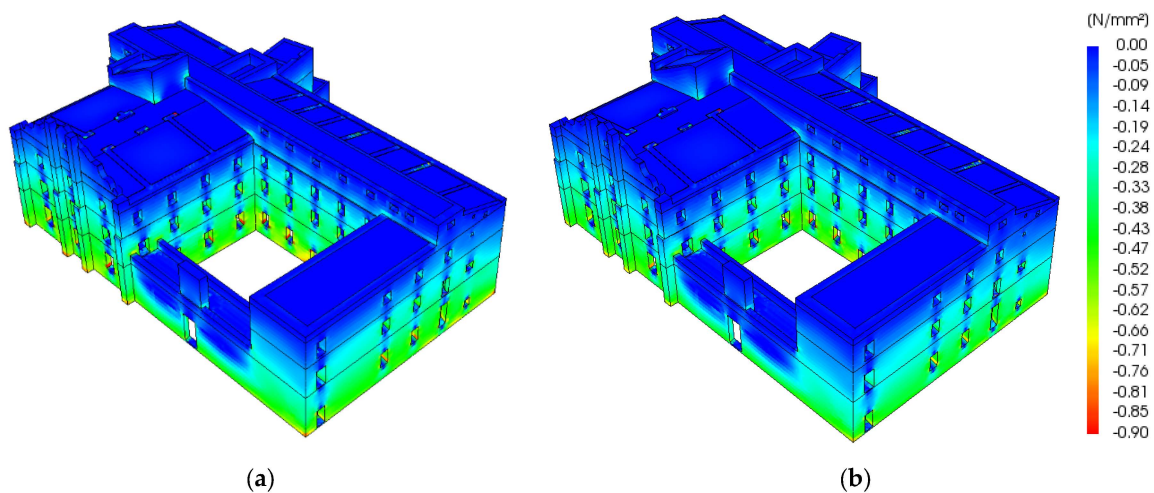
Figure 12. Vertical stresses due to the gravity load combinations applied following the code requirements: (a) Load combination LC₁; (b) Load combination LC₂.

The compressive stress limit is evaluated following the Eurocode guidelines using two design gravity load combinations [49]. To identify vulnerable zones, structural components prone to compressive stress concentration are investigated in detail. Load combination (LC₁) evaluates the structure under unfavorable permanent loads while the load combination (LC₂) considers unfavorable variable actions arising from the superimposed floor loads. The tensile ($f_{t,CF} = 0.30$ MPa) and compressive ($f_{c,CF} = 5.1$ MPa) elastic stress limits of the masonry material are calculated for a confidence factor (CF) equal to 1.35 and

corresponding to the limited knowledge level (KL₁). The assignment of limited knowledge class is based on the non-availability of in situ material characteristics. Except for a few internal walls, the stress concentration at the base of the building is well under the compressive elastic stress limit indicating adequate compressive strength against crushing failure (indicated in Figure 12).

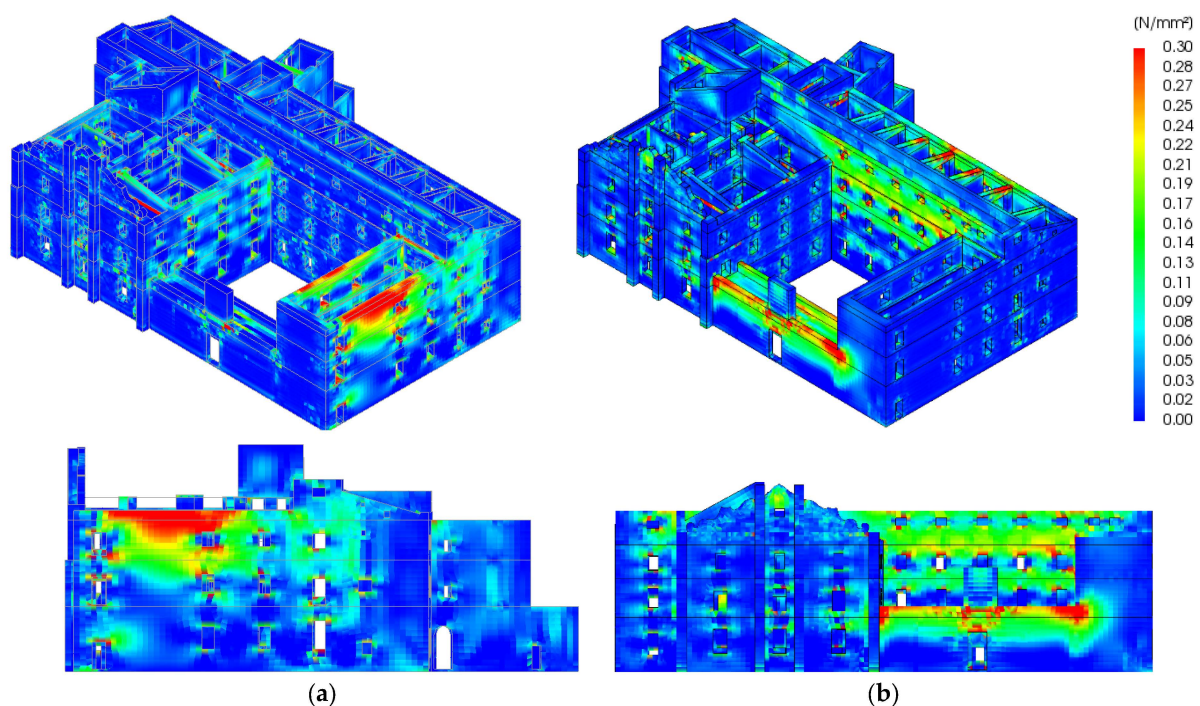
Figure 13. Tensile stresses in the walls resulting from the seismic load combinations: (a) Load combination LC_3 ; (b) Load combination LC_4 .

The tensile stresses are shown in Figure 13 where the legend is bounded such that the red color represents the regions where maximum tensile stress exceeds the elastic stress limit and cracking is expected to occur. In the case of LC_3 , high tensile stresses are observed around the corners of the opening and near the wall–floor connections in the west wing. In the case of LC_4 , parts of the front façade show considerable tensile stresses due to out-of-plane deformations, especially in the upper portions of the wall where the cantilever motion is not restricted (gable wall). Wall segments in the west façade show relatively smaller stresses in comparison to the east façade because of the fewer openings and torsional motion caused by the irregularity of the building in-plan. The sway motion of the west- and east-wing façade causes stress concentration at the reentrant corners. An evaluation corresponding to the seismic action level corresponding to the different seismic zones in Croatia shows that the tensile stresses stay below the elastic tensile limit until the peak ground acceleration (a_{gR}) is 0.10 g. However, the capacity is exceeded for a_{gR} equal to 0.20 g in localized regions, such as openings and critical corners identified from the modal analysis.

The numerical results indicate numerous wall segments in the building that experience stresses higher than the elastic tensile limit of 0.30 MPa. Critical zones with high tensile stresses due to the out-of-plane bending of the walls are identified to provide recommendations for strengthening and retrofitting. These include the facade walls of the west wing, the north façade of the south wing where there is an intersection with the east and west wings, the base of the clock tower, the piers between adjacent wall openings, the walls of the hallway in the south wing, the south-wing facade, and the west-wing façade. Out-of-plane bending is observed at the west- and south-wing walls. The out-of-plane bending is primarily attributed to the absence of moment stabilizing elements, flexible diaphragms, and the minimal torsional effects caused by inherent eccentricity. The wall sections between adjacent openings are prone to shear stress concentration due to the relatively small slenderness ratios (see Figure 15, indicated by red colors).

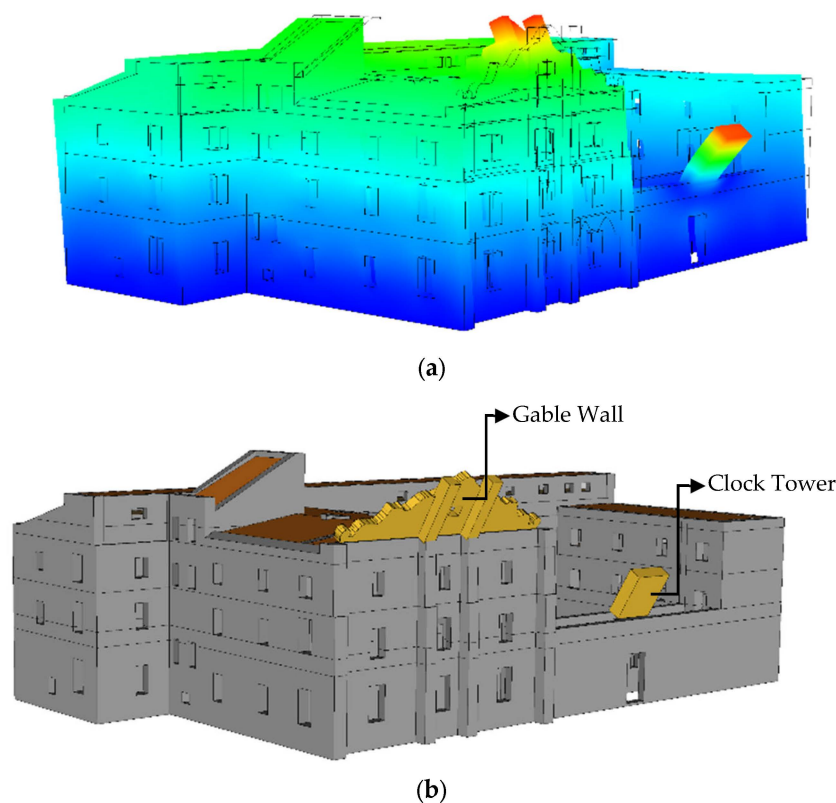
Figure 16. Out-of-plane failure mechanism: (a) Identification of vulnerable areas using modal analysis; (b) Kinematic block of the gable wall and clock tower.

The clock tower situated at the entrance of the building as well as the free-standing gable wall located at the top of the front façade, exhibit considerable deformations even when subjected to low frequencies, making them particularly vulnerable to out-of-plane bending (see Figure 16a). Geometrical characteristics of the macro-element involved in the overturning are defined using the unsupported height and by assuming no connection to the orthogonal walls (see Figure 16b). The Croatian National Annex to Eurocode 8 requires the verification of damage limitation and ultimate limit states with a peak ground acceleration equal to 0.301 g and 0.156 g, respectively [50].

In the case of the clock tower with a height of 4.95 m, the relatively low value of the horizontal load multiplier indicates that a peak ground acceleration of 0.05 g is sufficient to activate the local mechanism, rendering the wall vulnerable to excessive deformations/bending. The local mechanism is activated at a slightly higher peak ground acceleration of 0.09 g in the case of the gable wall with a height of 6.18 m. The non-compliance corresponding to both limit states indicates high vulnerability even at low peak ground acceleration levels (see Table 5).
