Architectural Features and Soil Properties of Traditional Rammed Earth Houses: Eastern Croatia Case Study

Source / Izvornik: **Buildings, 2024, 14, 2049 - 2076**

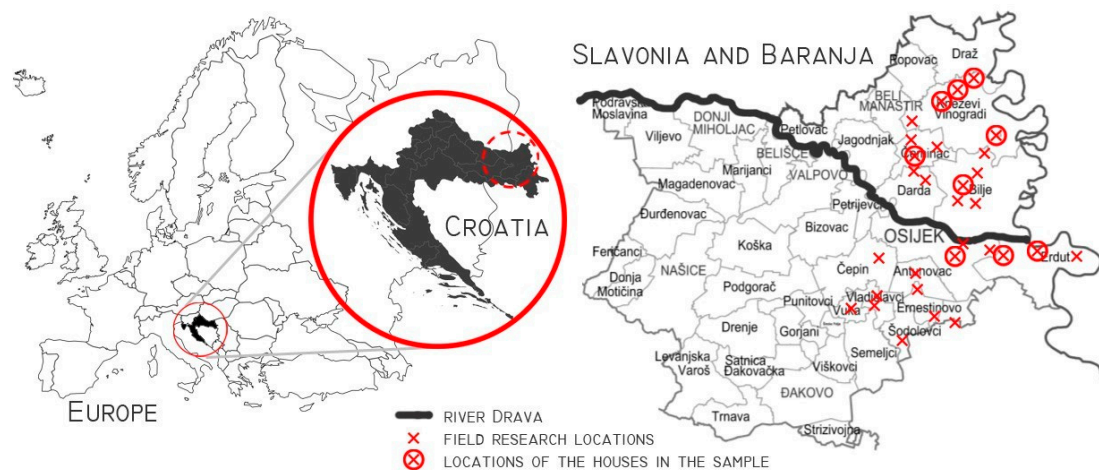
Figure 1. Phases of conducting research work.

The first phase of the research consisted of a review of domestic and foreign literature (books, manuals, and scientific papers) on the subject of earth building with a focus on rammed earth houses, followed by field and laboratory research. The research process is illustrated in Figure 1. The study area was selected based on information about the locations of earthen houses from the domestic literature. Since earth houses can be found in several counties in Croatia, the study area was initially limited to municipalities around the city of Osijek. The areas of Slavonia and Baranja are included in the study in an approximately equal area (the municipalities in Slavonia cover 724 km², whereas those in Baranja cover 777 km²). Initially, 32 settlements were included in the study: 16 in Slavonia and 16 in Baranja, with the river Drava serving as the boundary line (Figure 2). Preliminary fieldwork in the cities of Osijek and Beli Manastir revealed that the number of earth houses was very small compared to the total number of houses; therefore, these two cities were excluded from the sample. The study shows the results of field research in 30 villages in which all streets were inspected (Figure 1, Step 2). The locations of all types of earthen houses (adobe, rammed earth, or their combinations) were mapped.

Fieldwork was carried out in March, April, November, and December 2021 and November and December 2023. The locations of the earth houses were determined by visual inspection of the houses (with the permission of the owner, the yard, and/or the building itself was entered, and for houses where tenants were not encountered, visual inspection was carried out from the public area). For buildings that were inhabited and for which information about the material of the walls could not be obtained by visual inspection, information was obtained from the owner (Figure 1, Step 3).

Permission was obtained for the analysis of the 22 houses (Figure 1, Step 4). To facilitate the presentation of the results, the houses were assigned codes under which they were listed in this paper. Table 1 contains a list of the examined houses, as well as basic information about their location and the code of the samples taken. All houses were photographed, their characteristic building elements were sketched, and information was entered into prepared forms (address, number, and area of the cadastral parcel, owner, and, if known, information on the year of construction). Permission to obtain wall samples was obtained for 21 houses (Figure 1, Step 5), and 12 houses were analyzed in detail, photographed, and provided with architectural plans (Figure 1, Step 6). The architectural plans were included in a catalog that contained the site plan, façades, floor plan, and cross-section when the house was allowed to be entered. In addition to the architectural and urban planning data collected, the catalog also included a brief description of the architectural features of the houses as well as structural and technical data: the structural system, the largest span (in cases where the interior of the building was not accessible and could not be measured, the span was estimated based on the measured thickness of the wall at the window), the dimensions of the walls and columns, the type of roofing, the type of ceiling structure, and the types of materials used for the aforementioned building elements. Based on the field measurements and data collected, architectural plans were drawn up, and the geometric characteristics of these houses were explained by a statistical analysis that sheds light on their diversity and common characteristics.

The houses that were analyzed in detail are located in four municipalities: Kneževi Vinogradi, Čeminac, Bilje, and Erdut (Figure 1). Based on the surveyed houses and houses in the sample, two examples of the most common spatial organization of houses were selected and analyzed: a gabled house and a house with an “L” floor plan. (Figure 1, Step 7).

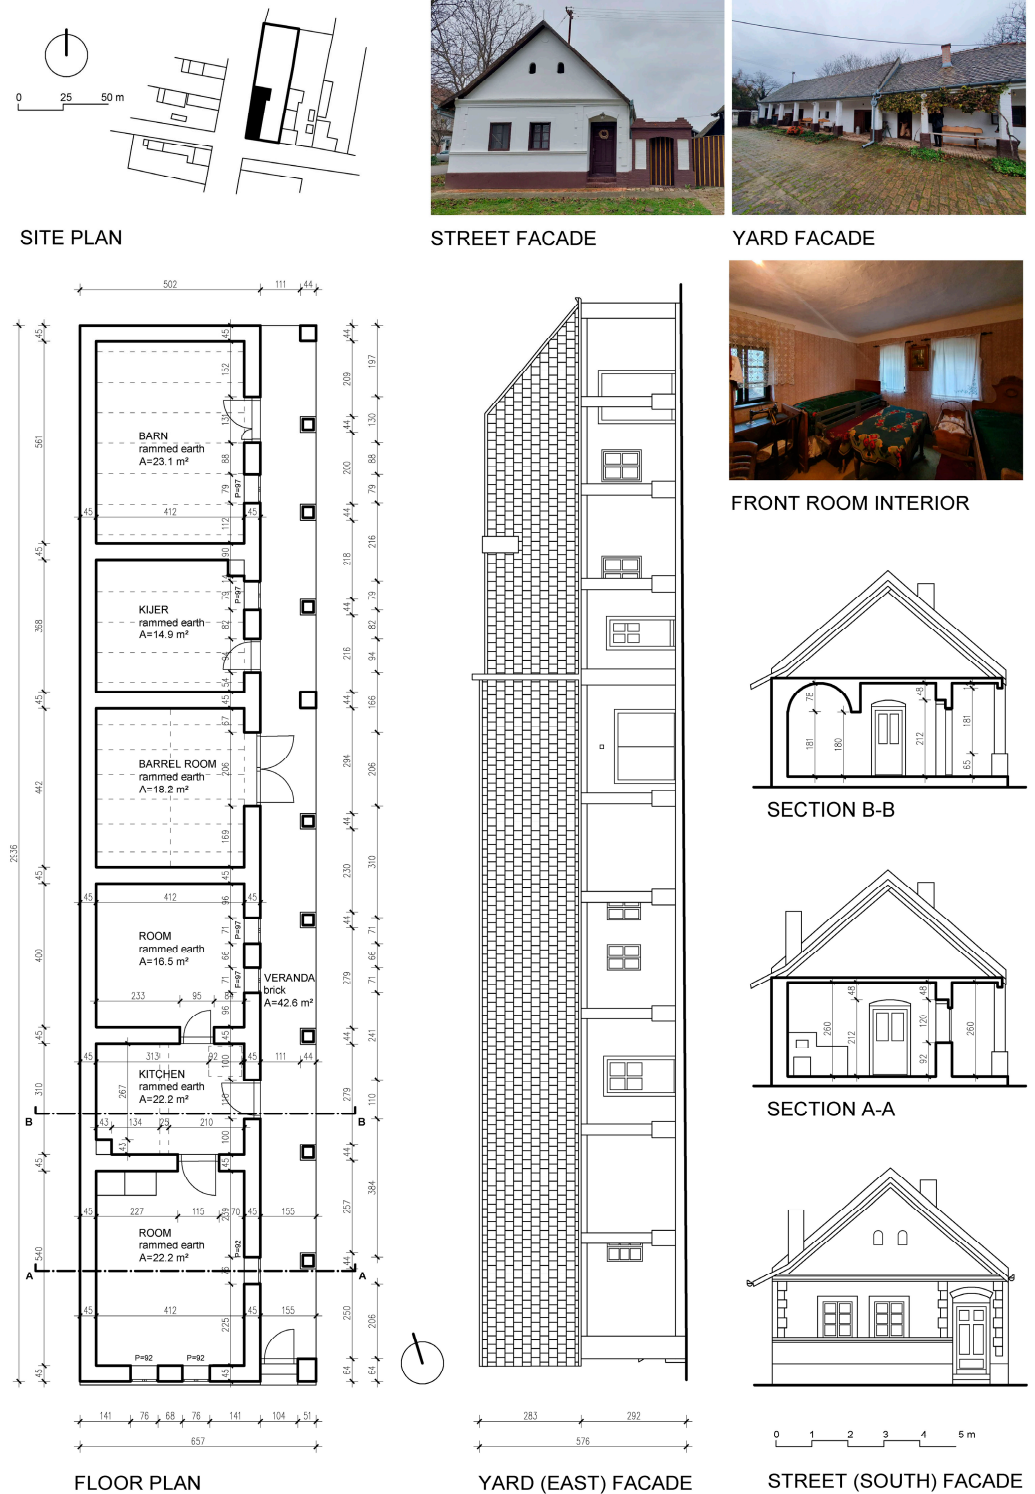
Figure 3. Floor plan, section, façade, and interior and exterior photographs of the house in Bijelo Brdo with the gable facing the street. Author’s photos and drawings.

An example of a house with an elongated floor plan is a house in the village of Bijelo Brdo, built in the last decade of the 19th century. In this research, the house was kept under code BB-2. The house plot is located at a crossroads and has an area of 1251 m², a width of 18.5 m, and a length of 65 m. The longer side of the plot was oriented north-south (with a 10° deviation clockwise to the east), with an entrance from the south. The house is located in the southwest corner of the property, and the windows face south and east (Figure 3).

The external dimensions of the house are approx. 6.5×29 m. The street façade is characterized by a gable with two windows and a door for access to the veranda. The courtyard façade has a veranda that runs the entire length of the house and is flanked by 11 columns. The house is divided lengthwise into two parts: the front, the main living area, and the rear, with utility rooms. The front, which is the main living area of the house, consists of three rooms. The veranda leads to a centrally located kitchen, which has a room on either side: a common room at the front and a slightly smaller room at the back. The first room of the house, with two windows (76×98 cm) facing the street, was also the largest and most important room in the house. This room served as the living room, bedroom, and dining room for the entire family. Its dimensions are 4.10×5.40 m, while its height is 2.60 m. The room has a window facing the courtyard and a rammed earth stove on the wall facing the kitchen. The central room of the house was divided into two functional parts. The first part is a kind of entryway, accessed from the veranda and courtyard, which also provides access to the front and back rooms, while the second part is the kitchen. These two parts are separated by a large ceiling beam, behind which is a large fireplace with an open chimney in the kitchen area, where meat is dried in winter and where there is now a barrel vault. The dimensions of the kitchen were 4.1×3.1 m. The kitchen has no windows, but the door to the veranda has a glazed section. In the corner of the entrance area, toward the back room, there is an opening in the ceiling through which a ladder leads to the attic. The third room, at the back, is 4.1×4.0 m and is lit from the veranda via two smaller windows (71×91 cm). This room was used as the guest room. The veranda is the most important communication space for the houses. It is 1.55 m wide and over 29 m long. The veranda begins with a door on the street façade and ends with an opening to the back-courtyard. It protects users from the external influences of rain and snow in winter and from the sun in summer. It is raised in two steps from the street side, while the difference in height in the courtyard is only one step owing to the slope of the terrain. Behind the main living area, the following rooms are lined up along the veranda: a barrel room (cro. *kacara*) where wine and sauerkraut barrels were kept (4.1×4.4 m), a room for young married couples, cro. *kijeri* (4.1×3.7 m) with a small window to the veranda and barn (4.1×5.6 m). All rooms enter directly from the veranda, and the doors to the barrel room and barn are double-leafed and open to the veranda. The house ended with an outhouse. The front part of the house was separated from the rear part by a 12 cm thick brick firewall, as the hay for the cattle was stored in the rear part of the attic.

The house has rammed earth walls (with 45 cm thick rammed earth walls reinforced with vine branches in the corners), a wooden ceiling (approx. 6.5 m long beams), and a traditional wooden roof (rafters with wind trusses) covered with flat clay tiles (cro. *biber crijep*).

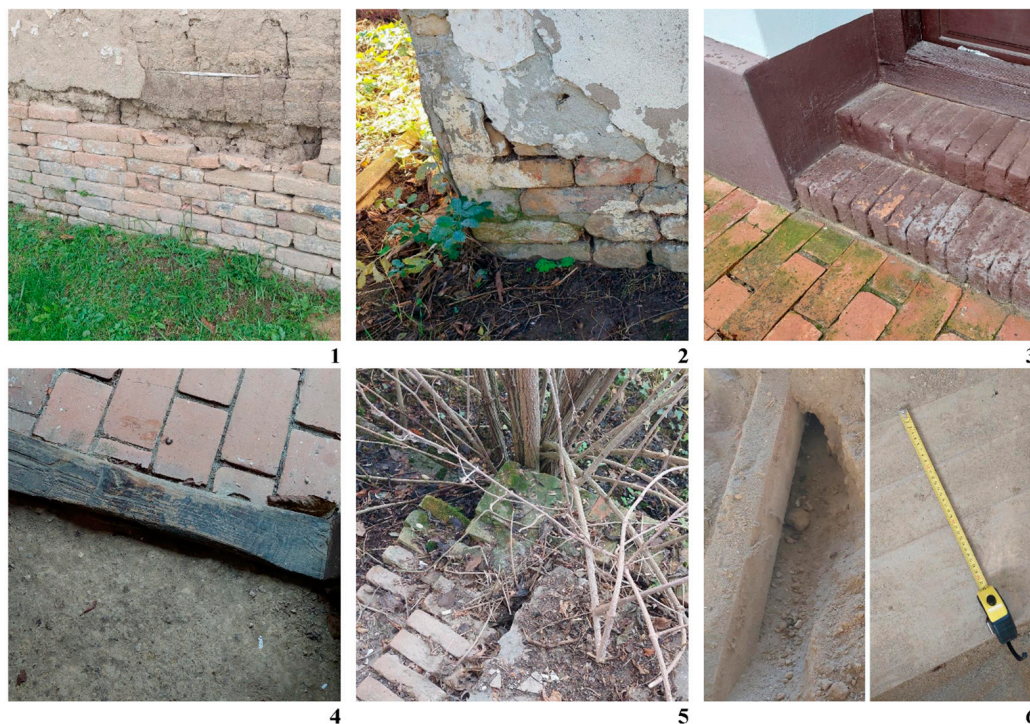
Figure 5. Various options for solving the houses plinths: (1)—RE with bricks cladding; (2)—brick plinth; (3)—dark brown colored brick plinth; (4)—RE floor; (5): brick stairs; (6)—wooden floors. Author's photos.

- covering the wall with a layer of brick cladding (Figure 5-(1)),
- building the plinth (Figure 5-(2), house ALJ-3),
- building the lower part of the wall from the bricks (described in more detail in the Section 3.2.2).

The brick cladding was made by removing a layer of earth from the rammed earth wall façade, and a brick cladding was inserted into the resulting groove, forming a plane of the wall together with the upper rammed earth part of the wall. The example in Figure 5-(1) shows a wall with cladding of new-size bricks stacked 10 rows high without a binder. This type of cladding was observed at the back of the houses. Some houses have brick plinths (*cro. sokl*) on street façades. The plinth was painted in a darker color, usually brown

(Figure 5-(3), house BB-2), and protruded beyond the wall surface by half the width of the brick. In the examined houses, the plinth consists of five to seven rows of bricks and is usually approximately 60 cm high. The plinth was plastered with a mixture of earth, cement, and lime and coated with lime or cement mortar.

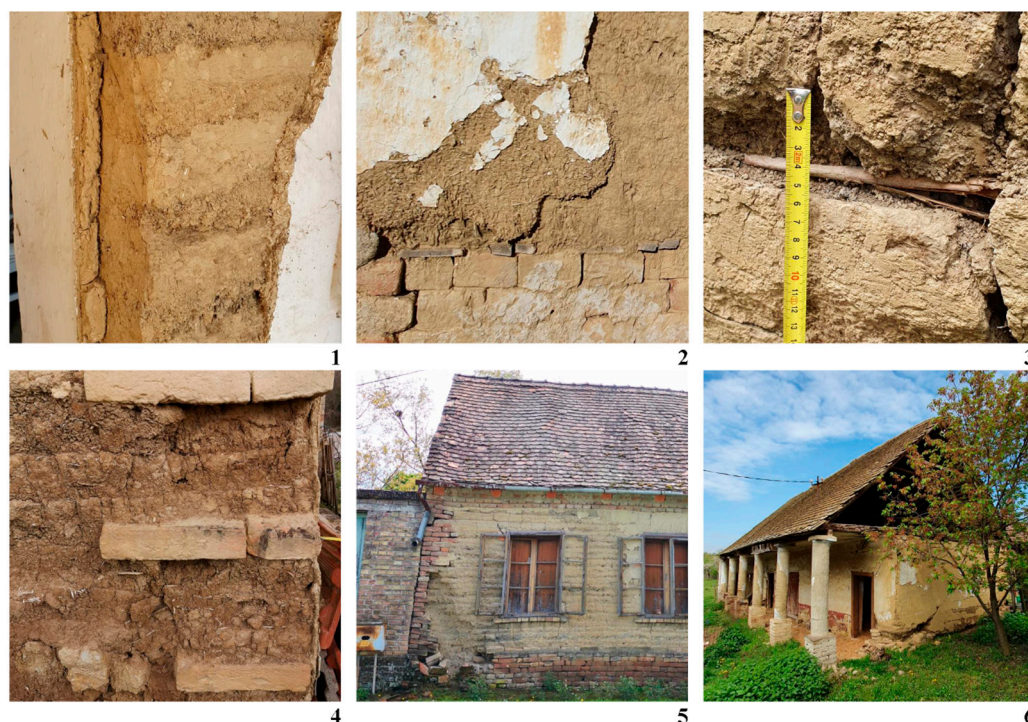
Figure 6. Construction details of rammed earth walls: (1)—RE layers (app. 10 cm); (2)—RE wall built on a layer of planks on a brick base; (3)—RE layers reinforcements; (4)—corner reinforced with layers of reeds or wickerwork; (5): brick corners and columns set into the wall; (6)—columns with a round cross-section. Author's photos.

The measurements conducted on 95 walls resulted in a minimum thickness of 0.38 m, maximum thickness of 0.55 m, and average thickness of 0.47 m (Table 2). The exterior walls of the houses in the sample had a thickness of 40–55 cm, with walls with a thickness of 50 cm predominating. In most houses, the interior walls had the same thickness as the exterior walls, while in a few houses, a lower thickness of the interior walls was observed, but rarely less than 40 cm. The heights of the compacted soil layers in the walls ranged from 4 (6) to 15 cm, with the most common layer height being approximately 10 cm (Figure 6-(1), house ALJ-4).

In several houses, the lower zone of the wall consists of seven to eight rows of bricks. This formed a barrier that prevented moisture from rising. In the example of the Zmajevac house, it was found that the rammed earth wall was built on a layer of planks on a brick base (Figure 6-(2), house ZM-3).

- The rammed earth layers were reinforced with layers of reeds or wickerwork composed of vines, hazels, and willows (Figure 6-(3)). house BB-1).
- Vertical bundles of reeds or layers of bricks were placed at the corners (Figure 6-(4), house ČM-1).
- The brick corners and columns were set in the walls (Figure 6-(5), house ALJ-4).

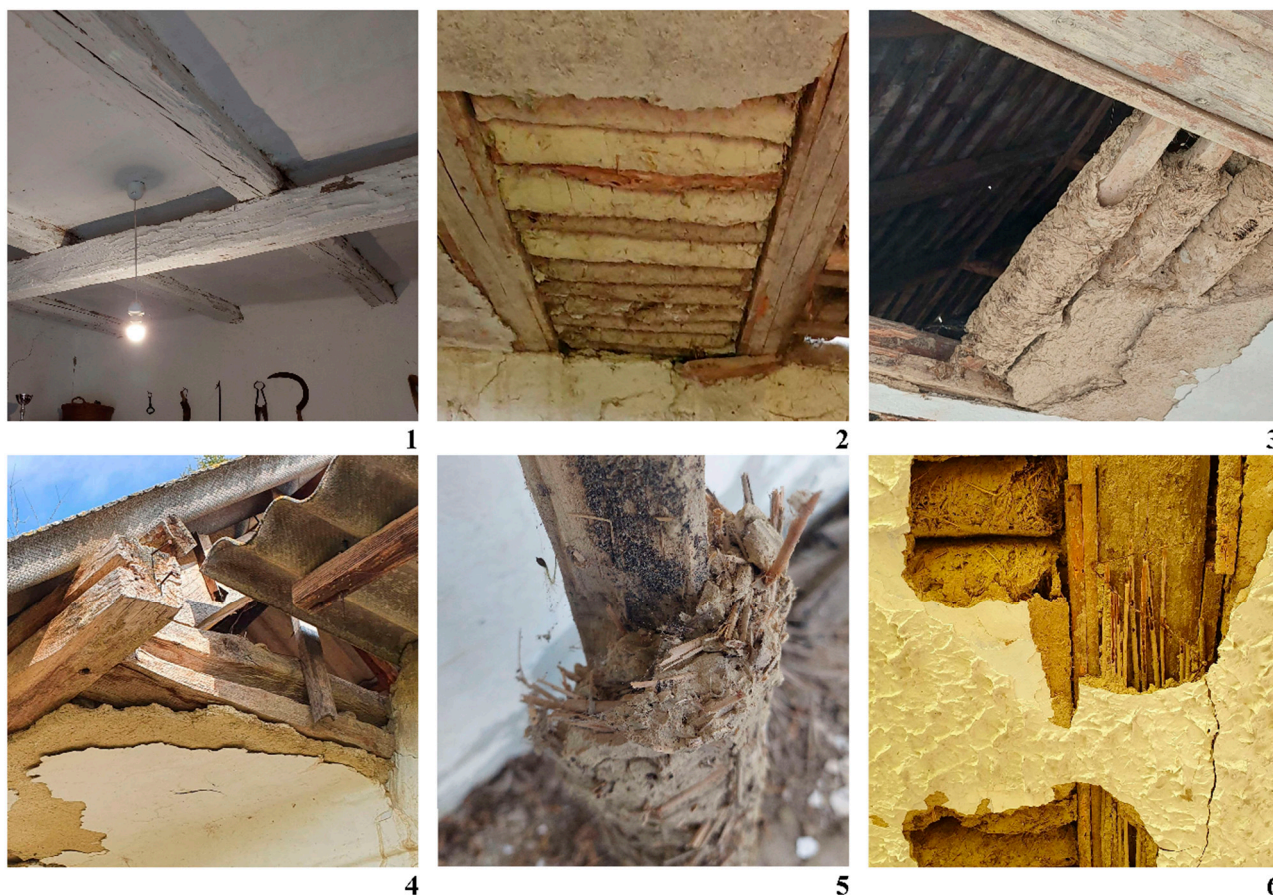
Figure 7. Structural solutions for wooden ceilings in rammed earth houses: (1)—exposed timber beam with joists; (2)—ceiling with *vitlovi*; (3)—*vitlovi* placed between the beams on the battens nailed to the sides; (4)—*vitlovi* placed in grooves cut into the beams; (5)—detail of *vitlovi*; (6)—wooden formwork placed on the underside of the beams. Author’s photos.

The ceiling with exposed beams has a base, whereas on the upper side, it has a wooden covering, that is, the floor of the attic. A ceiling with *vitlovi* is more complicated to build. *Vitlovi* were placed between the beams on the battens nailed to the sides (Figure 7-(3), house ALJ-3) or in the grooves cut into the beams (Figure 7-(4), house KV-2). *Vitlovi* are 60–100 cm long wooden poles (depending on the distance between the ceiling beams) that are wrapped in straw rolled in a fine mixture of fine soil and water. The cross sections of the sticks were approximately 4 × 4 and 3 × 5 cm in size (Figure 7-(5), house ALJ-3). After drying, these elements function as sound and heat insulators. In the case of ceilings with *vitlovi*, the underlay was made in two different ways. In the first case, the underside of the *vitlovi* was coated with clay and then whitewashed with lime. In the second case, a lower wooden formwork was placed on the underside of the beams onto which the reed

was nailed, which served as a support for the soil plaster (Figure 7-(6), house ALJ-2). Both types of ceilings were covered with a layer of compacted earth.

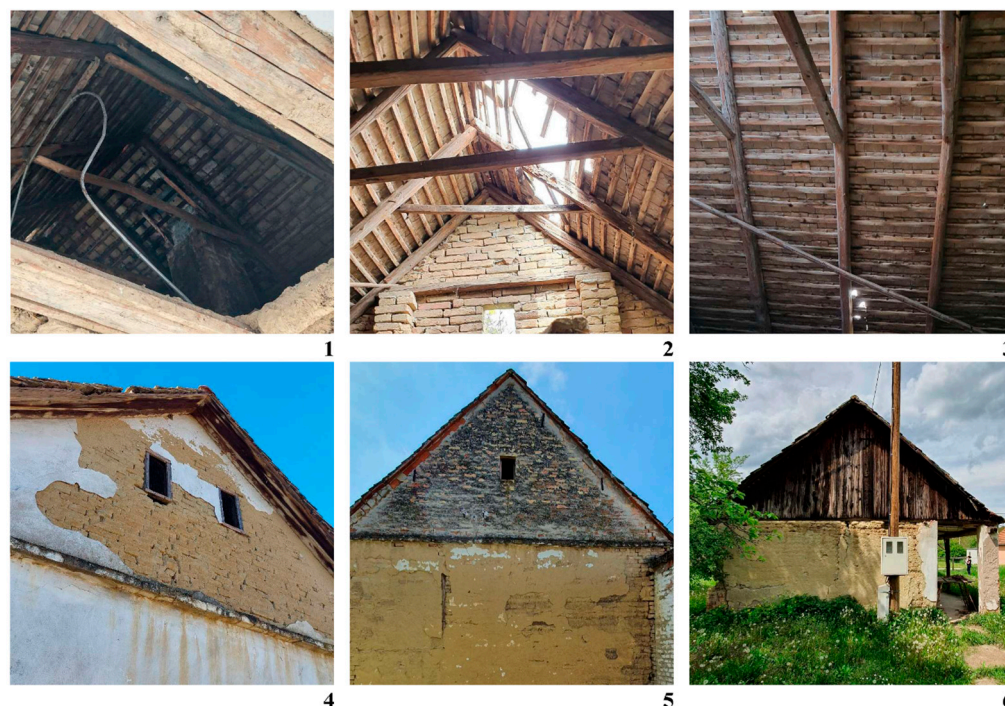
Figure 8. Traditional gabled wooden roofs: (1)—pair of rafters form a triangle with a ceiling joint; (2)—pair of rafters stiffened with a collar tie; (3)—reinforcement with timber wind braces; (4)—adobe gable; (5)—brick gable; (6)—wooden gable. Author’s photos.

The gables of the rammed earth houses were built last when the rammed earth walls were well dried. They were made of adobe (Figure 8-(4), house ALJ-3) or fired bricks (Figure 8-(5), house ALJ-4), but gable walls made of wood (e.g., planks) were also found (Figure 8-(6), house ALJ-2). There are typically two small openings in the gable to ventilate the attic space. The gable walls are usually 12 cm thick, and to reinforce these walls, columns are made of adobe or fired bricks that protrude from the wall for half the length of the fired brick (Figure 8-(2), house ALJ-1).
