EXPERIMENTAL EXAMINATION OF EROSION THREATENED WATERFALLS ON TUFF BEDS PROTECTION – NATURAL LANDSCAPE, HISTORICAL AND CULTURAL VALUES ON THE EXAMPLE OF THE TOWN JAJCE

Preliminary notes

The possibilities of technical interventions in waterfall area formed in heterogeneous tuff sediments are described in this paper. The river Pliva's waterfall was chosen for the test site, as it is a unique natural phenomenon placed in the middle of the old town of Jajce. The applicable methods for technical stabilization of waterfall are conditioned by natural, urban, architectural, historical and specific values of the town landscape. That is why that concrete or reinforced concrete structure should be avoided and priority given to binders for natural tuff detritus that do not change the shape or color of naturally hardened tuff are preferred. Laboratory experiments on a large number of samples have shown good results when micro-cement was injected into tuff beds, but the usability of other injection suspensions was also examined on the research region. The injection suspensions were adjusted to the tuff lithological composition. Comparisons of the control samples in laboratory and on site have s

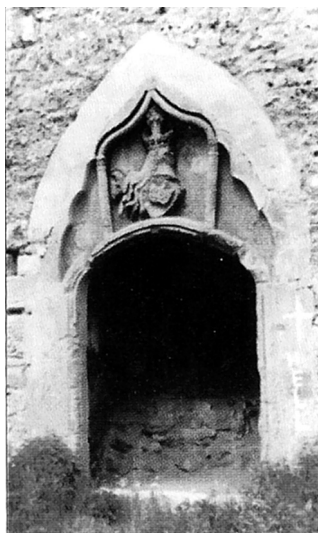
- The Royal port with the shield of Kotromanić from 15th century. The emblem was shaped in tuff in Gothic style and is composed of a crown shaped like lily. The Crown, armor and flower bouquet are placed in the middle. The emblem was shaped in tuff in Gothic style, [2].
- The Banjaluka gate, earlier known as Franciscan doors, dating from the bricklaying time of Jajce. The main construction material is shaped tuff, [2].

Figure 3 The Royal portal and emblem
Slika 3. Kraljevski portal i grb
