Project 3 - Evaluation of seismic performance of a template design RC school building before and after strengthening

Source / Izvornik: **Model Validation and Simulation, 2013, 309 - 318**

Project 3 — Evaluation of seismic performance of a template design RC school building before and after strengthening

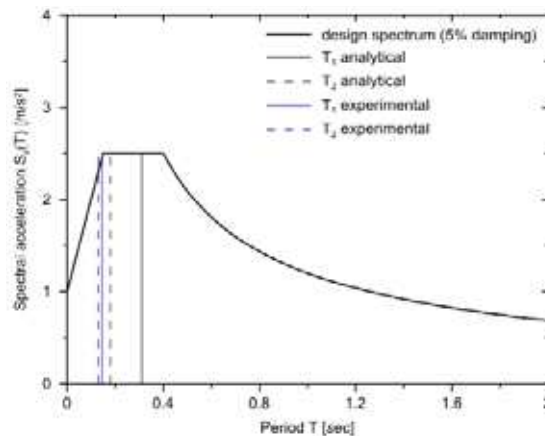
Therefore the natural frequencies of the analytical model are so far not comparable with the results from the measurement, which indicates the need of model calibration. The results show, that modeling of complex 3D structures bases on the construction plan can lead to much different dynamic behavior and thus to un-conservative seismic load assumption (see Figure 8).

Figure 8 — Indication of the influence of the characteristic periods on the example of the Turkish Code Spectrum
