Project 3 - Evaluation of seismic performance of a template design RC school building before and after strengthening

Source / Izvornik: **Model Validation and Simulation, 2013, 309 - 318**

Project 3 — Evaluation of seismic performance of a template design RC school building before and after strengthening

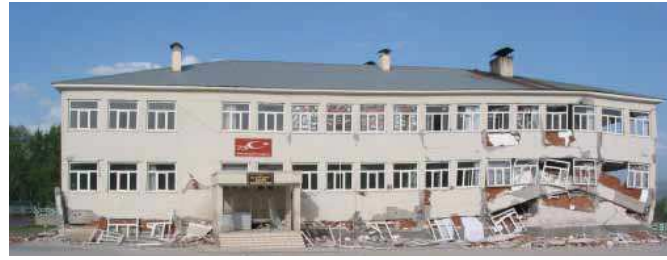
The magnitude 6.6 Bingöl (Türkiye) earthquake on May 1, 2003 caused severe damages and collapse to school buildings (see Figure 3). The comparison of the general layouts from the damage structures and the study object indicates the representativeness of the studied object and provides the opportunity to adopt the experiences from the Bingöl earthquake to the study area Antakya. Thus, the results of the damage prognosis can be compared with the observed damages on school building with a nearly identical (template) design for a known seismic action.

Figure 3 — Damage of a school building caused by the 1st May Bingöl earthquake [2]
