Locating Hidden Elements in Walls of Cultural Heritage Buildings by Using Infrared Thermography

Source / Izvornik: **Buildings, 2019, 9**

Keywords: cultural heritage buildings; nondestructive testing method; passive thermography; active thermography

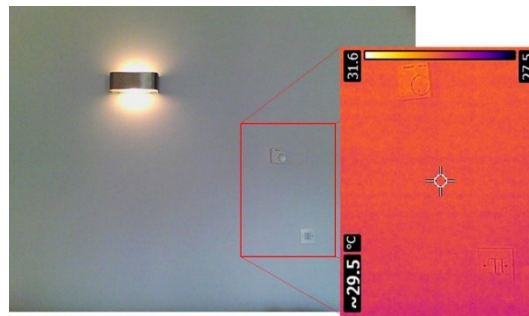
Figure 7. The partition wall and thermogram of the area where the hidden junction box is located.

A third example of passive thermography is shown in Figure 7, illustrating the section of the partition wall in the stationary state the analysis was performed in. The mean measured temperature is 29.6 °C, with a difference of 0.7 °C between the maximum and the minimum reading value being attributed to the difference in the emissivity of the wall, switches and thermostats. Reflection of the surrounding sources exists as well, but to a lesser extent. The partition wall has no heat flow, and therefore, the temperature distribution over the surface is homogeneous. In the case of an inspected body that has the same temperature as the environment, as can be seen in Figure 7, active thermography is needed.

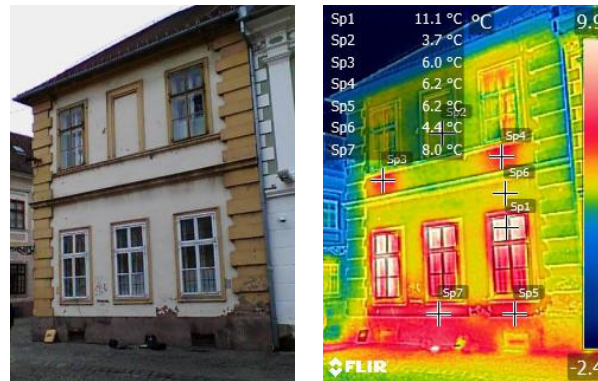
Figure 16. Thermogram of the whole building.

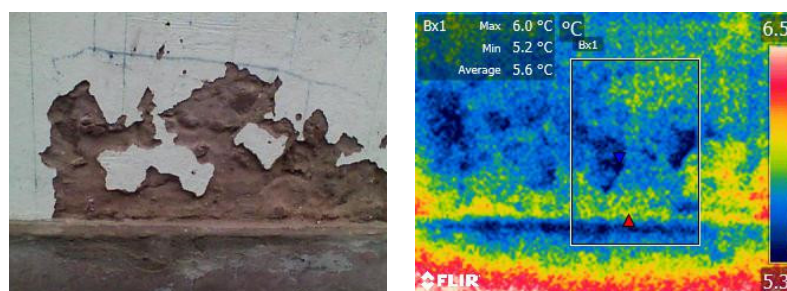
Figure 17. Analysis of facade damage.

The outer envelope (i.e., the facade) has not been renewed since the 1980s. An additional analysis on the parts of the envelope with visible damage was carried out, but the conclusion that can be provided is that the shape of the damage does not strictly correlate with the thermal pattern (Figure 17).

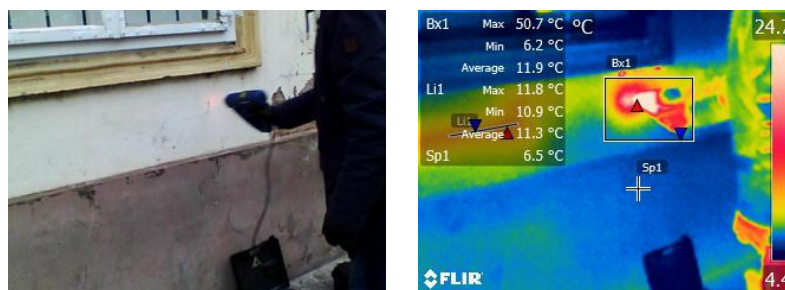
Figure 19. Initial application moment of thermal excitation.

In order to determine the existence of discontinuity in the outer envelope, heating was applied, as is shown in Figure 19.
