The Zagreb (Croatia) M5.5 earthquake on 22 March 2020

Source / Izvornik: **Geosciences, 2020, 10**

Journal article, Published version

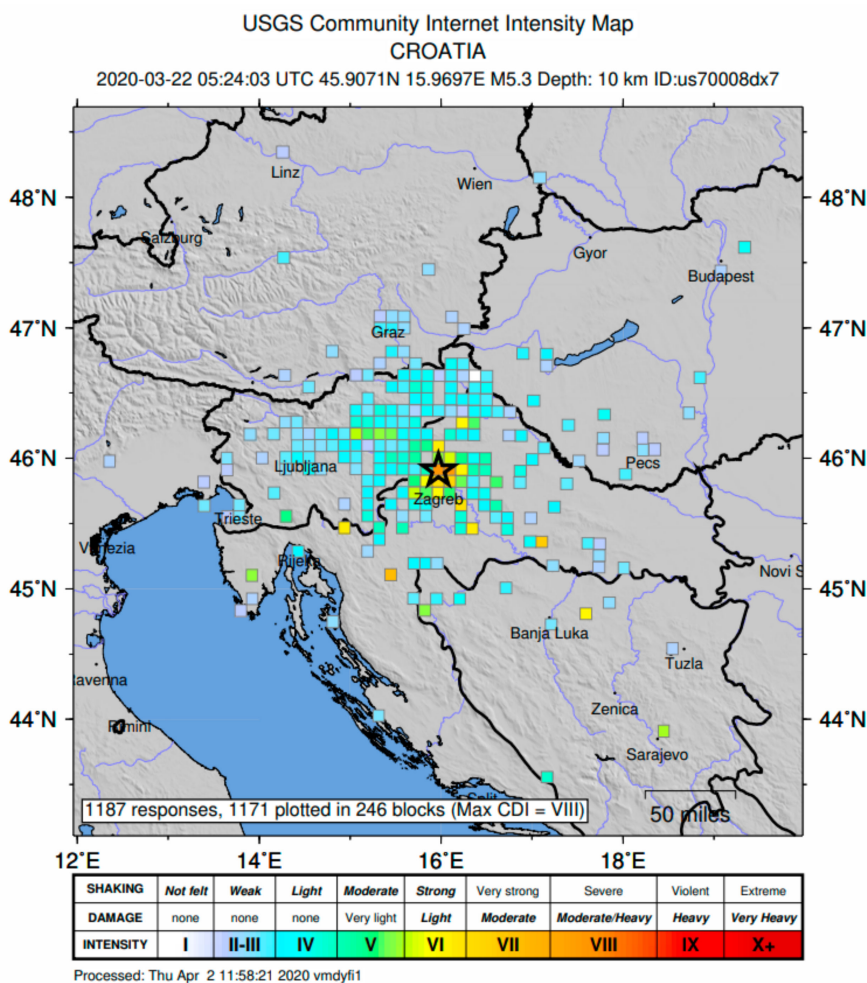
Figure 3. Intensity map according to data collected by USGS [19].
