Source / Izvornik: **Geosciences, 2020, 10**

The Zagreb (Croatia) M5.5 Earthquake on 22 March 2020

Keywords: Zagreb earthquake; Medvednica Mountains; seismicity; amplification; structural modeling; building damage

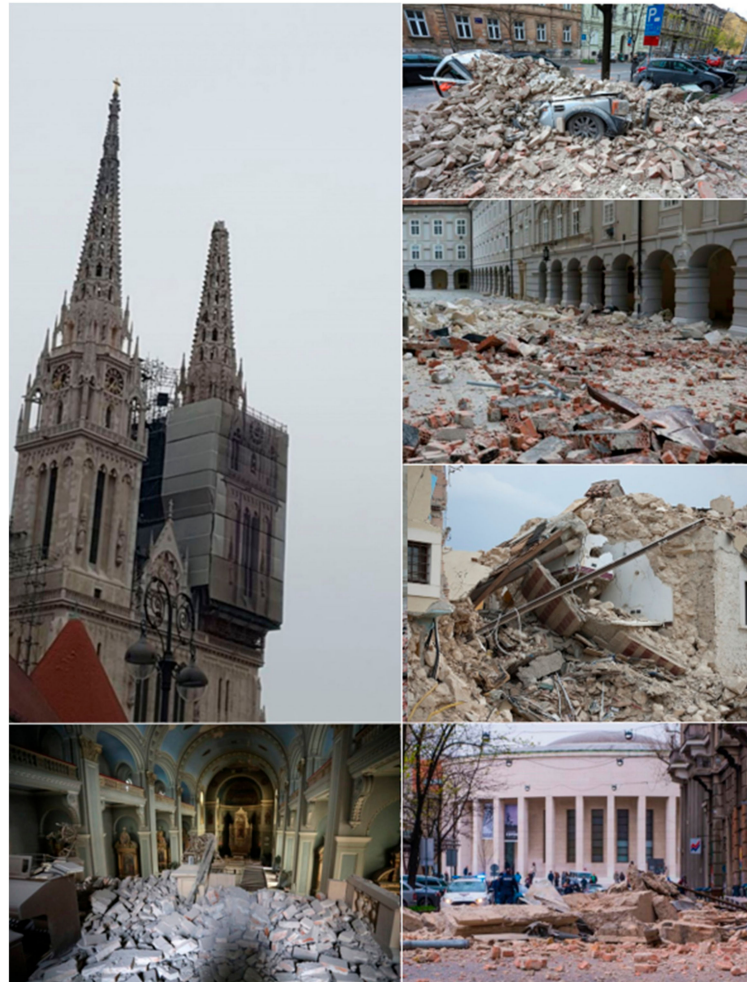
Figure 6. Photos of damage in Zagreb caused by the 22 March 2020 earthquake.

The earthquake hit the city center hardest, and the initial information indicated that the damage was great. Much damage to the cultural and historical architectural heritage of the city of Zagreb was reported, with severe damage to the south tower of Zagreb Cathedral. About 16,555 residential, public and monumental buildings were damaged (Figure 6) as declared by [21,22].

Figure 6 illustrates that in the old city center, three- to five-story masonry buildings, constructed from the time period of the Austro-Hungarian monarchy to 1920, sustained very heavy damage or were destroyed due to the M5.5 Zagreb earthquake on 22 March 2020. There were 26,197 damaged buildings in total (approximately 1900 uninhabitable), among which 9642 were family houses (as declared by [21,22]). As stated in the Disaster Risk Assessment for the Republic of Croatia [24], before 1920, masonry buildings used wooden slab construction, while reinforced concrete (RC) slabs were introduced in the period from 1920 to 1945. Before 1945, buildings possessed only initial earthquake resistance, and earthquake load was not considered in design (up to 5% of relevant peak ground acceleration-PGA was considered in design due to wind load). In compliance with Earthquake Hazard Map of Republic of Croatia [25], the relevant PGA based on 10% exceedance in 50 years, i.e., a return period of 475 years in the Zagreb area goes up to 0.28 g. The consideration of earthquake action in the design of buildings dates from 1946; however, the designs provided inadequate solutions. From 1945 to 1964, earthquake load was considered in the design of buildings by using simplified methodologies (the horizontal force at the top of the building); however, only up to 10% of the relevant PGA was considered in design. In 1964, as a result of the M6.9 Skopje (North Macedonia) earthquake in 1963, the Ordinance on Temporary Technical Regulations for Construction in Seismic Areas (Federal Republic of Yugoslavia (FRY) Official Journal, [26]) was issued. The ordinance required the construction of vertical or horizontal confining elements in masonry buildings, but it provided low earthquake resistance in general. In 1981, it was replaced by the Ordinance on Technical Standards for the Construction of High-Rise Buildings in Seismic Areas (FRY Official Journal, [27]), which provided moderate resistance. Between the years 1964 and 1998, 30–50% of the relevant PGA was considered in the building earthquake resistance design, and 70–100% was considered between 1998 and 2013. The aforementioned regulations were completely replaced by the contemporary standard EN 1998-1 [28] in 2013, which ensured high earthquake resistance (i.e., the earthquake load considered equals 100% of the relevant PGA).
