Locating Hidden Elements in Walls of Cultural Heritage Buildings by Using Infrared Thermography

Abstract: The structure of Tvrđa and its buildings date back to the Middle Ages. Tvrđa represents the Old Town of the city of Osijek and the best-preserved and largest ensemble of Baroque buildings in Croatia. After the withdrawal of the Ottomans in 1687, during the 18th century, the Austro-Hungarian administration systematically formed a new fortification system, regulated streets and squares and built a large number of military objects. Tvrđa took its present form in the 19th century and has kept it since then. Investigating the historical development of individual buildings, in addition to archival sources and existing architectural documentation, the obvious source of information are the buildings themselves. The aim of this paper is to explore the possibilities of using infrared thermography to find structural elements and hidden openings in historic buildings in Osijek's Tvrđa. This paper describes the exploration of the 18th century openings on the facades of the former Kostić houses. The facades were bricked into the walls in the 19th century because houses were reused and their

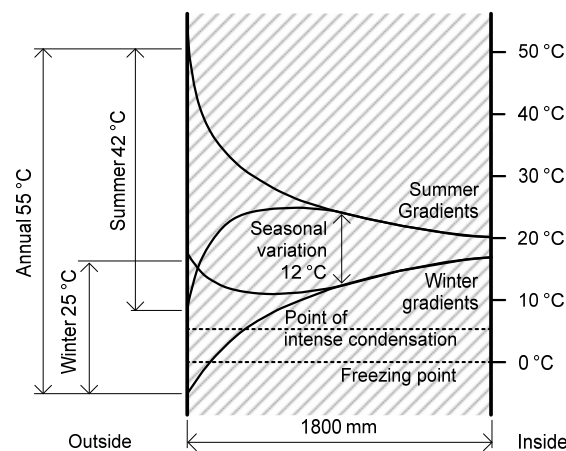
Figure 13. Theoretical temperature changes in a thick wall [25].

As shown in Figure 13, the wall temperatures varied by up to 55 °C or more on the surface, decreasing below freezing on cold winter nights. This wide discrepancy should be compared with a 12 °C seasonal variation in the wall center and 2 °C in the interior the latter, which probably receives some heating in winter. Daily variations of the surface temperature will be greater in summer, e.g., 42 °C, compared with winter, e.g. 25 °C. The dew point for interstitial condensation is located near the outer surface. Consequently, this can result in freezing in the outer layers, since a great deal of heat is required to raise the temperature of a heavy building with thick walls by even 1 °C, i.e., it takes time for the heat to flow through the brick and mortar. There is a tendency for the outer face to be heated up prior to a response the core can provide and long before the inner face is affected. This time lag would affect the theoretical temperature gradient.

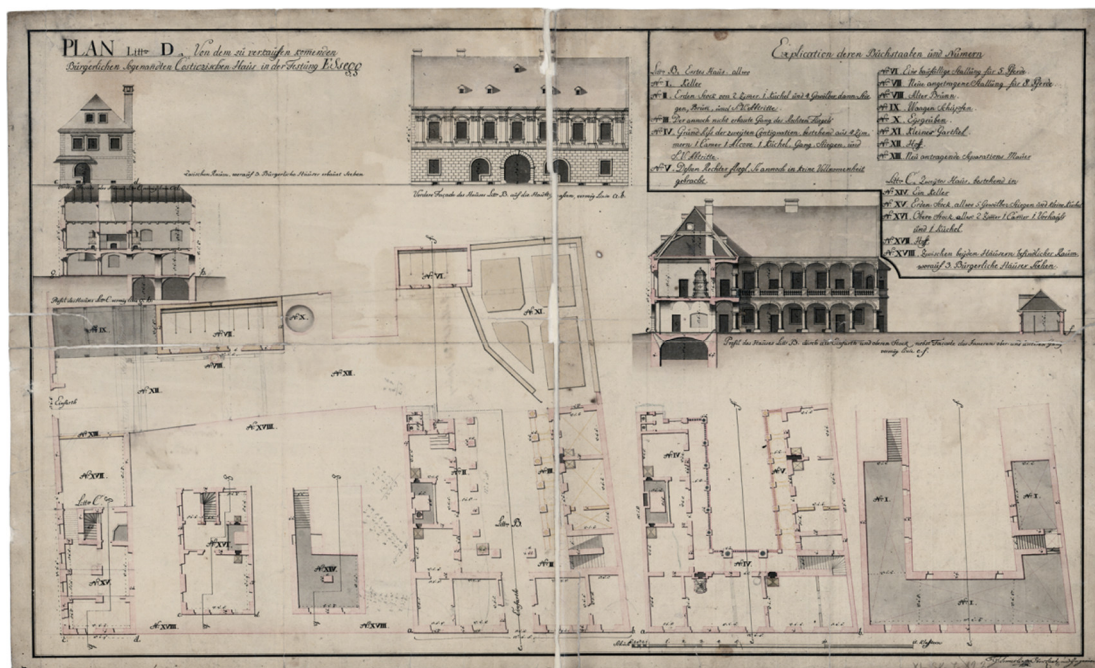
Figure 15. Architectural drawings of Kostić houses in 23 Kuhačeva Street from the 1774 [27].
