# Destructive M6.2 Petrinja Earthquake (Croatia) in 2020—Preliminary Multidisciplinary Research

**Keywords:** Petrinja earthquake; Dinarides; Pannonian basin; strike-slip faults; Kupa Valley (Pokupsko); SAR images; land displacement; building damage; local soil effects

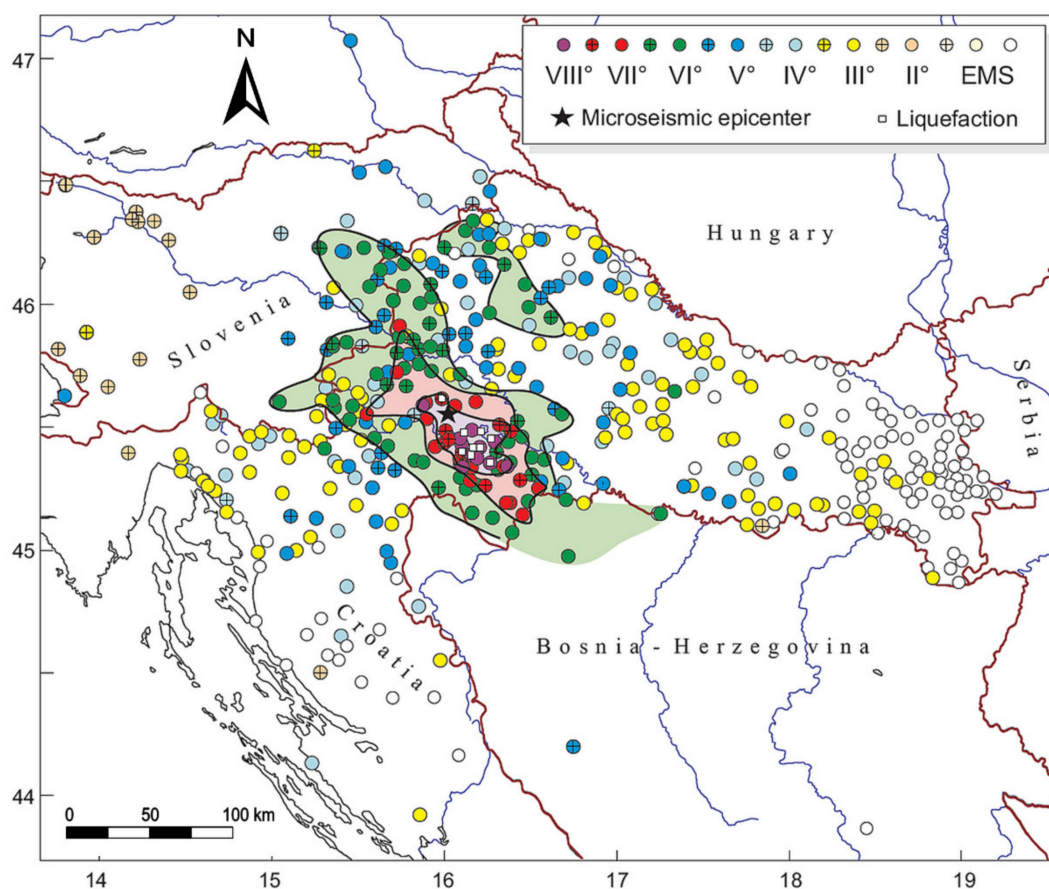
**Figure 2.** Isoseismal map of the Kupa Valley earthquake on 8 October 1909—macro seismic intensities were assessed according to the European Macroseismic Scale (EMS) [7].

As discussed earlier, the strongest earthquake that occurred before the Petrinja 2020 event was the earthquake that occurred on 8 October 1909, the epicentre of which was located 9 km north of Pokupsko (the Kupa Valley earthquake). The magnitude was 5.8, and the hypocentral depth was 14 km. The effects it caused were evaluated according to the intensity of the VIII °MCS. Extensive macro seismic analysis enabled the development of a macro seismic isoseismal map (Figure 2). The quake area was elongated in the NW–SE direction, and the earthquake was also strongly felt in Zagreb, where it knocked down many chimneys.

In contrast to the macroseismic isoseismal map of the 1909 event (Figure 2), the highest intensities extend in the NE–SW direction (Figure 3). This direction is almost perpendicular to the direction of the maximal intensity isoseist (pleistoseist) in the case of the Kupa Valley 1909 earthquake.

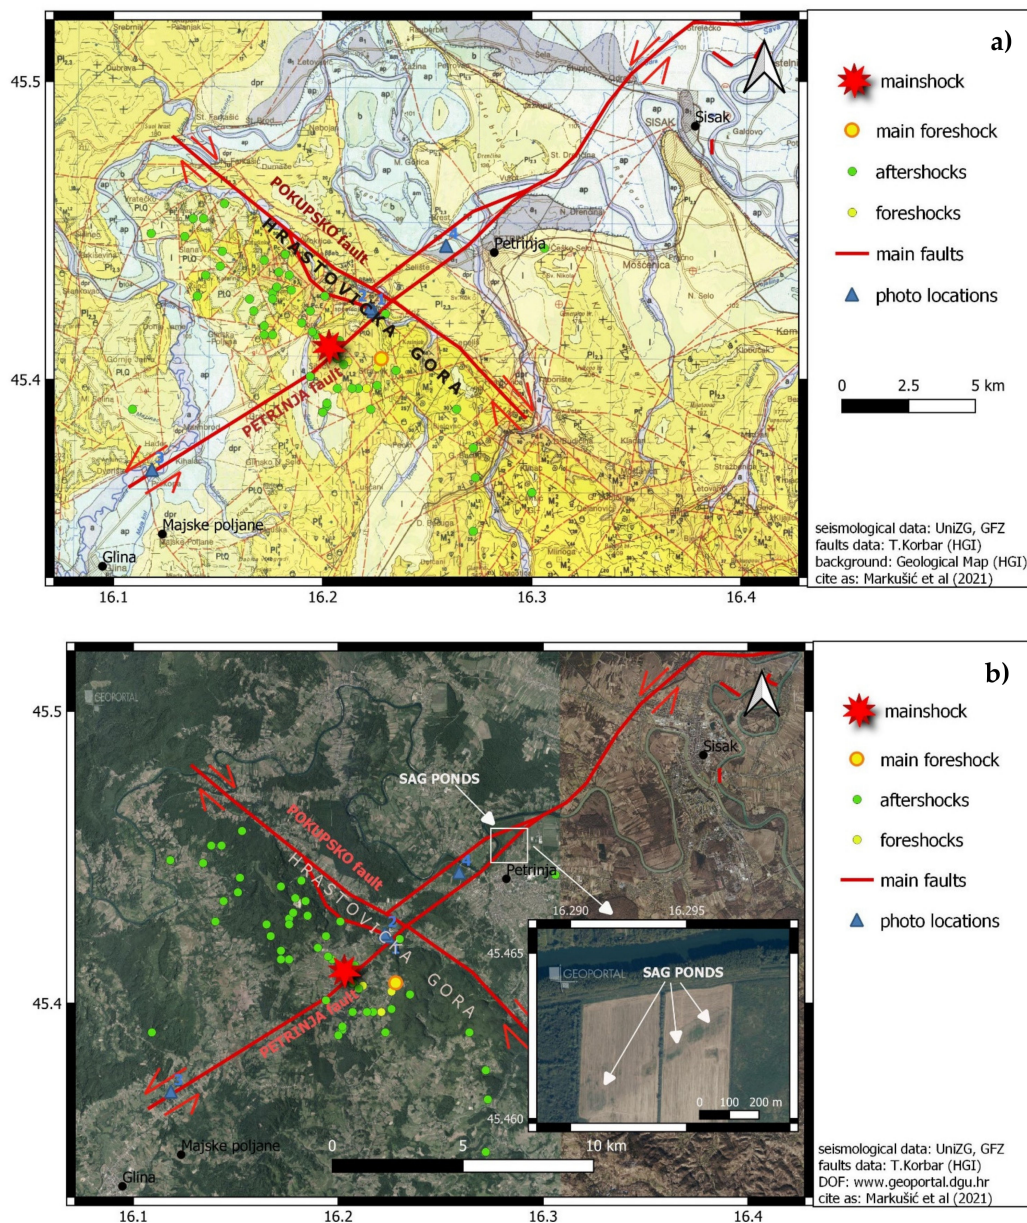
**Figure 5.** (a) A geological map of the Sisak, Petrinja and Glina areas in Croatia [14] with main faults (thick red lines) of the activated fault system highlighted, the activation of which caused earthquakes on 28 and 29 December 2020 (orange units = Paleogene (Pc, E), yellow units = Neogene (M), light yellow units = Quaternary loess (l) and colluvium (dpr), gray and light blue units = Quaternary alluvium (a, ap), light green units = palustrine); and (b) An interpreted orthophoto image [13] of the activated fault system that was captured a few years before the 2020 earthquakes. Numbers and blue triangles mark the positions of the field photographs that are shown in Figure 6: 1–6A, 2–6B, 3–6C, 4–6D. The inset shows sag ponds along the main creeping sinistral fault line, appearing on an active agricultural land (the orthophoto image is taken in 2018).

The intersection of two faults (longitudinal and transverse faults) on the extension of the Dinarides (NW–SE) can be identified (Figures 5, 7 and 8). Both faults consist of multiple faults with horizontal strike-slip block movements. The transverse fault is a less known, nearly aseismic creeping fault, which is referred to as the sinistral Petrinja Fault. The longitudinal fault is the well-known regional dextral Pokupsko Fault. This fault system is a textbook example of deformations that occur in rock due to compressional stress along the generally north–south axis (Figure 4) and the pre-existing fault net (Figure 5).

An orthophoto image (which was captured a few years before the 2020 earthquakes) of a section of the Petrinja Fault that strikes NE–SW and crosses the Kupa Valley (Figure 5) shows typical strike-slip sag ponds, which were created due to probably continuous movements along the creeping Petrinja Fault. The sag ponds are clear evidence of the fault

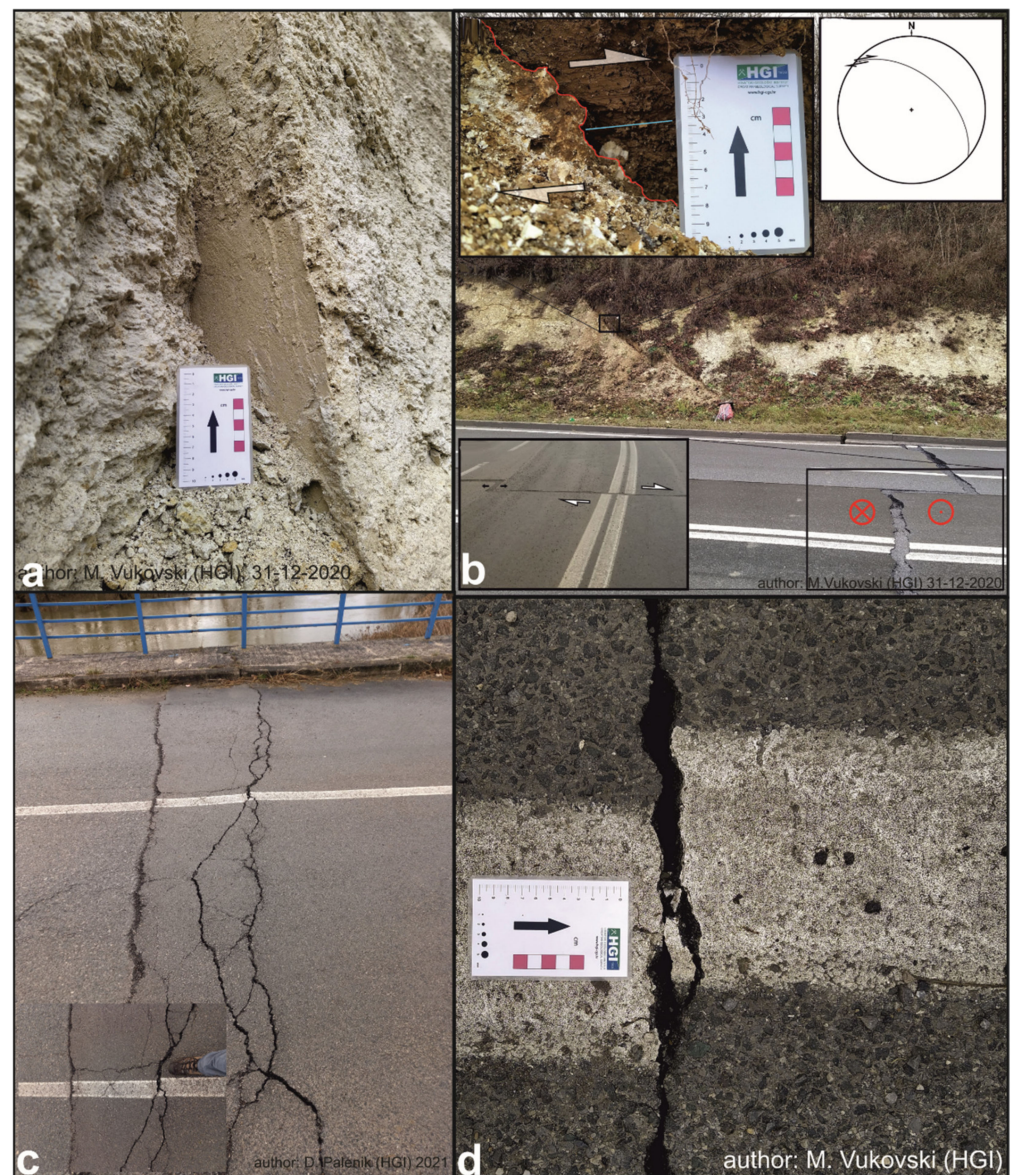
**Figure 6.** (a) The dextral coseismic displacement along the NW–SE striking subvertical fault plane in an abandoned quarry SW of Župić (WGS: 45.4229/16.2243); (b) Dextral coseismic displacement across a road west of Župić. Note fresh sub-horizontal striations in the soil (WGS: 45.4239/16.2226). Insets show the fault details with marked displacement and the fault surface projection on the lower hemisphere; (c) Sinistral displacement of a bridge NE of Glina (WGS: 45.3697/16.1183); and (d) Sinistral displacement on the road W of Petrinja (WGS: 45.4449/16.2590). The locations of the field photographs are presented in Figure 5.

Both left-lateral (sinistral) and right-lateral (dextral) coseismic surface movements were recognized along the fault lines in the wider epicentral area (Figure 6).

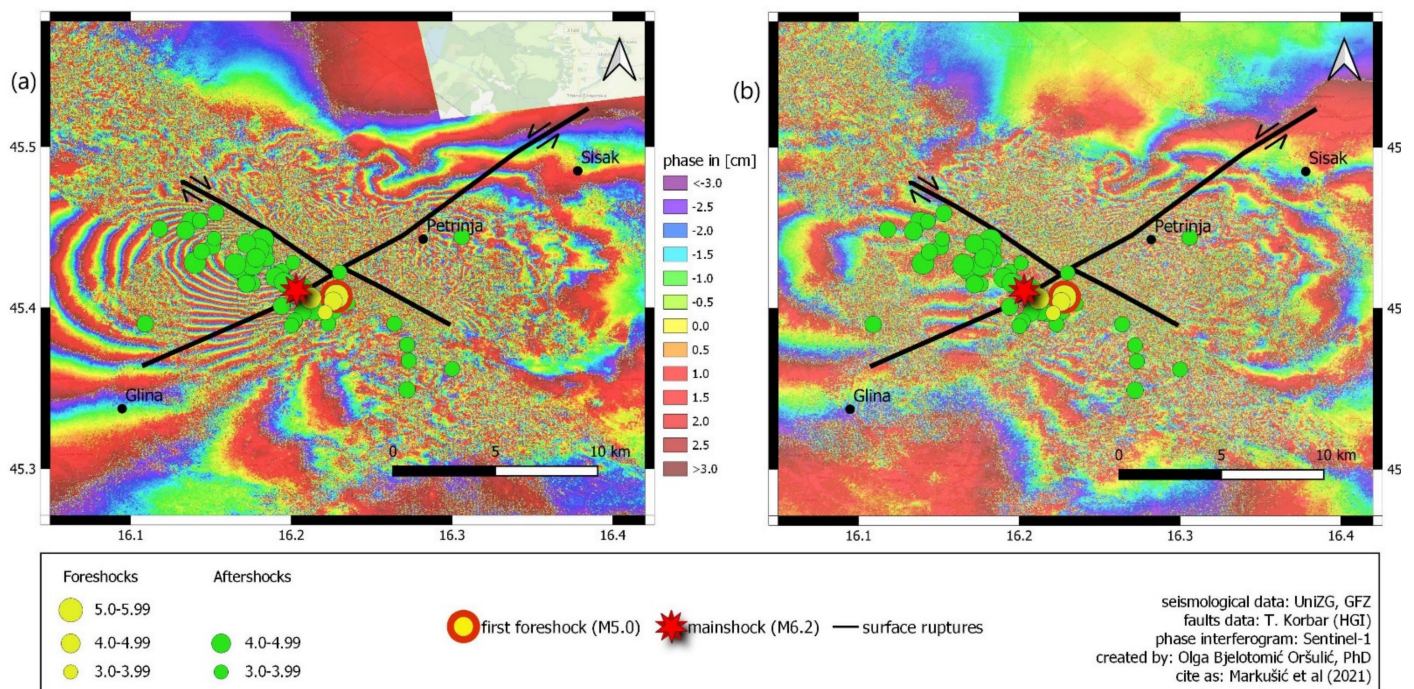
**Figure 7.** Interferogram of the (a) Sentinel-1A ascending orbit T146 and (b) Sentinel 1-B descending orbit T124. Each colour fringe corresponds to 2.8 cm of ground displacement (corresponding to a displacement of half of a wavelength of 5.6 cm, since the origin of the data is C-band radar).

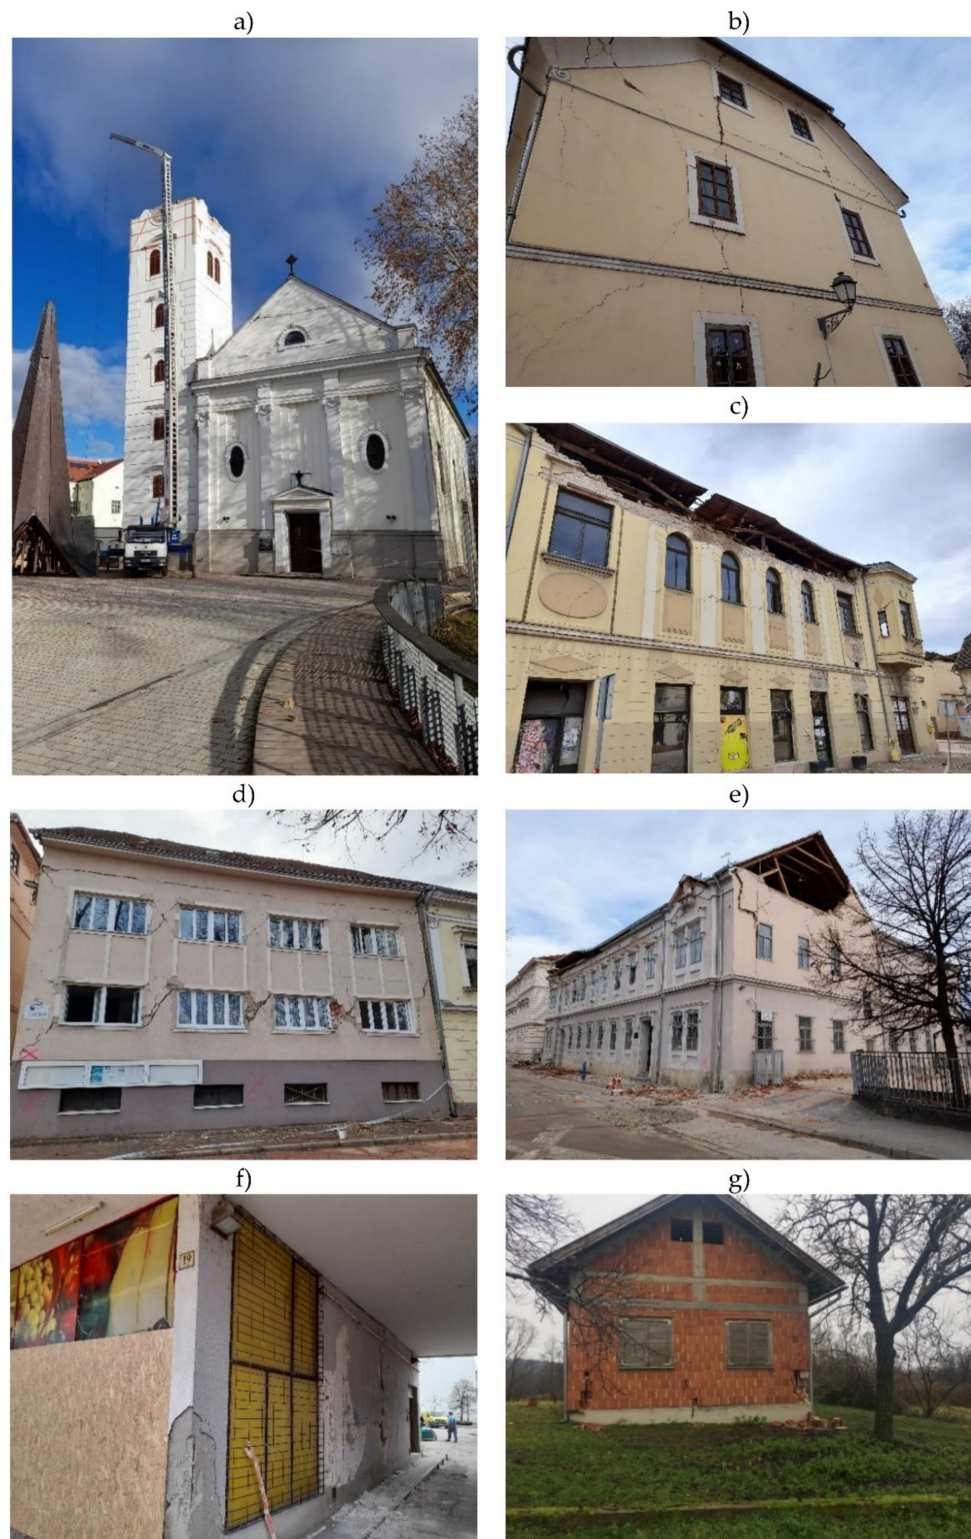
**Figure 11.** Damages that were sustained by various building types built in the pre-code era (before 1964) and in various code eras: (a) The Cathedral of the Exaltation of the Holy Cross in Sisak with the tower roof removed; (b) Crack distribution in an old masonry building in Petrinja; (c) Parapet wall collapse in an old masonry building in Petrinja; (d) Masonry pier diagonal tension cracking; (e) Gable wall out-of-plane collapse in an elementary school in Petrinja; (f) Damage to the masonry-infilled RC frame (soft storey collapse); and (g) Damage to a building that was built without vertical confining elements as part of a rebuilding programme in the post-war era [58] (author of all photos: D. Penava).

However, unreinforced masonry buildings with RC slabs and horizontal confining elements, which belonged to vulnerability class C in compliance with the EMS-98 scale [43] and that were built in the building code period from 1965 to 1981 [37], along with those that were built in the later periods, namely from 1982 to 1998 [38], also experienced Grade 3 (DG 3) to Grade 5 (DG 5) damage, which was due to workmanship issues. However,

the confined masonry buildings that belonged to vulnerability class D in compliance with the EMS-98 scale [43] and were built in the same building code periods performed significantly better when the damage was reduced to Grade 1 (DG 1) or Grade 2 (DG 2). These observations led to controversy, since residential masonry buildings (houses) were a part of a rebuilding programme that was conducted in 1997 after the Croatian War of Independence (1991–1995). The controversy was related primarily to the assumption of non-enforcement of standards at all stages of the design and construction process and consequently, to complaints that the government rebuilding programme did not satisfy the building code requirements (e.g., vertical confining elements were not inserted into existing buildings or used in the design of new buildings). As evident from the survey, their presence provided a significant degree of protection against the M6.4, which was a VIII (heavily damaging) to IX (destructive) °EMS earthquake event. The regulations of the corresponding time period [37–41] allowed for masonry buildings of up to two storeys above ground to be built without vertical confining elements (see Tables S1 and S2 in the Supplementary Materials).

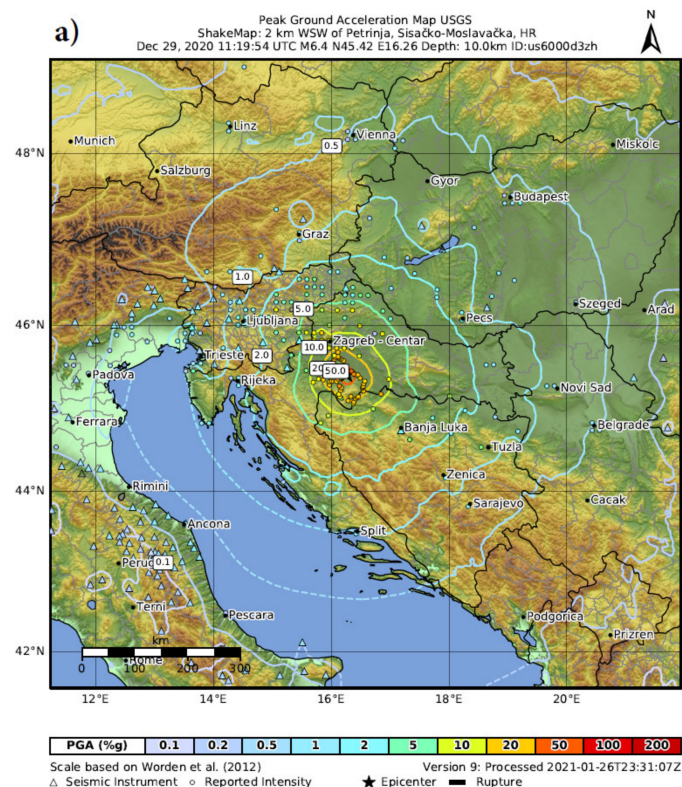
Figure 12. Cont.

**Figure 12.** USGS Shake Map analysis: (a) The peak ground acceleration map and (b) GMPE peak ground acceleration predictions (thick purple line) and observations (seismic stations—blue triangles, Did You Feel It DYFI—coloured circles) in consideration of local site effects [59].

Following the destructive 29 December 2020 M6.2 earthquake near Petrinja, ShakeMap, which was developed by the U.S. Geological Survey (USGS), rapidly mapped earthquake ground motions [59] and portrayed the distribution and severity of shaking in the area (Figure 12). The peak ground acceleration was estimated to be approximately 0.5 g in an area approximately 5 km from the epicentre, 0.2 g at distances of 20–30 km and 0.1 g at a distance of 50 km (Figure 12a). Comparison of predictions and observations of a PGA scaling with rupture distance were estimated by GMPE Peak Ground Acceleration prediction (Figure 12b) considering local site effects [59].
