Residential building stock in Serbia: classification and vulnerability for seismic risk studies

Source / Izvornik: **Bulletin of earthquake engineering, 2023, 21, 4315 - 4383**

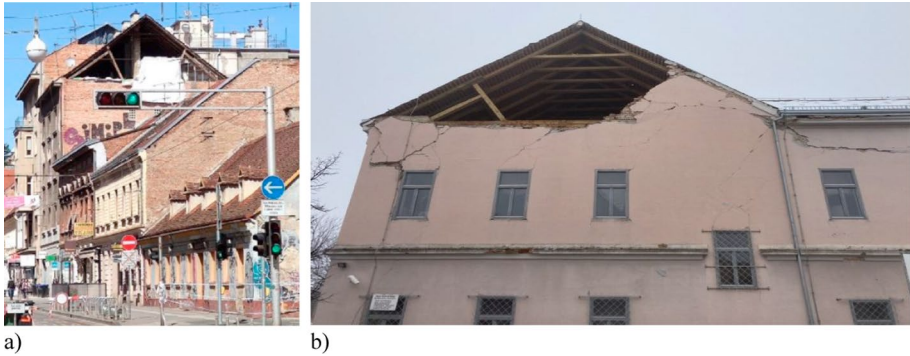
Fig. 31 Damage of URM buildings (type M2) due to the 2020 Croatia earthquake: **a** typical damage due to the March 2020 Zagreb earthquake (Stepinac et al. 2021) and **b** typical damage due to the December 2020 Petrinja earthquake (SUZI-SAE 2021)

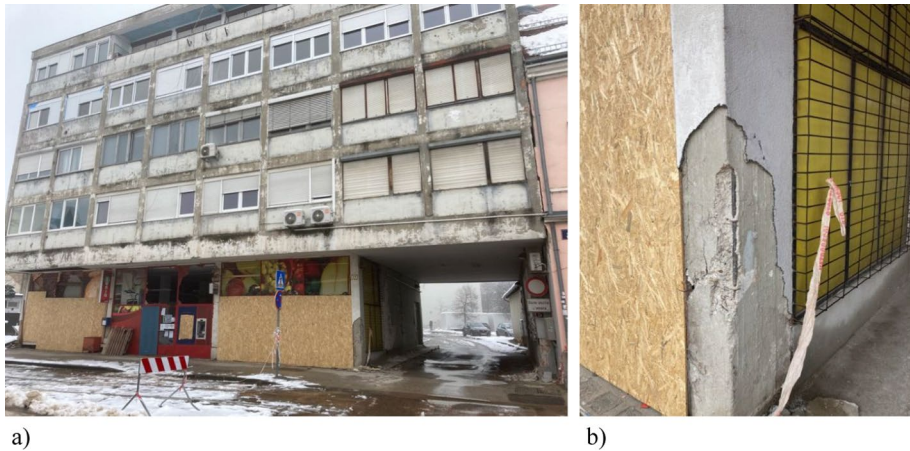
Fig. 33 Damage of type RC1 residential building in Petrinja, Croatia due to the December 2020 earthquake: **a** exterior view showing open ground floor space which used as a store before the earthquake, and **b** a detail of the damaged RC column (SUZI-SAE 2021)

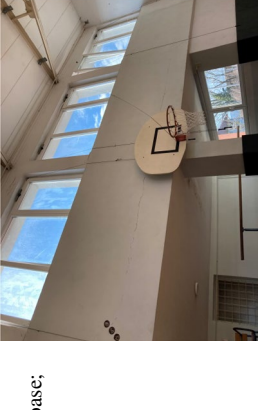
<p>Gymnasium in Primary School “Dragutin Tadijanović”, Petrinja (SUZI-SAAE) December 29, 2020 Petrinja, Croatia earthquake $M_w = 6.4, I (^{\circ}MCS) = 9$</p>
Example	Light cracks in plaster in the infill masonry walls

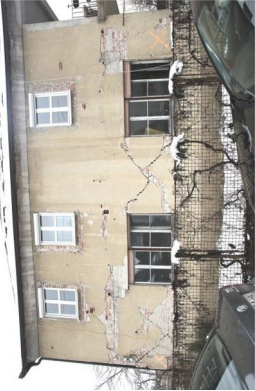
<p>Example</p>	<p>In-plane shear cracks in load-bearing walls; most of the walls were damaged; failure of partition walls</p>	  <p>Residential building in Petrinja (SUZI-SAEI) December 29, 2020 Petrinja, Croatia earthquake $M_W = 6.4$, $I (^{\circ}MCS) = 9$</p>

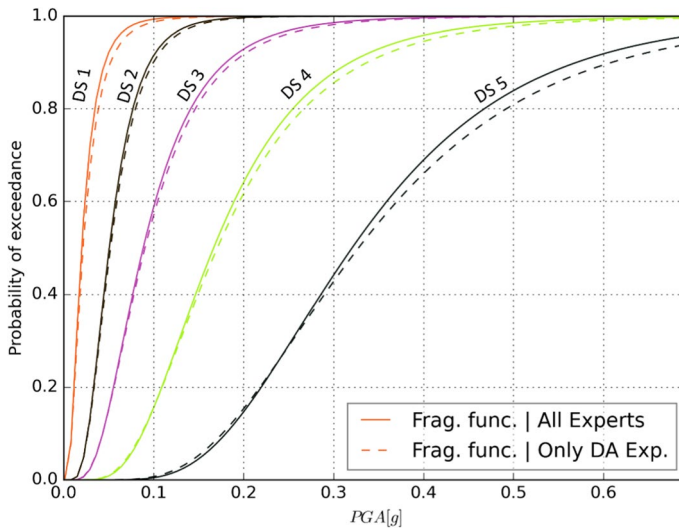
Fig. 35 Fragility functions for the URM building with rigid floors (type M3-M) derived from expert judgement for different DSs. Solid lines are the DS fragility functions derived based on the opinion of all 40 experts that filled the questionnaire (“All Experts”), while dashed lines are the DS fragility functions derived based only on the opinion of experts with post-earthquake damage assessment experience (“Only DA Exp.”)

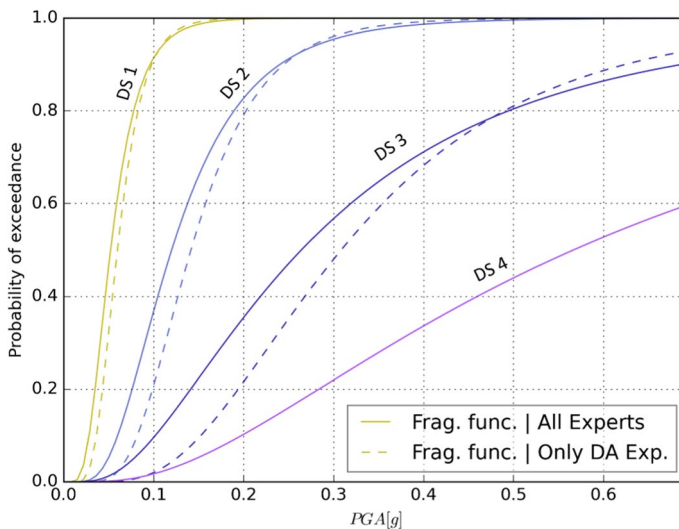
Fig. 36 Fragility functions for the three-story reinforced concrete frame with infills typology (RC1) from the survey form. The fragility functions are derived from expert judgement for different DSs. Solid lines represent the DS fragility function derived based on the opinion of all 40 experts that filled the questionnaire (“All Experts”), while dashed lines are the DS fragility functions derived based only on the opinion of experts with post-earthquake damage assessment experience (“Only DA Exp.”)
