# Residential building stock in Serbia: classification and vulnerability for seismic risk studies

*Source / Izvornik:* **Bulletin of earthquake engineering, 2023, 21, 4315 - 4383**

**Journal article, Published version**

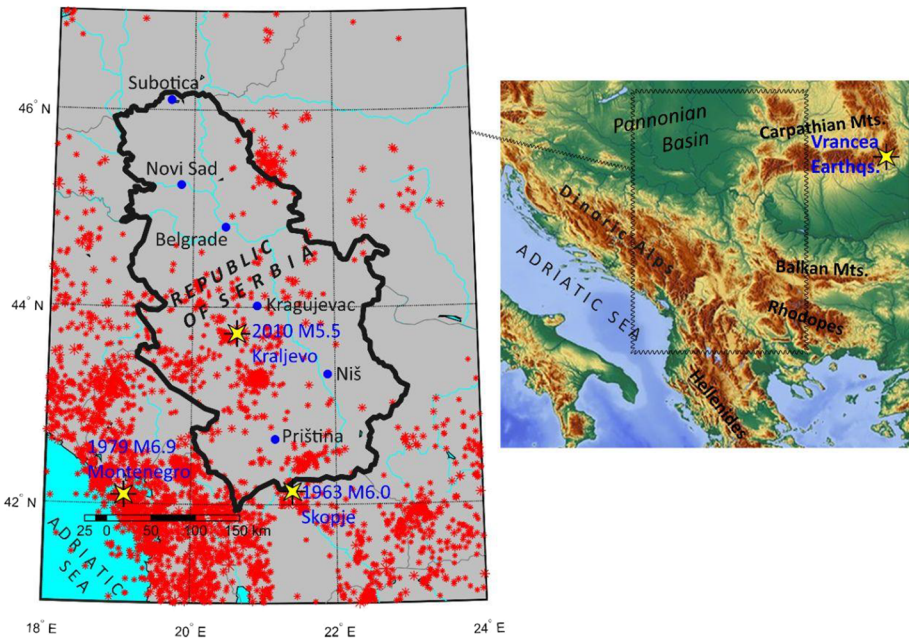
**Fig. 1** Earthquakes in Serbia and the region. **a** Epicenters of the regional earthquakes with  $M_w \geq 3.0$ , recorded between 1900 and 2021 (USGS 2021), including the epicenters of the most significant seismic events from 1963-present, and **b** a geographic map of Serbia (shown within the frame) and the Balkan region, showing the location of the Vrancea, Romania seismic source zone

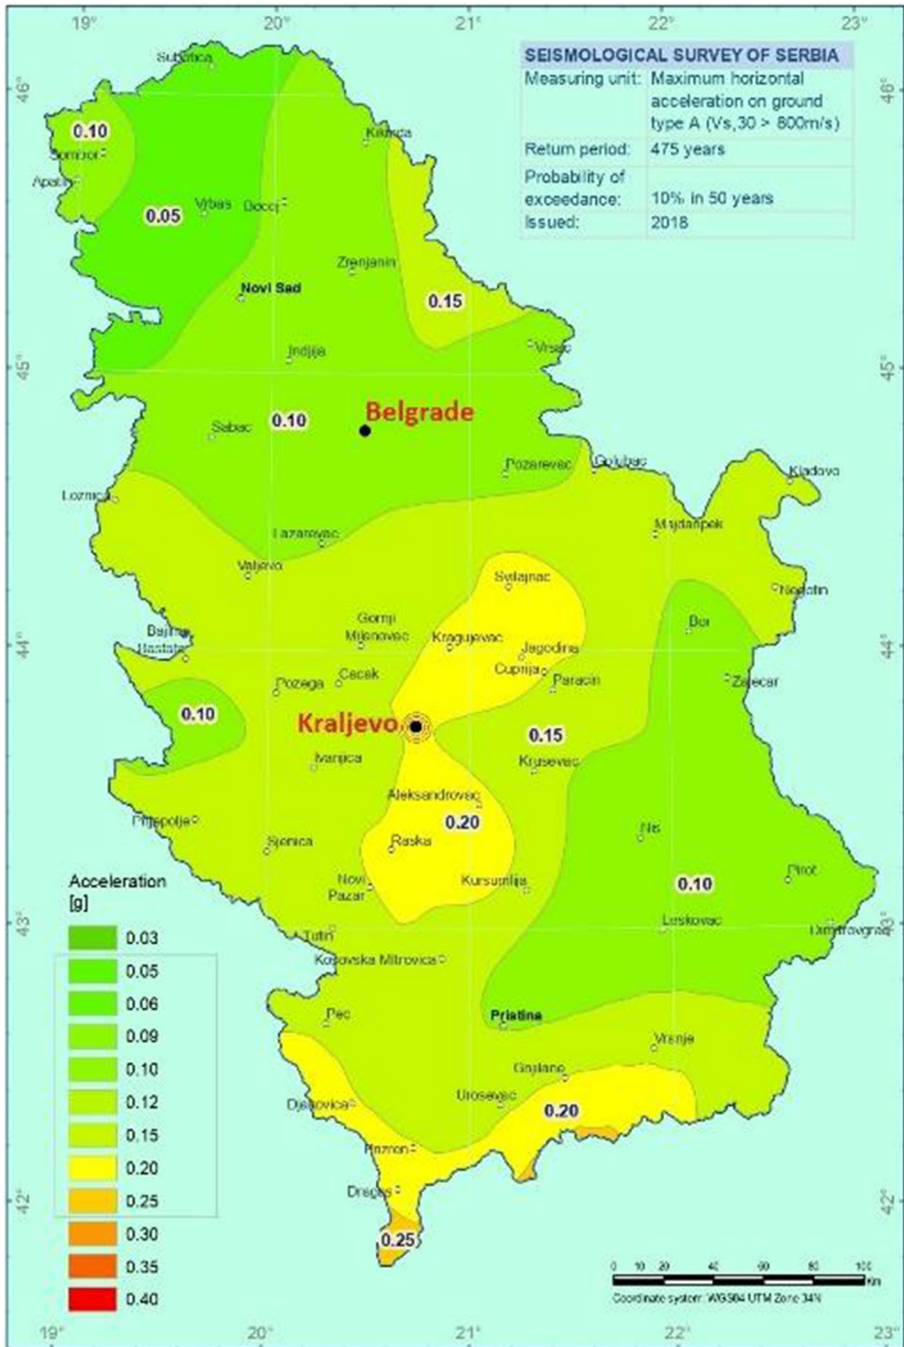
**Fig. 2** Seismic hazard map for Serbia showing the PGA values for an earthquake with a 10% probability of exceedance in 50 years according to the Eurocode 8 requirements (SSS 2018)

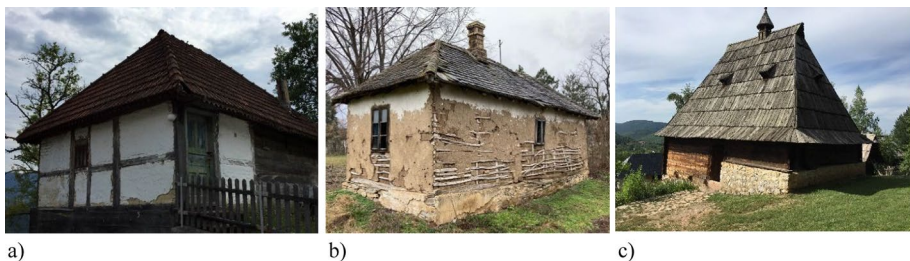
**Fig. 9** Wooden building typology(W)—examples from Serbia: **a** a single-storey timber frame (*bondruk*) house close to Valjevo; **b** a single-storey rural house (*čatmara*) in the Nemenikuće village, and **c** a wood log rural house (*brvnara*), Zlatibor

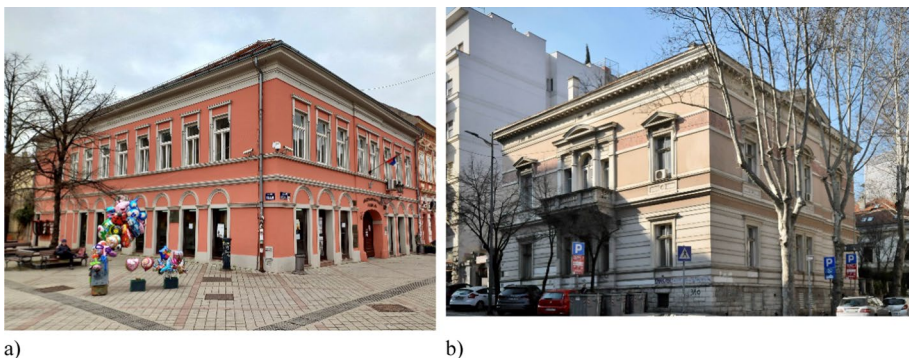
**Fig. 10** URM buildings with flexible diaphragms: **a** type M1: an URM building with adobe walls constructed at the beginning of the nineteenth century in Dunavska Street 2, Novi Sad and **b** Type M2: an URM house with brick masonry walls constructed in Belgrade in 1884

These buildings had wooden floors, consisting of 14 cm×20 cm wooden beams at 80 cm spacing and 2.5 cm thick wooden planks. Flooring consisted of 8 cm thick rammed earth layer supporting a hardwood floor. A vaulted brick floor system, known as jack arch system or Prussian vault (*Pruski svod* in Serbian) was used for the construction of suspended floors above the basement and ground floor levels. The main components of the Prussian vault were shallow brick vaults spanning between the iron beams. Wooden floors were widely used in Serbia until the end of WWI, but were subsequently replaced by ribbed RC floor systems, primarily for building construction in urban areas. The M2-type buildings usually have sloped wooden roofs covered by clay tiles.

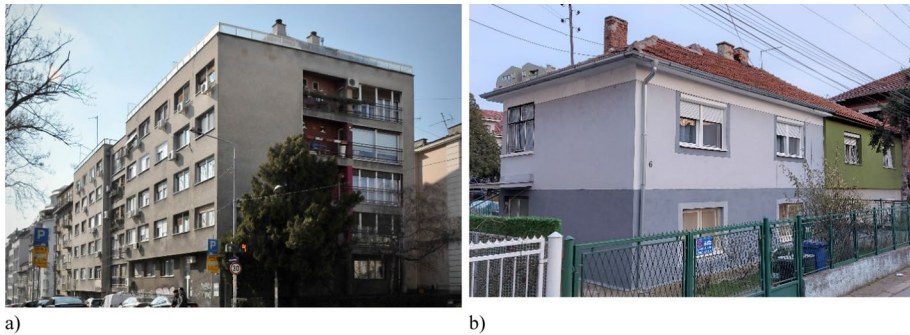
**Fig. 11** URM buildings with rigid diaphragms: **a** type M3-M: a typical 5-storey multi-family residential building in Belgrade (post-WWII construction) and **b** type M3-S: a single-family residential building of the 1960 vintage in Niš

Masonry buildings of type M3-M were constructed from the end of WWI until the beginning of the 1970s. These are multi-family apartment buildings found in Serbian urban centres and usually have 3 to 6 floor levels (Fig. 11a). These buildings are regular in plan and elevation, their wall layout is relatively symmetrical, and there are no elevators (only staircases). Load-bearing masonry walls were typically constructed using solid clay bricks and cement:lime:sand mortar. Typical wall thickness is 38–51 cm and 25–30 cm for exterior and interior walls respectively.

Masonry buildings of type M3-S were constructed from the 1950s until the present time. These are low-rise single-family residential buildings found both in suburban areas of urban centres and rural areas (Fig. 11b). Load-bearing masonry walls were typically constructed using modular (multi-perforated) clay blocks or solid clay bricks and

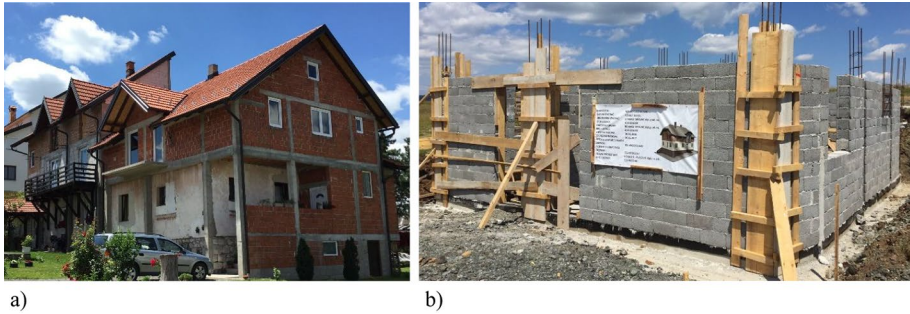
**Fig. 12** Confined masonry buildings – type M4: **a** a 2-storey rural house and **b** a rural house under construction, showing formwork for RC confining elements

The M4 buildings have masonry walls reinforced with horizontal and vertical RC elements. Provision of horizontal and vertical RC confining elements in masonry buildings was required by the first seismic design code of Yugoslavia, which was issued in 1964; however, it is believed that wider application of this technology started in the 1970s. These low-rise buildings (usually 1- to 4-storey high) are used both for single- and multi-family residential construction in urban and rural areas of the country (Fig. 12). These buildings

have masonry walls constructed using modular (multi-perforated) clay blocks, which have been widely used since the 1970s and have replaced solid clay bricks (Đukanović, 2021). Wall thickness ranges from 19 to 25 cm, and a typical mortar composition is a mix of cement, lime, and sand. These buildings have rigid floors, either in the form of cast-in-situ solid RC slabs or semi-prefabricated floor systems (same as M3-type buildings), but the LMT system is also widely used in contemporary construction. These buildings usually have either flat RC roofs (multi-family residential buildings) or sloped wooden roofs (single-family buildings).

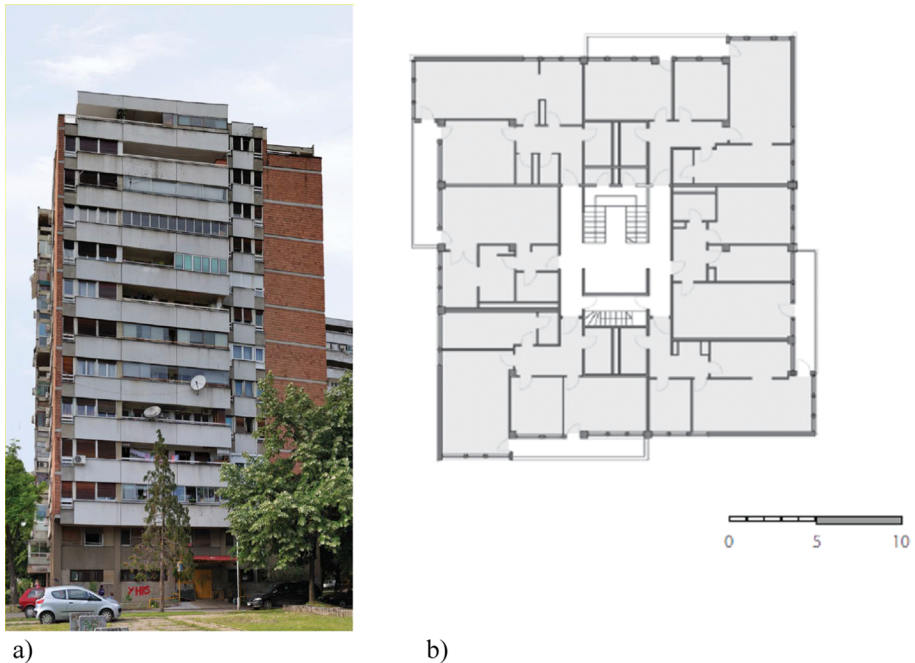
**Fig. 13** Cast-in-situ RC frame building typology—type RC1: **a** a 13-storey multi-family residential building in New Belgrade (Block 45) constructed circa 1970 and **b** a typical floor plan (Jovanović Popović and Ignjatović 2011)

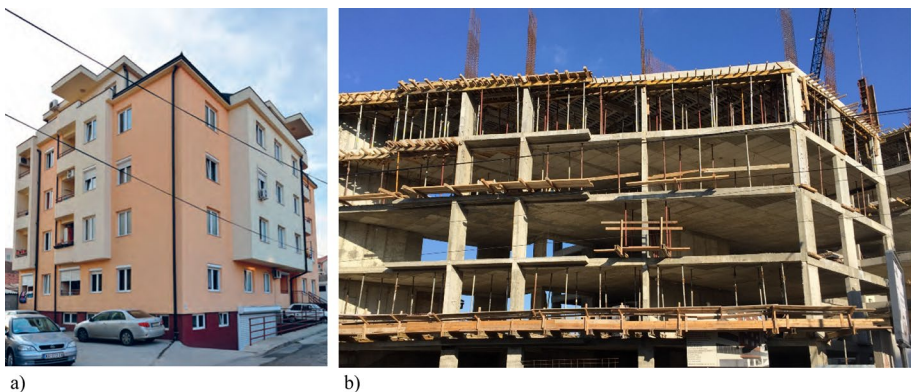
**Fig. 14** Cast-in-situ RC frame-wall building typology—type RC2: **a** a 4-storey multi-family residential building in Belgrade (Jovanović Popović et al. 2013c) and **b** an RC2 building under construction in Belgrade

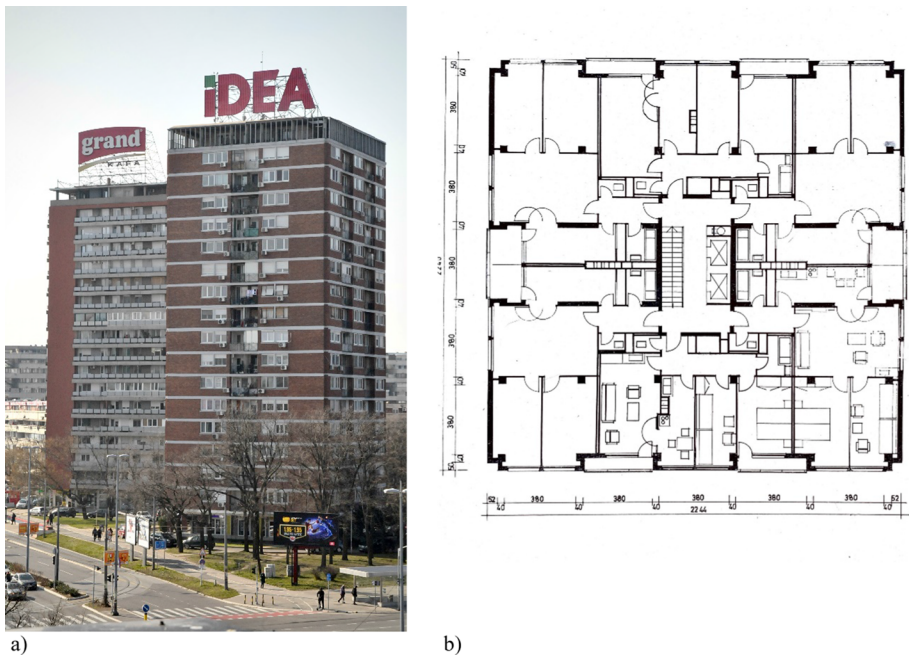
**Fig. 15** Prefabricated RC building typologies—type RC3: **a** a 17-storey multi-family residential building in New Belgrade (Block 21), a part of the complex “The six corporals” constructed in the early 1960s using the IMS technology, and **b** a typical floor plan, showing column grid and RC structural walls (Zanko 1965)

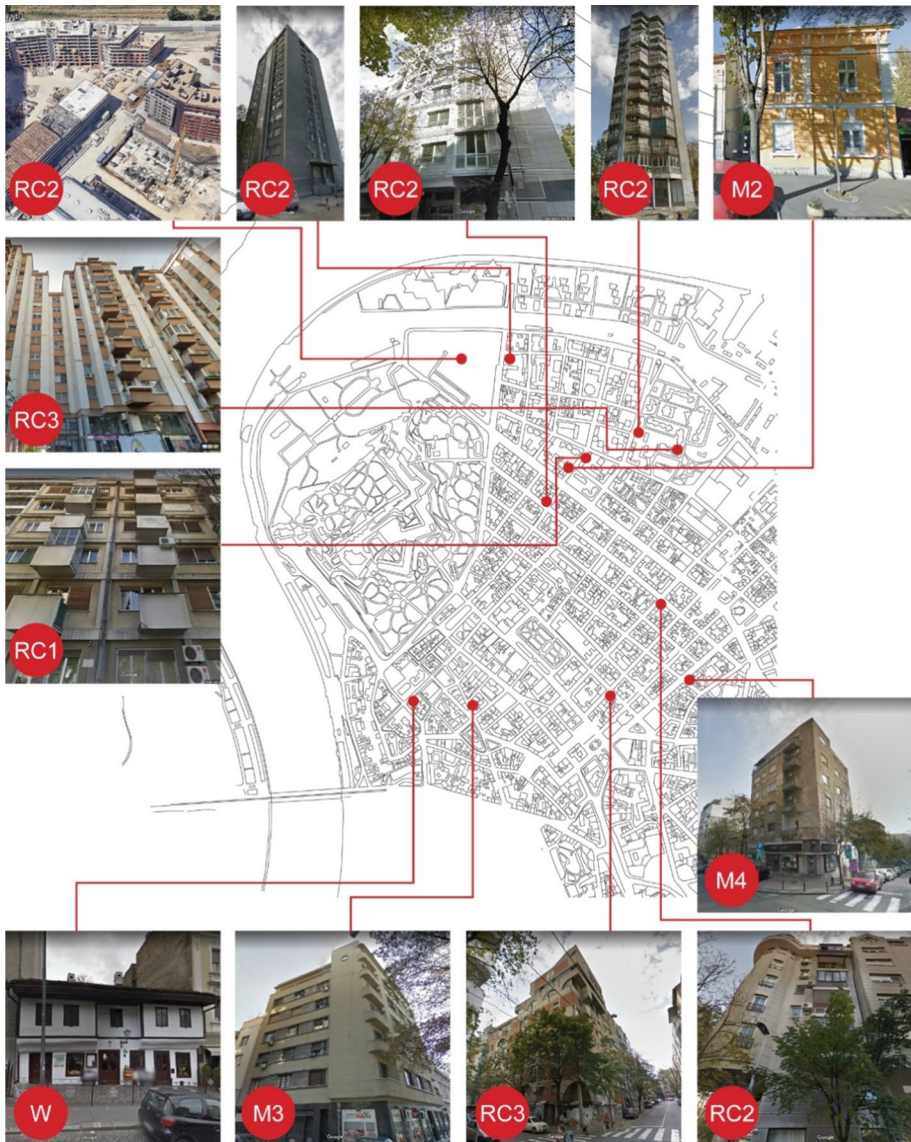
Fig. 16 Map of the centre of Belgrade showing examples of urban building typologies characteristic of major Serbian urban centres

longer used for residential construction. Figure 16 shows a partial map of the centre of Belgrade and illustrates building typologies presented in Table 2. It can be seen from the map that the centre of Belgrade showcases a variety of residential building typologies which are located close to one another.

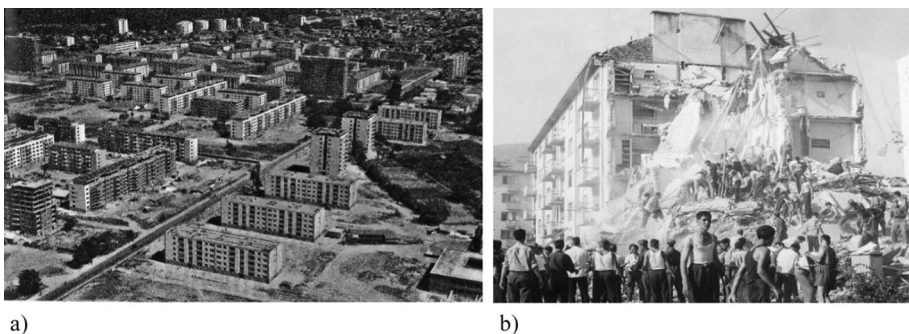
**Fig. 17** Damage of masonry buildings (type M3) in the 1963 Skopje earthquake: **a** Karpoš building complex with 40 3–5 storey URM apartment buildings, and **b** a partially collapsed building No.13. (Source: Milutinovic 2022)

Performance of type M3 buildings in the earthquake can be illustrated on the example of the Karpoš residential complex in the western part of Skopje, which was constructed in the 1950s (Berg 1964), Fig. 17a. The complex comprised of 40 buildings, with the height ranging from 3 to 5 floors. The buildings were designed according to standardized designs, with load-bearing walls provided only in one direction (either longitudinal or transverse). One of the densely populated 5-storey buildings (labelled No. 13) partially collapsed and caused 159 fatalities (Fig. 17b). Various damage patterns were observed in these buildings, ranging from in-plane shear cracks to horizontal offset at floor levels (Berg 1964). Detailed reports on post-earthquake surveys of these buildings are available (Milutinović 2022).

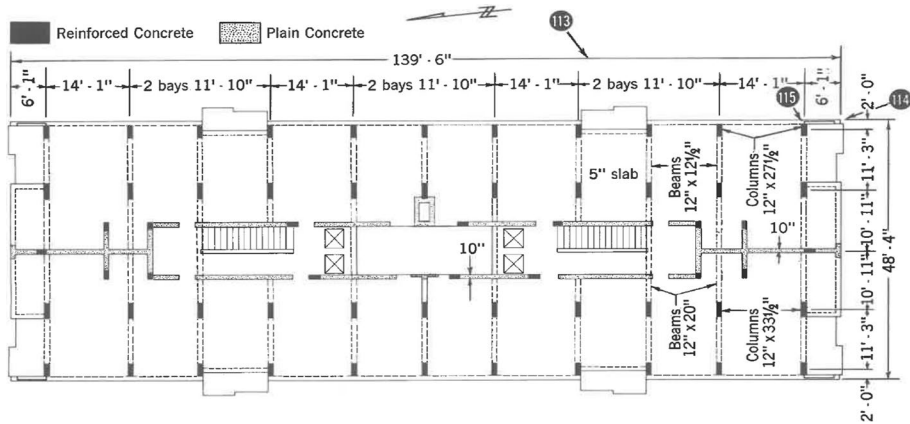
**Fig. 18** Floor plan of Karpoš Tower, Skopje (Berg 1964)

Three 14-storey RC apartment buildings in the Karpoš residential complex (called the Karpoš Towers) were also exposed to the 1963 Skopje earthquake (Berg 1964). The buildings had a cast-in-situ RC frame system with RC floors and can be classified as RC1-type buildings according to the proposed classification. The buildings had a rectangular plan, 43 m long and 15 m wide (Fig. 18). Lateral load-resisting system in the transverse direction consisted of parallel RC frames, at approximately 4.0 m spacing. The frames were discontinued at the stairwells. Plain concrete structural walls were provided in the longitudinal direction along two interior gridlines and around the stairwells. Rectangular RC columns had 70 cm by 35 cm cross-sectional dimensions, 6 longitudinal reinforcing bars

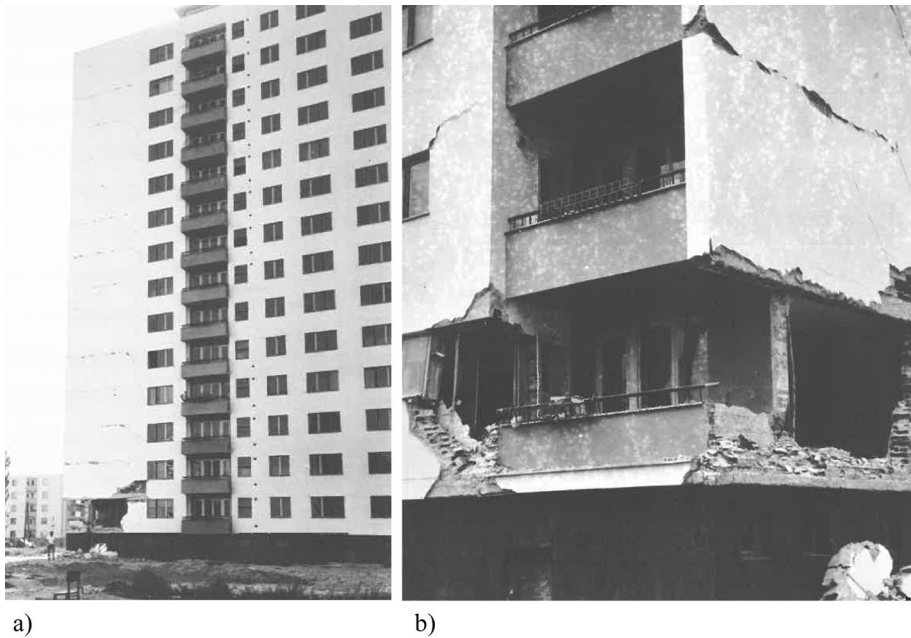
**Fig. 19** Damage of RC buildings (type RC1) in Skopje due to the 1963 earthquake: **a** damaged Karpoš Tower (note the extensive damage at the ground floor level), and **b** a close-up of the damaged region (Berg 1964)

(16–20 mm diameters) and 6 mm ties at 300 mm spacing. Concrete compressive strength of 20 MPa was specified by the original design. Two out of three towers experienced only minor damage, while the third tower experienced severe damage, including cracking in interior walls, horizontal cracking at the floor levels, and severe damage/failure of a corner RC column at the ground floor level (Fig. 19).

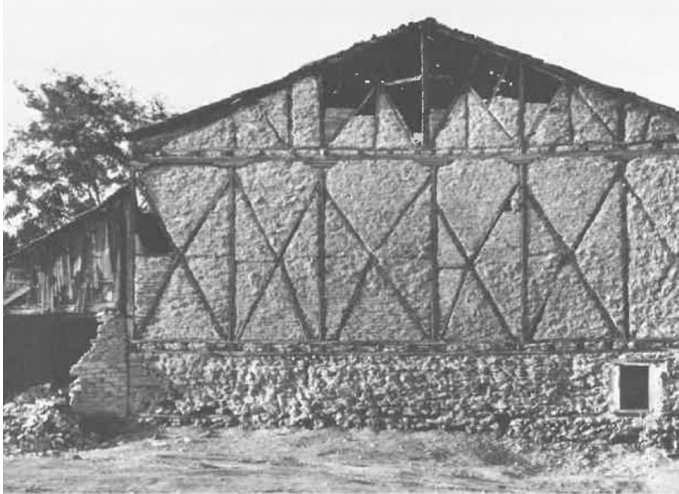
**Fig. 20** Minor damage of a timber-framed house (type W) in the centre of Skopje due to the 1963 earthquake (Berg 1964)

At the time of the earthquake, several older timber-framed houses infilled with adobe bricks (*bondruk*) existed in Skopje (type W according to the proposed classification). A type W building shown in Fig. 20 was located close to the Karpoš residential complex and experienced only a minor damage, as opposed to severe damage and destruction of modern masonry buildings (Berg 1964).

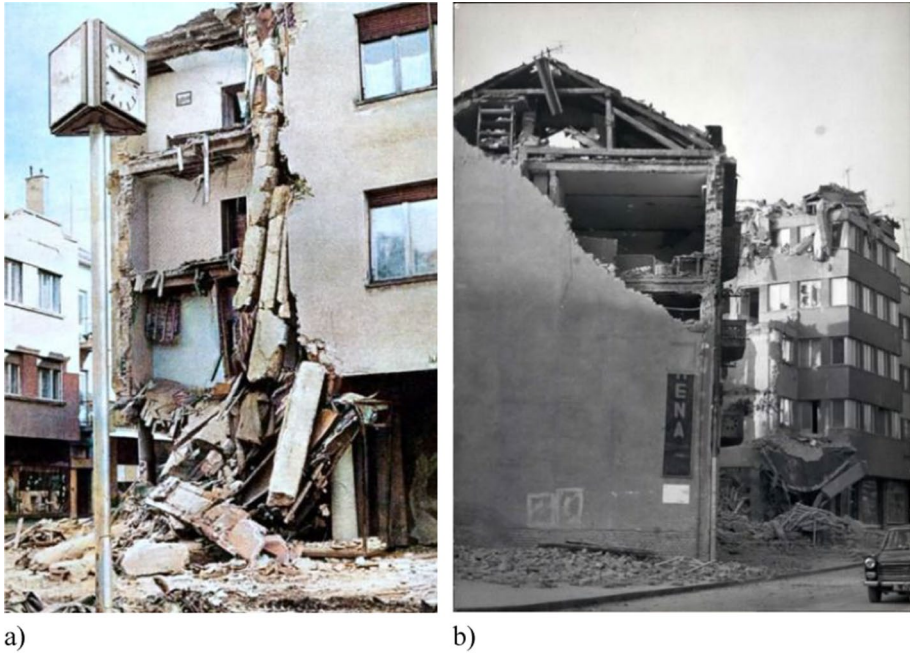
**Fig. 21** Examples of type M2 residential URM buildings in Banja Luka affected by the 1969 earthquakes: **a** a partial collapse of the building with wooden floors (Banja Luka 2009) and **b** collapse of a gable wall (Blic 2019)

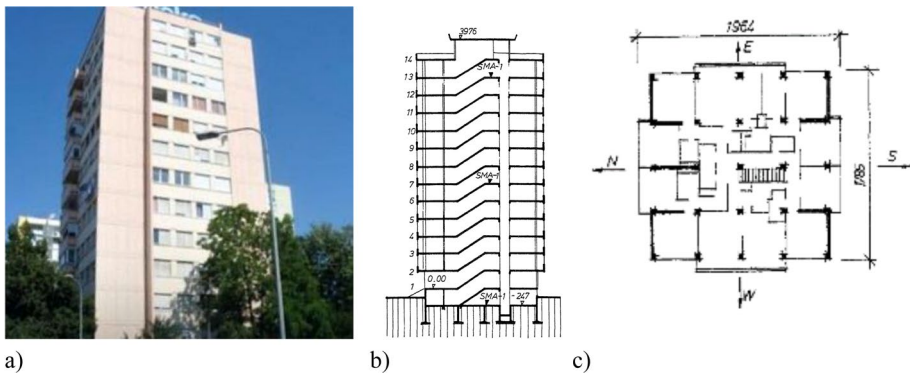
**Fig. 22** An example of type RC3 prefabricated RC building in Banja Luka: **a** exterior view of a 14-storey residential building; **b** elevation, and **c** typical floor plan (Jurukovski et al. 1988)

was not located in an earthquake-prone area according to the official seismic hazard map (UNIDO 1983). Buildings with RC structural walls, including two 14-storey towers which were the tallest buildings in Banja Luka at the time of these earthquakes, experienced either insignificant damage or remained undamaged (Fig. 22). However, a few of the IMS prefabricated RC buildings without structural walls experienced significant non-structural damage of the partition and façade walls and had to be repaired. Some of these buildings

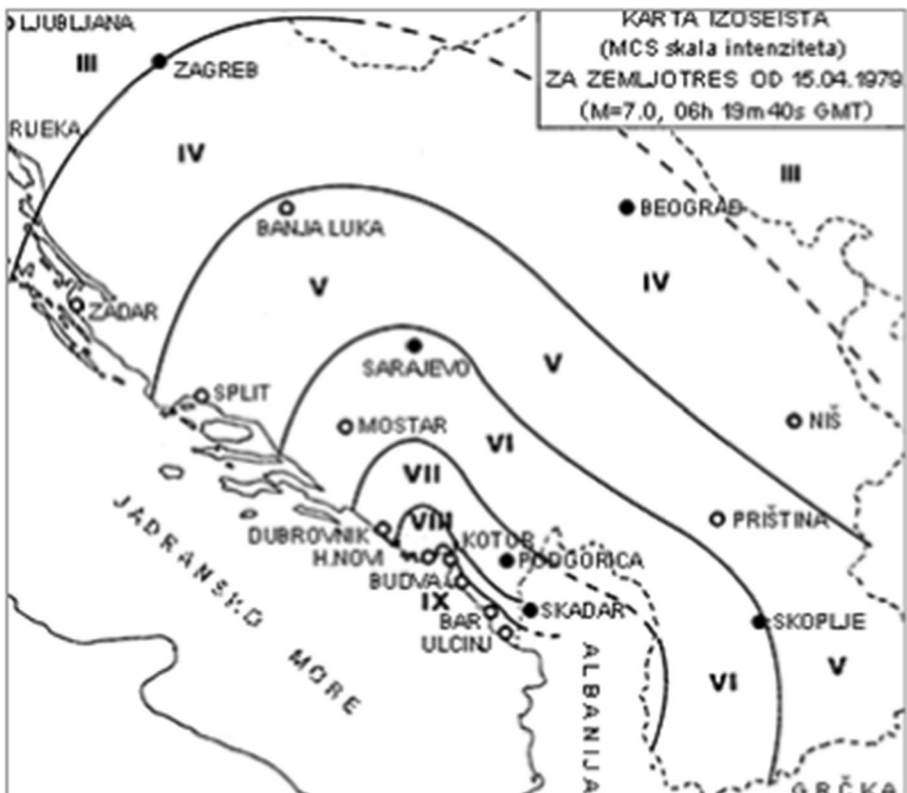
Fig. 23 Intensity map for the 1979 Montenegro earthquake (ZHMS 2013)

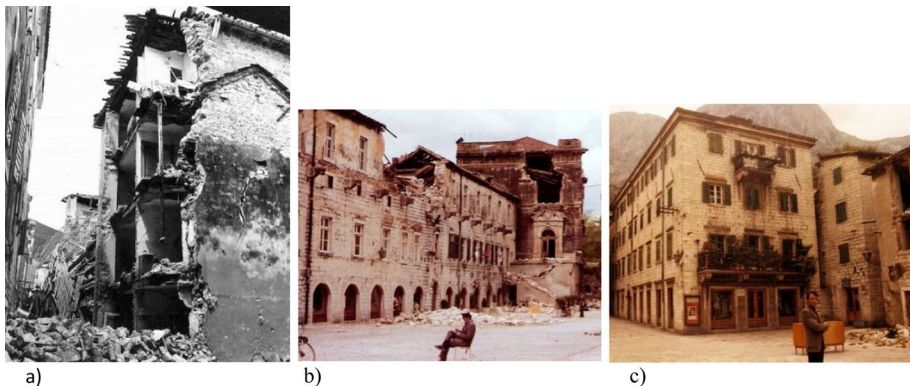
**Fig. 24** Examples of type M1 stone masonry buildings in Montenegro affected by the 1979 earthquake: **a** a street in the historic centre of Budva, showing collapse of stone masonry buildings with wooden floors (RTV Budva 2015); **b** damaged buildings in the historic centre of Kotor (Cafe del Montenegro 2016), and **c** undamaged stone masonry buildings in the centre of Kotor (Petrović 1979)

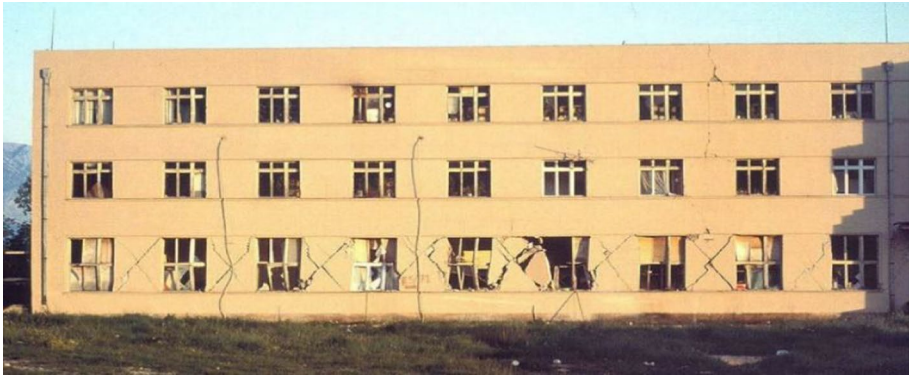
**Fig. 25** Budva Town Hall—an example of a type M3-M building damaged in the 1979 Montenegro earthquake (M. Fischinger)

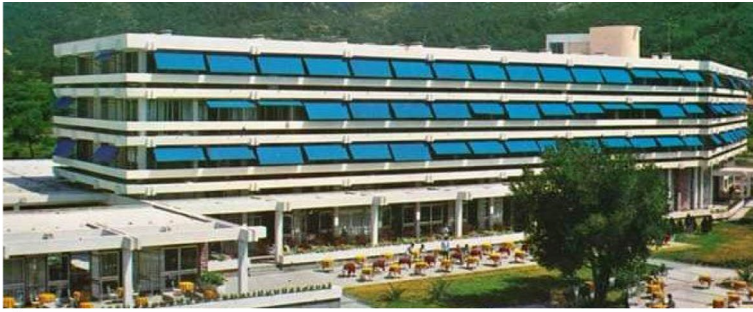
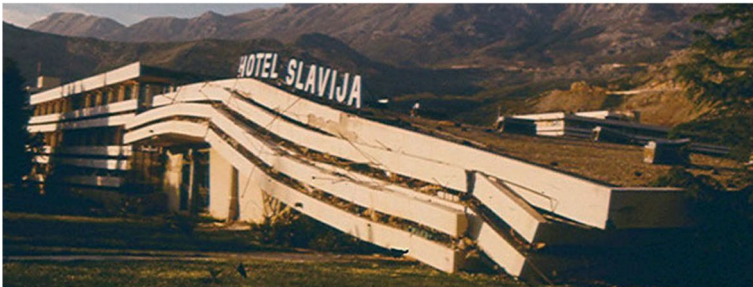
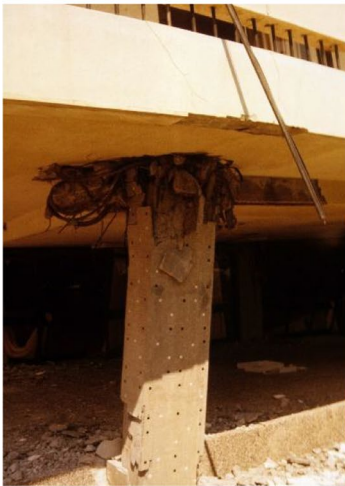
**Fig. 26** Damage of the Hotel “Slavija” buildings (type RC1) in Budva due to the 1979 Montenegro earthquake: **a** an exterior view of the hotel before the earthquake (FOS Media 2020); **b** the collapsed block, and **c** a column damage detail (Petrović 1979)

Hotel “Slavija” in Budva was constructed after WWII (Fig. 26a). It comprised of three near-identical, rectangular-shaped 4-storey building blocks (type RC1). The hotel had an open-space restaurant at the ground floor level, while at the upper floors brick masonry infills were constructed between the rooms. The lateral load-resisting system consisted of RC frames in the transverse direction, but there were neither frames nor structural walls in the longitudinal direction. The floor structure consisted of ribbed RC slabs, which formed a column-slab system in the longitudinal direction. One of the hotel blocks collapsed in the earthquake (Fig. 26b), while the other two blocks experienced severe damage, particularly at the ground floor level, showing signs of instability and the *soft storey* failure mechanism (Fig. 26c). Several RC columns at the ground floor level experienced damage, extending to the slab at the top, due to high seismic drift demand.

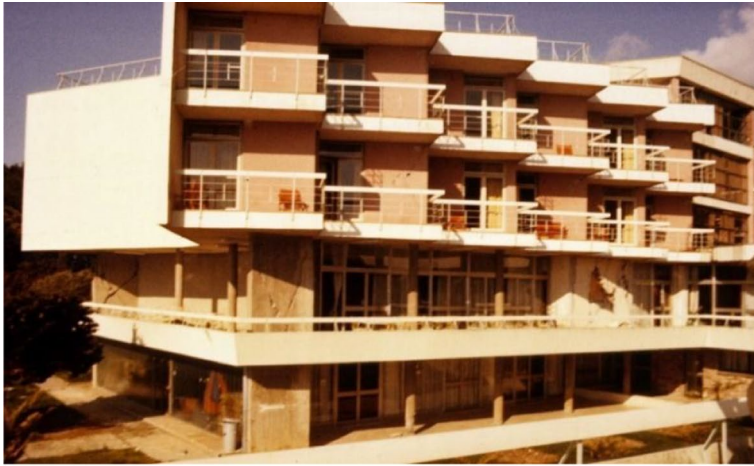
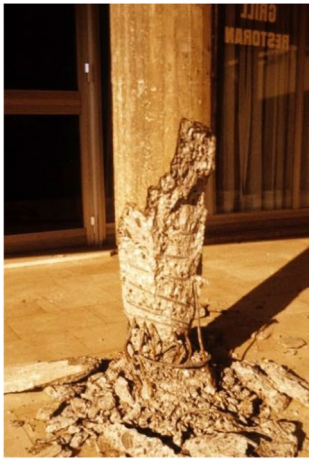
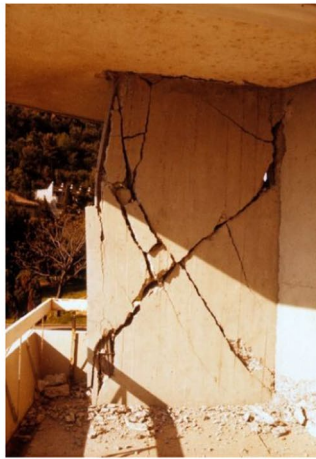
**Fig. 27** Damage of the Hotel “Oliva” building in Petrovac (type RC2) due to the 1979 earthquake: **a** an exterior view of the building showing the damaged RC structural walls at the second floor level; **b** damaged base of a circular RC column at the ground floor level, and **c** extensive damage of an RC structural wall (Petrović, 1979)

Hotel “Oliva” in Petrovac, a small coastal town located 18 km south of Budva, was a 4-storey RC frame structure constructed after WWII (Fig. 27a). RC structural walls (type RC2) were constructed as a part of the retrofit project after the earthquake which hit the region in 1966. The columns were provided at approximately 4 m spacing in the longitudinal direction, and 5 m spacing in the transverse direction. Circular RC columns at the ground floor level were severely damaged, and plastic hinges formed at the base (Fig. 27b). RC structural walls at the second-floor level experienced severe damage in the form of shear cracks, which indicated inadequate horizontal reinforcement (Fig. 27c). Lateral drift demand in the (more flexible) longitudinal direction caused significant damage in partitions located at the second-floor level.

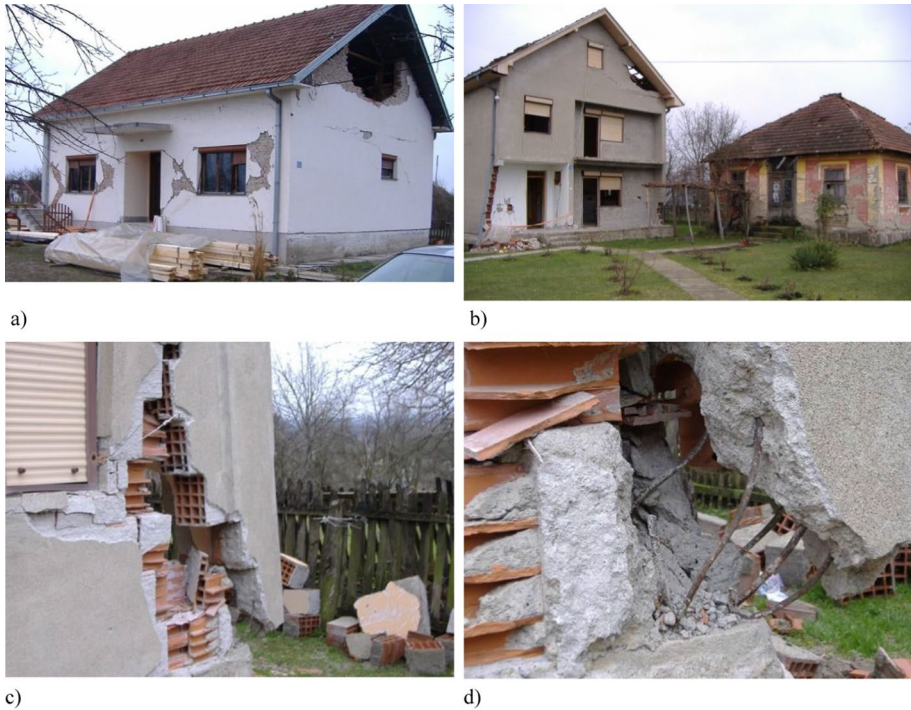
**Fig. 28** Rural single-family masonry buildings affected by the 2010 Kraljevo, Serbia earthquake: **a** a severely damaged type M2 building; **b** a damaged inadequately confined M4 type building (left) adjacent to an undamaged old timber-frame (bondruk) building; **c** and **d** damage at the corners of the building shown in figure **b** due to construction flaws (Manić and Bulajić 2014)

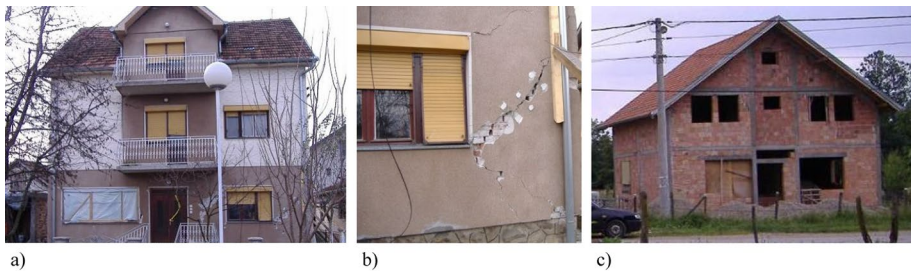
**Fig. 29** Performance of type M4 single-family buildings in the 2010 Kraljevo, Serbia earthquake: **a** a partially confined building (ground floor unconfined and upper floors confined); **b** damage of the same building at the ground floor level, and **c** a fully confined M4 type building under construction remained undamaged (Manić and Bulajić 2014)

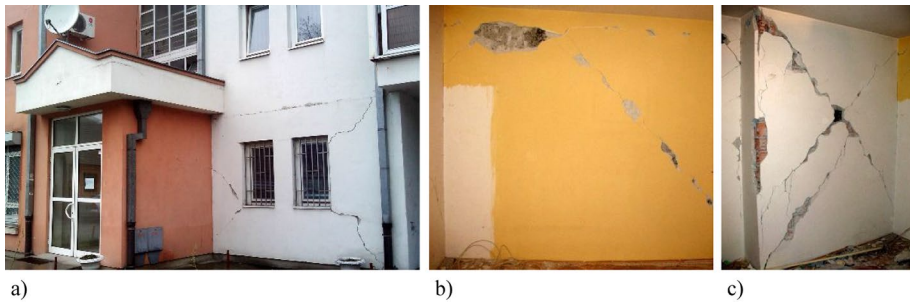
**Fig. 30** Performance of type M3-M multi-family residential buildings in the 2010 Kraljevo, Serbia earthquake: **a** diagonal and horizontal cracks in an exterior wall; **b** in-plane damage of a load-bearing interior wall (solid clay bricks), and **c** extensive cracking in a partition wall (multi-perforated clay blocks) (Blagojević 2022)

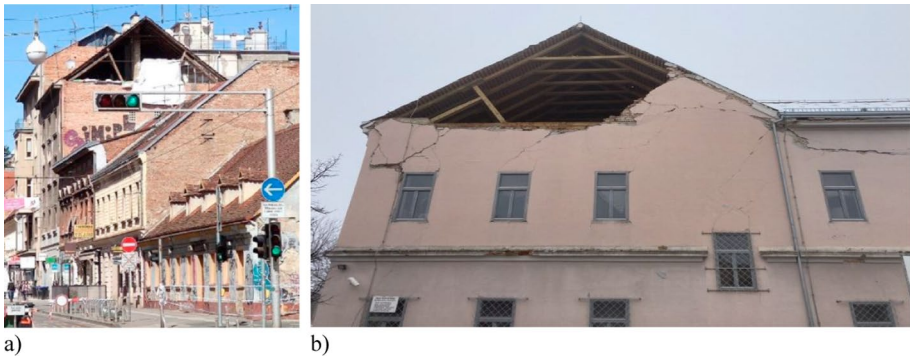
**Fig. 31** Damage of URM buildings (type M2) due to the 2020 Croatia earthquake: **a** typical damage due to the March 2020 Zagreb earthquake (Stepinac et al. 2021) and **b** typical damage due to the December 2020 Petrinja earthquake (SUZI-SAE 2021)

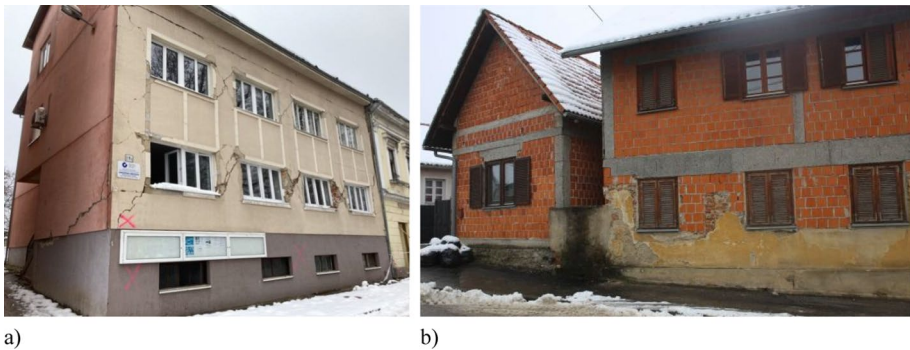
**Fig. 32** Damage of masonry buildings due to the December 2020 Petrinja, Croatia earthquake: **a** significant in-plane shear cracking in an M3 building in Petrinja and **b** undamaged type M4 buildings in Petrinja (SUZI-SAE 2021)

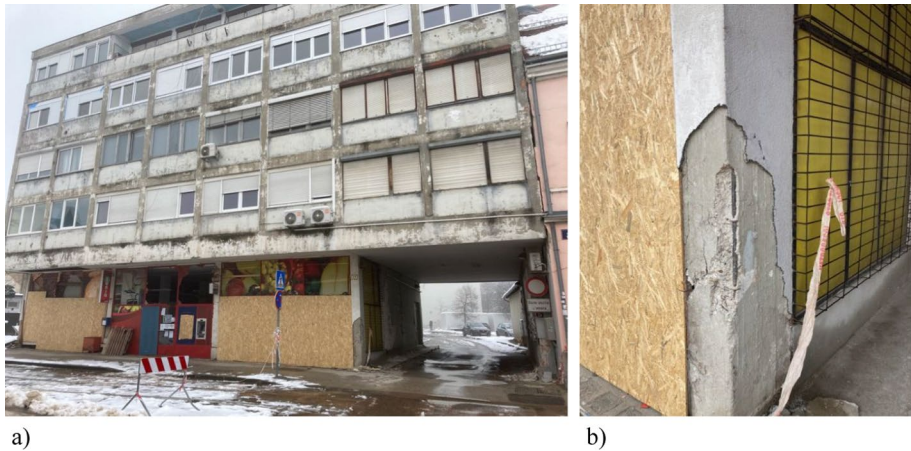
**Fig. 33** Damage of type RC1 residential building in Petrinja, Croatia due to the December 2020 earthquake: **a** exterior view showing open ground floor space which used as a store before the earthquake, and **b** a detail of the damaged RC column (SUZI-SAE 2021)

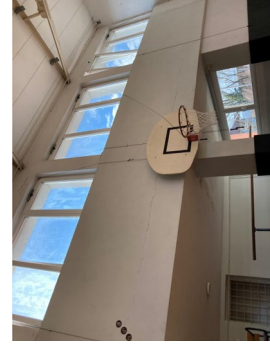
Example	Light cracks in plaster in the infill masonry walls	<p>Gymnasium in Primary School “Dragutin Tadijanović”, Petrinja (SUZI-SAAE) December 29, 2020 Petrinja, Croatia earthquake <math>M_w = 6.4, I (^{\circ}MCS) = 9</math></p>

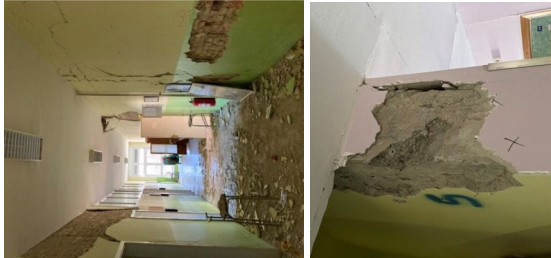
<p>Example</p>	<p>Cracking of interior infill walls; spalling of plaster; damage at the infill-frame interface; cracking of RC columns</p>	<p>Retirement home, Petrinja (SUZI-SAPEE) December 29, 2020 Petrinja, Croatia earthquake <math>M_w = 6.4, I (\text{°MCS}) = 9</math></p>

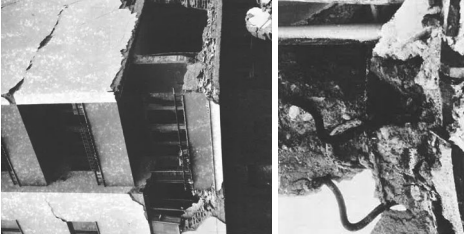
<p data-bbox="444 149 503 296">Example</p>	<p data-bbox="444 313 503 578">Cracking in interior infills; failure of exterior walls and RC columns with inadequate confinement (amount of horizontal reinforcement) at the first-floor level</p>	<p data-bbox="444 666 503 1178">Karpoš Tower, Skopje (Berg 1964) 1963 Skopje earthquake <math>M_w = 6.0</math>, <math>I ({}^{\circ}MCS) = 9</math></p>

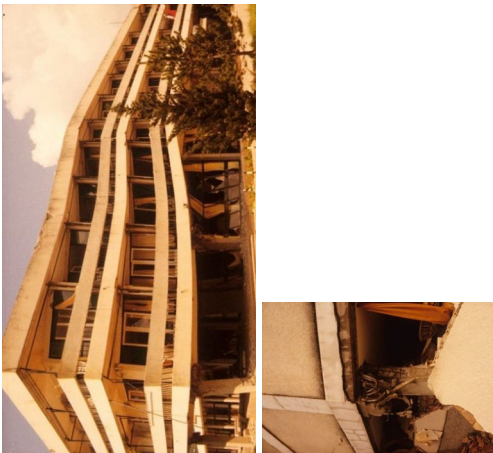
<p>Example</p>	<p>Significant damage of RC structure at the ground floor level—instability and onset of the “Soft-storey” failure mechanism; buckling of reinforcement at the top of RC columns at ground floor level</p>	<p>Hotel “Slavija”, Budva (Petrović, 1979)                      1979 Montenegro earthquake  <math>M_w = 6.9, I (^{\circ}MCS) = 9</math></p>

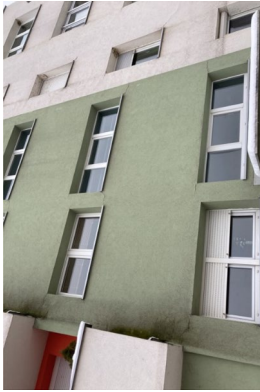
<p>Residential building in Petrinja (SUZI-SAEI) December 29, 2020 Petrinja, Croatia earthquake <math>M_w = 6.4</math>, <math>I (^{\circ}MCS) = 9</math></p>
<p><i>Damage State 2 (DS2): Moderate damage</i>                      Slight structural damage, moderate non-structural damage</p>	<p>Hairline cracks in some exterior walls (mostly in the window corners); most of the walls are undamaged                       Cracks in many walls                      Fall of large pieces of plaster                      Partial collapse of chimneys</p>

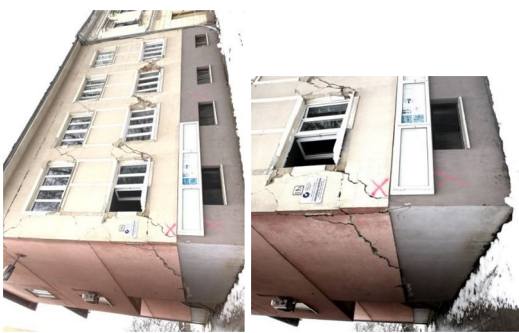
<p>Example</p>	<p>Severe damage of masonry walls in the form of shear cracks. Partial failure at the corner</p>	<p>Chamber of Crafts in Petrinja (SUZI-SAEI)                      December 29, 2020 Petrinja, Croatia earthquake  <math>M_w = 6.4</math>, <math>I(^{\circ}MCS) = 9</math></p>

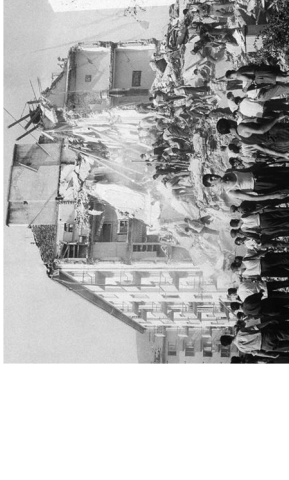
Example	Partial collapse of building No. 13, which had load-bearing masonry walls only in one direction (Berg 1964)	Karpoš residential complex, Skopje (Militinović, 2022) 1963 Skopje earthquake $M_w = 6.0$ , $I (^{\circ}MCS) = 9$

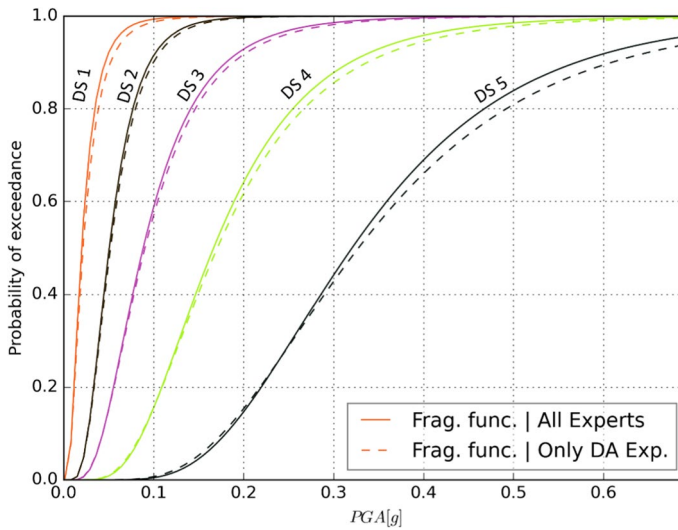
**Fig. 35** Fragility functions for the URM building with rigid floors (type M3-M) derived from expert judgement for different DSs. Solid lines are the DS fragility functions derived based on the opinion of all 40 experts that filled the questionnaire (“All Experts”), while dashed lines are the DS fragility functions derived based only on the opinion of experts with post-earthquake damage assessment experience (“Only DA Exp.”)

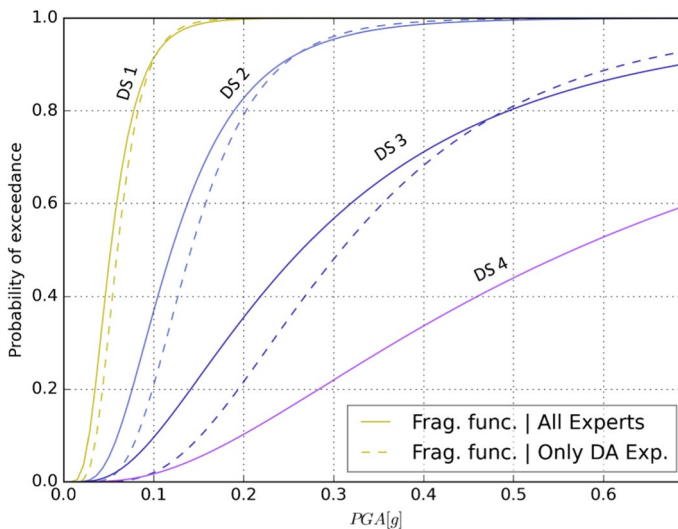
**Fig. 36** Fragility functions for the three-story reinforced concrete frame with infills typology (RC1) from the survey form. The fragility functions are derived from expert judgement for different DSs. Solid lines represent the DS fragility function derived based on the opinion of all 40 experts that filled the questionnaire (“All Experts”), while dashed lines are the DS fragility functions derived based only on the opinion of experts with post-earthquake damage assessment experience (“Only DA Exp.”)
