Seismic Performance Assessment of the 18th Century Jesuit College in Dubrovnik's Old City

Uzair, Aanis; Abrahamczyk, Lars; Vrban, Ante; Penava, Davorin

Journal article, Published version

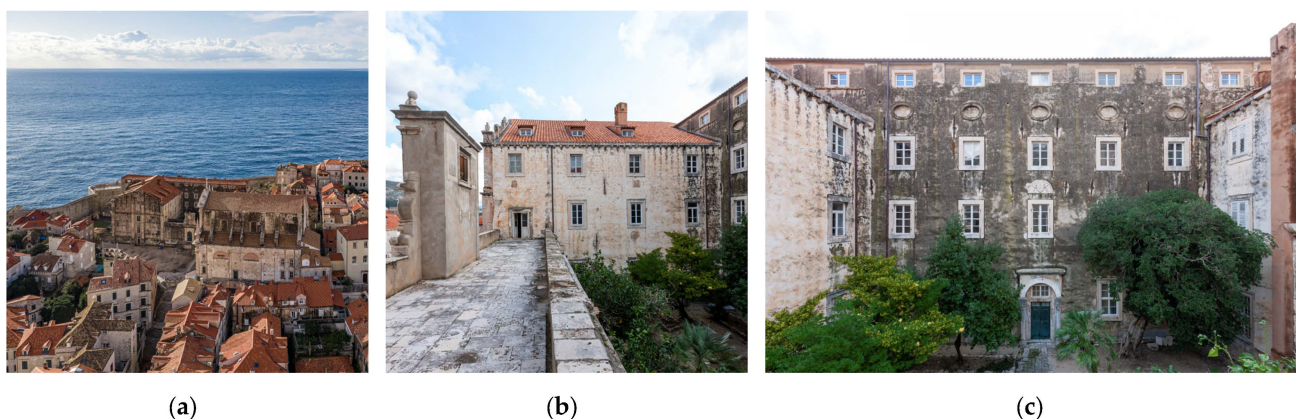
Figure 1. Overview of the Jesuit College: (a) On the location within the Old Town; (b) East wing; (c) South wing (Photographic Collection of the Institute of Art History, Zagreb, photo by: Paolo Mofardin).

The Jesuit College is located in front of the monumental Jesuit Stairway and was originally designed by the Jesuit brother Serafino Fabrini, featuring Late Baroque Era architecture and decorative elements [22,23]. The construction started in 1662 and initially included a central church surrounded by a college. Halted by the great Dubrovnik earthquake in 1667, the development and expansion were undertaken by various architects and took more than a century to be completed in 1765 (see Figure 2). Today, the building hosts a Catholic gymnasium and is primarily used for educational purposes.

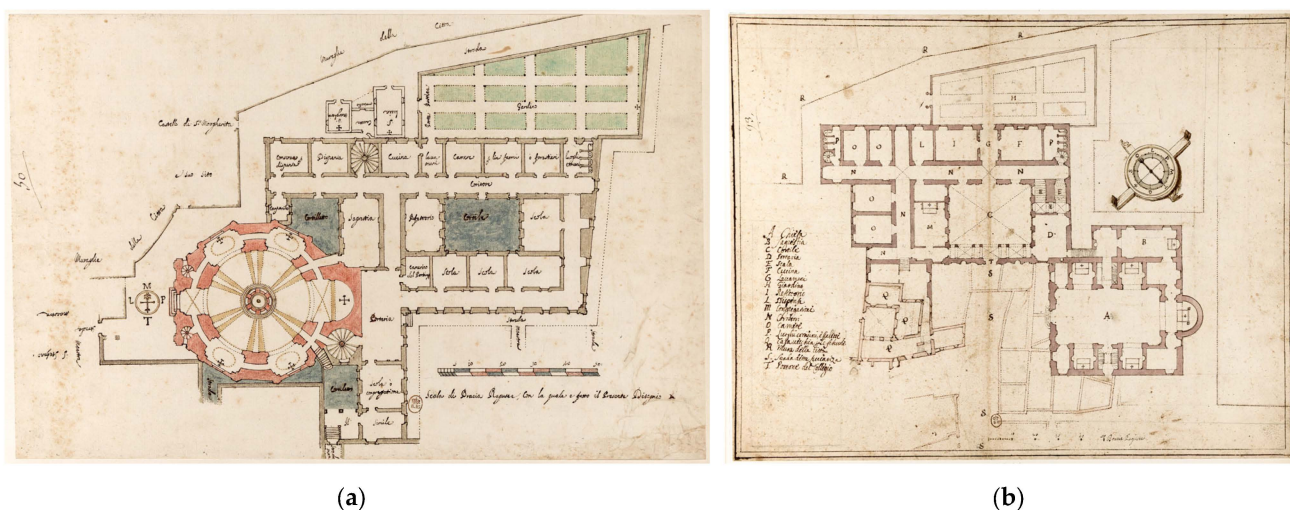
Figure 2. Architectural drawings of the Jesuit college by (a) Serafino Fabrini in 1659; (b) Henri Laloju in 1699, from the National Library in Paris [23].

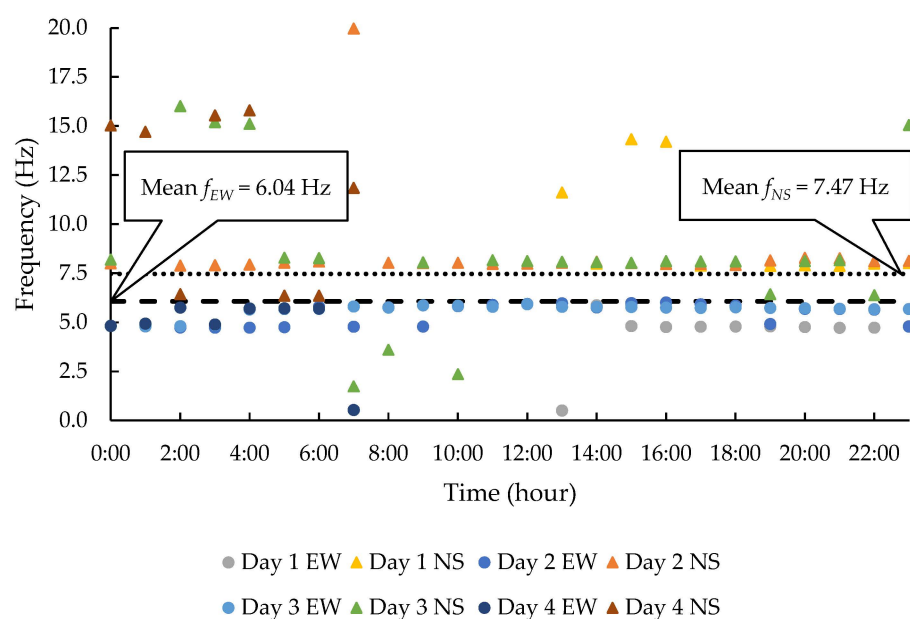
**Figure 6.** Natural frequencies of the Jesuit College obtained from the continuous measurements at the 2nd story, position no. 6 (see Figure 5b) [22,28].

Figure 6 shows the variation in the natural frequencies of the building based on continuous measurements with overall mean frequencies as reference values. The occasional discrepancies occurred due to external factors and were not considered in the analysis of vibrational characteristics ($4 \text{ Hz} < f < 10 \text{ Hz}$).
