Seismic Performance Assessment of the 18th Century Jesuit College in Dubrovnik's Old City

Keywords: cultural heritage; unreinforced masonry; earthquake performance; vulnerability assessment; ambient vibration testing; finite element modeling; numerical calibration

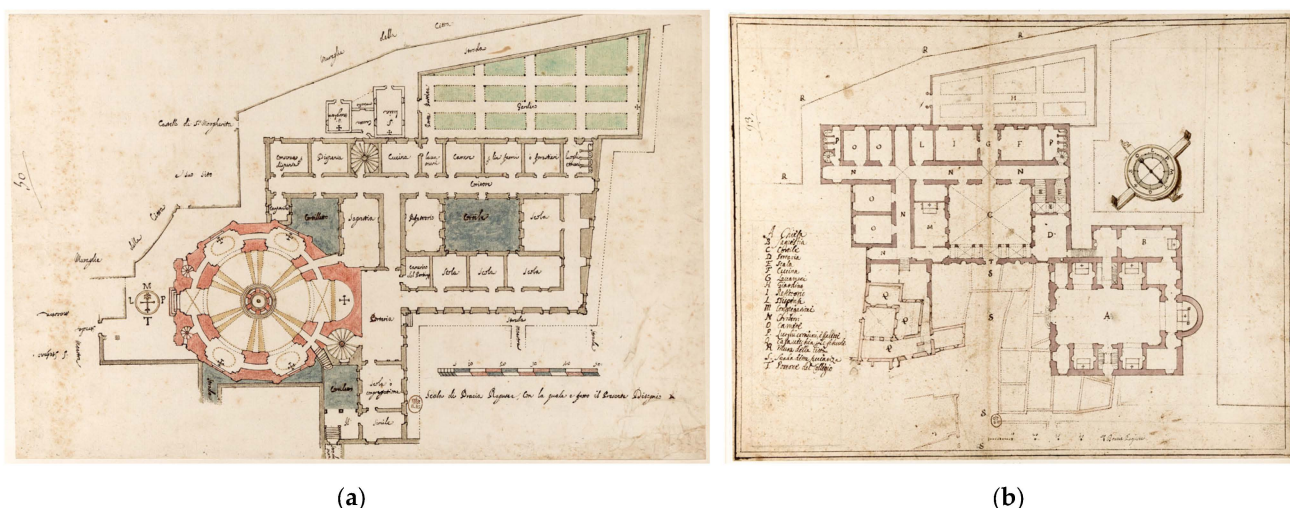
Figure 2. Architectural drawings of the Jesuit college by (a) Serafino Fabrini in 1659; (b) Henri Laloju in 1699, from the National Library in Paris [23].
