The Effects of Strong Earthquakes on Built Heritage: A Preliminary Case Study of Rector's Palace in Dubrovnik's Old City

Article

Keywords: Rector's Palace; Old City of Dubrovnik; heritage architecture; stone masonry construction; destructive earthquakes; retrofitting; earthquake performance

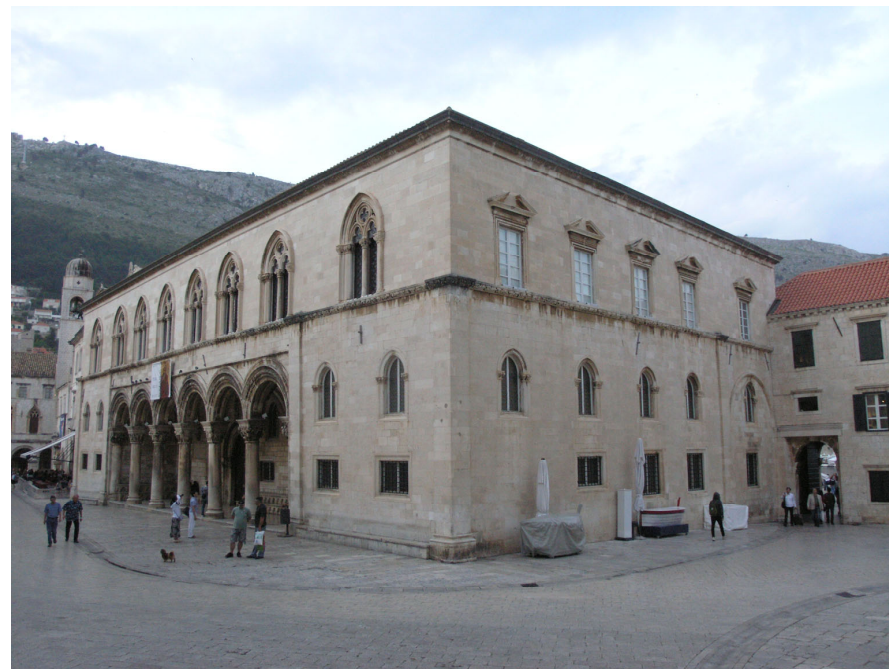
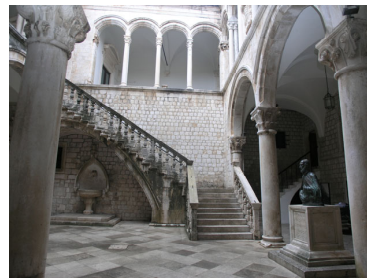
Figure 5. A view at the exterior and interior of the Rector's Palace architecture: (a) south-west corner of the building; (b,c) atrium; (d) arcades (courtesy of the Institute for the Restoration of Dubrovnik [14]).

The Rector's Palace in the Old City of Dubrovnik (see Figures 5–8) is a building of outstanding world historical and cultural heritage significance and value. It is included in the UNESCO World Heritage List [49] immediately after the 1979 $M_w = 7.1$ Montenegro earthquake caused structural damage to the building. In history, it was used as the seat of government and residence of the Rector, the highest political function in the Republic of

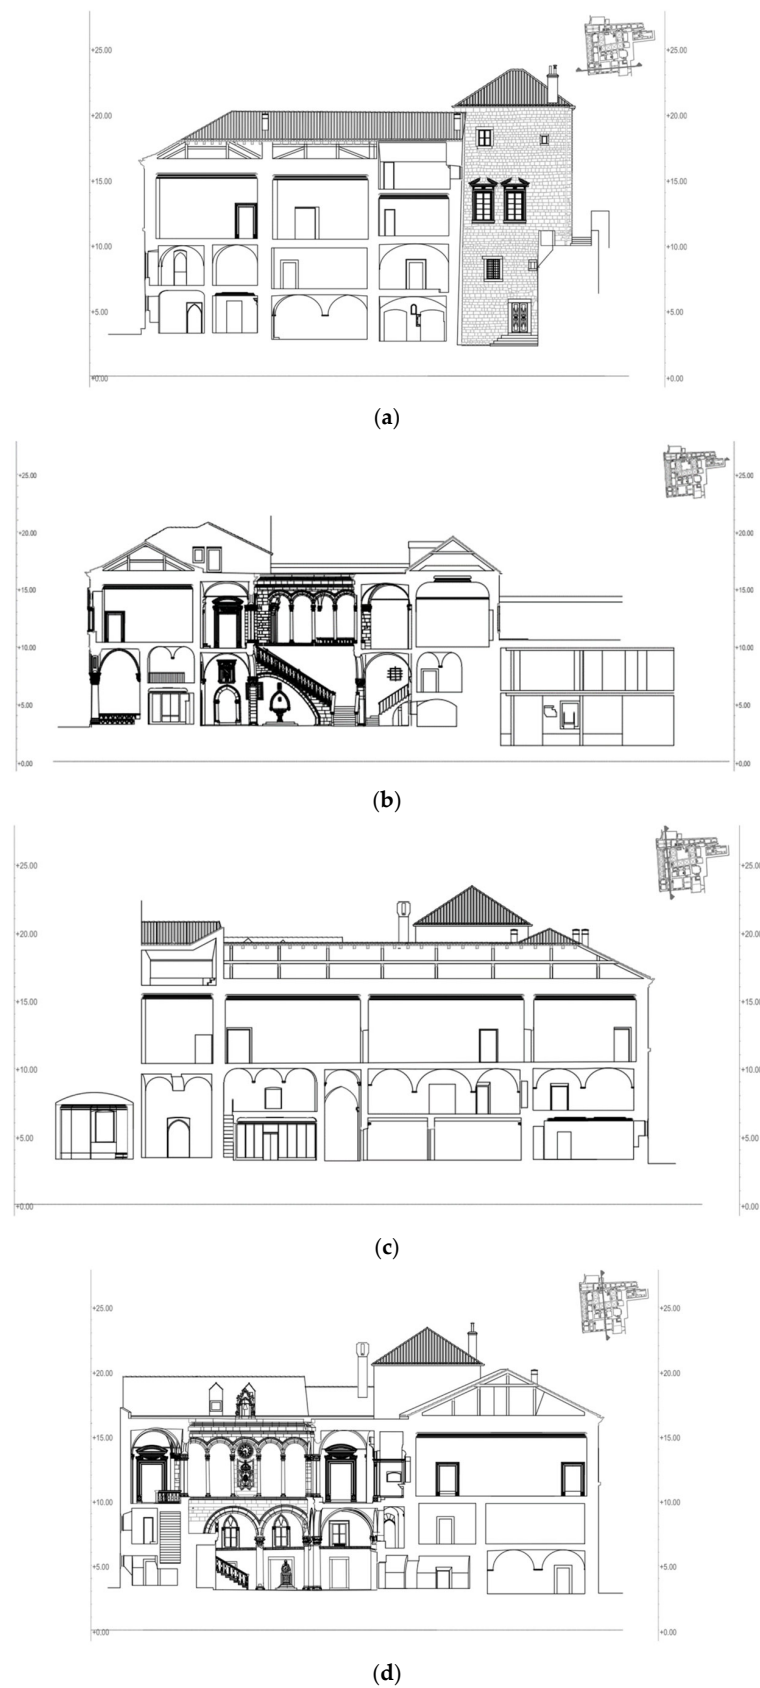
Figure 7. Selected cross-sections of the Rector's Palace: (a) "2-2"; (b) "3-3"; (c) "6-6"; (d) "9-9" as specified in original architectural drawings (courtesy of the Institute for the Restoration of Dubrovnik).
