Seismic Assessment of a Modernist Building in Sarajevo, Bosnia and Herzegovina

Abstract: This paper presents an in-depth analysis of the Kopčić House, a significant example of modernist architecture in Sarajevo, Bosnia and Herzegovina, focusing on its structural-specific features and seismic performance. The Kopčić House embodies a confined masonry structure with innovative construction features, combining load-bearing masonry walls with reinforced concrete elements. This architectural approach was pioneering for its time, combining traditional construction methods with innovative materials and techniques. Detailed analysis using numerical modeling techniques, specifically 3D modeling with the 3Muri software (Vers.14.2.0.4), was conducted to assess the seismic resilience of the structure. The analysis considered different load distributions and eccentricities to comprehensively evaluate the building's response to lateral forces. The findings of this research reveal the structural capacity and potential vulnerabilities of the Kopčić House when subjected to seismic events. While the building demonstrates inherent strength due to its confined masonry design, areas requiring structura

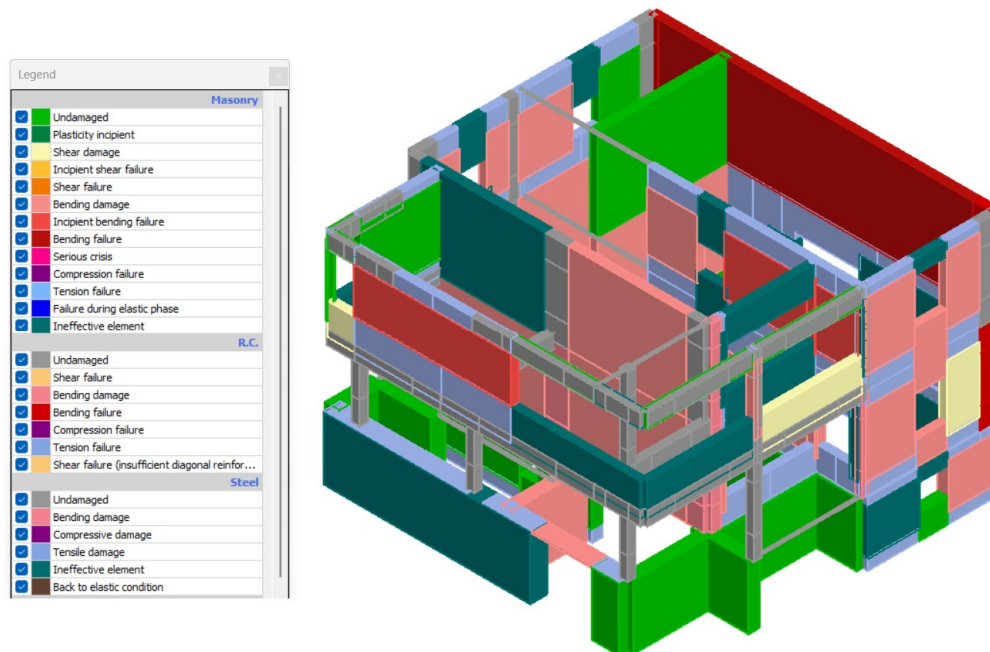
Figure 13. Damage of the structure during analysis No. 23.

In Figure 13, the damage incurred by the structural elements under loading case 23 (+Y-direction) is depicted, revealing a vulnerability index of 0.632. This index indicates a capacity of only 63.2%, highlighting significant structural vulnerability. Upon closer examination in the final step of the analysis, predominant damages are observed around the structural openings, primarily manifested as bending failures. Furthermore, evidence of shear damage and bending failure is observed within the “reinforced walls”, further emphasizing the structural challenges encountered. In the masonry walls, signs of incipient bending failure gradually progress to full bending failure, particularly pronounced along the outer longitudinal wall parallel to the street façade. Additionally, on the first floor, shear damage is evident, particularly notable around the balcony area.

This comprehensive evaluation of Figure 13 underscores the complex array of structural vulnerabilities presented across various elements under loading case 23. The observed damages provide valuable insights into the structural performance under applied loads, emphasizing the importance of mitigation strategies in enhancing structural resilience.

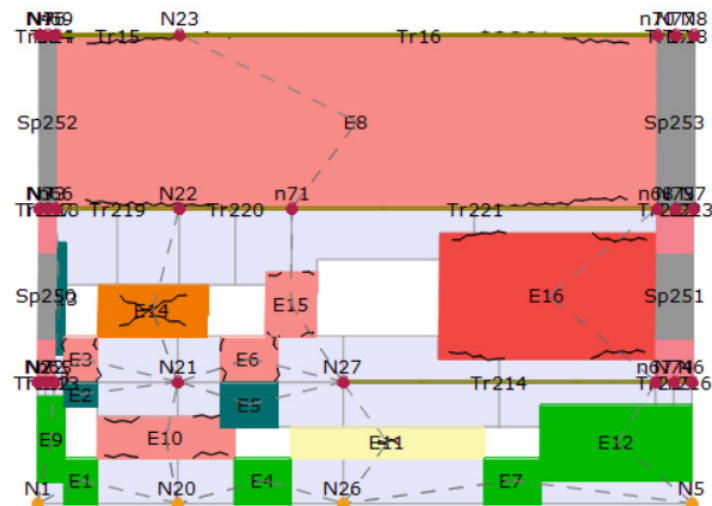
Figure 14. Damage of the wall during analysis no. 11.

The structural vulnerabilities are demonstrated in the form of apparent damage to various structural elements, as delineated by Figure 14. Notably, the “reinforcement walls” and tie-columns exhibit discernible signs of bending damage, indicative of structural

distress and compromised load-bearing capacity. Furthermore, the masonry walls display evident indications of bending damage, particularly around openings, progressing to incipient bending damage in localized regions. Additionally, instances of shear damage and even shear failure are observed in select locations, further emphasizing the structural vulnerabilities and susceptibility to loading-induced damage.
