Study on Effectiveness of Regional Risk Prioritisation in Reinforced Concrete Structures after Earthquakes

Journal article, Published version

Abstract: Depending on the characteristics of the existing buildings, earthquakes can cause damage at different levels and have a significant impact on the environment. The structural damages after the earthquakes have shown the importance of analysing both the existing and the damaged buildings. In this study, the Turkish rapid seismic assessment method, which was used for the existing building stock before a possible earthquake, was applied to the damaged reinforced concrete (RC) buildings after the 6 February earthquakes in Kahramanmaraş (Türkiye). The building data were used as a result of field observations in the provinces of Adıyaman, Hatay, and Kahramanmaraş, where the greatest destruction was caused by these earthquakes. Five RC buildings from each province were considered. The rapid assessment method was applied to a total of 15 buildings with different levels of damage. For this purpose, pre-earthquake images of the buildings were obtained, and an earthquake performance score was obtained for each building, taking into account th

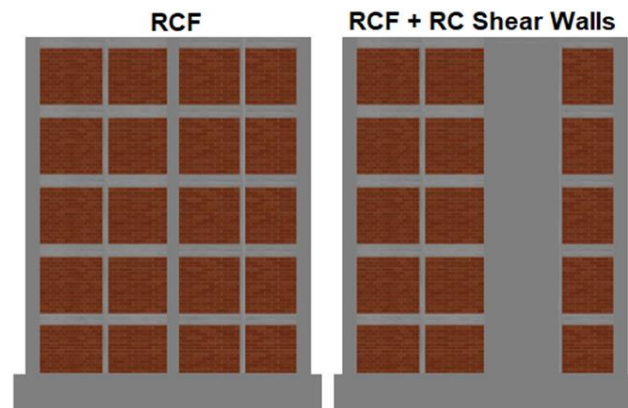
Figure 2. Types of the structural systems for the RC buildings.

Type of the structural system: It is the first parameter taken into consideration, and one of the reinforced concrete frame (RCF) and reinforced concrete frame + RC shear walls (RCF + RC Shear Walls) systems is selected as the load-bearing system of the building. Here, an additional structural system score is added, taking into account the effect of RC shear walls in resisting earthquake loads. If this situation cannot be detected, it would be appropriate to choose RCF. Schematic representations for these two different structural systems are shown in Figure 2.

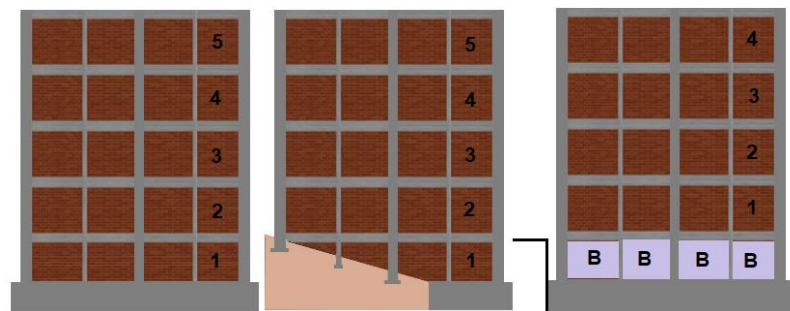
Figure 3. Determination of the number of storeys in RC structures.

Total number of storeys: It is the total number of storeys in a building, which is one of the causes of damage in earthquakes. In the method, the number of free storeys is determined in line with the principles given schematically in Figure 3.

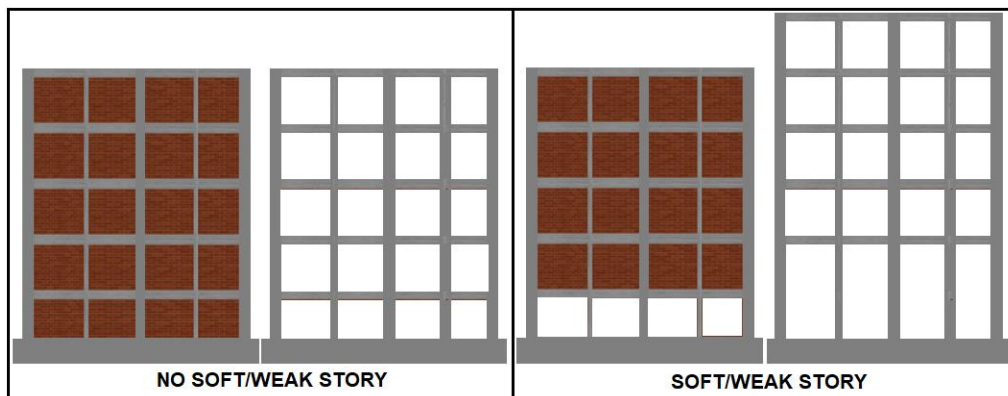
Figure 4. Detection of soft/weak storey in RC structures.

Soft/weak storey: It is determined observationally, taking into account the difference in storey height as well as the significant stiffness difference between storeys. Situations to be taken into account for determining the soft/weak-storey situation are shown in Figure 4. The concept of the relatively soft/weak storey is mentioned here. It should not be forgotten that detailed structural analyses are required to clearly reveal this situation in any structure.

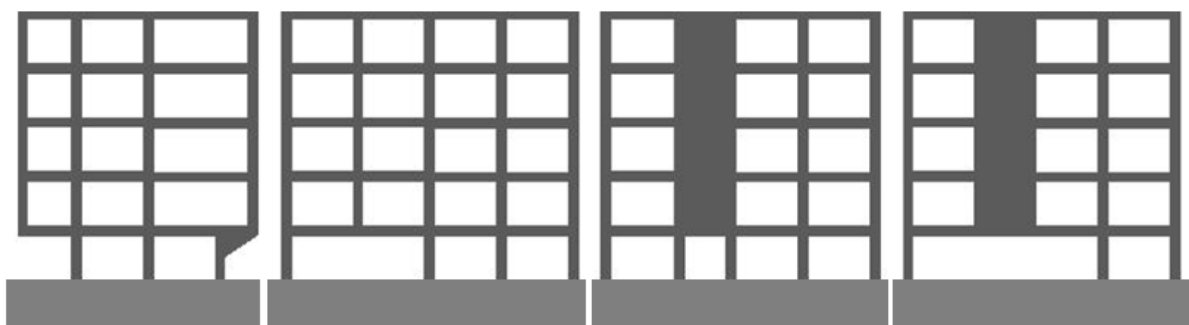
Figure 5. Vertical irregularities in RC structures.

Vertical irregularity: It is taken into account to reflect the effect of vertically discontinuous frames and changing storeys areas. Columns or shear walls that do not continue along the height of the building create vertical irregularities. The detection of vertical irregularity is shown in Figure 5.

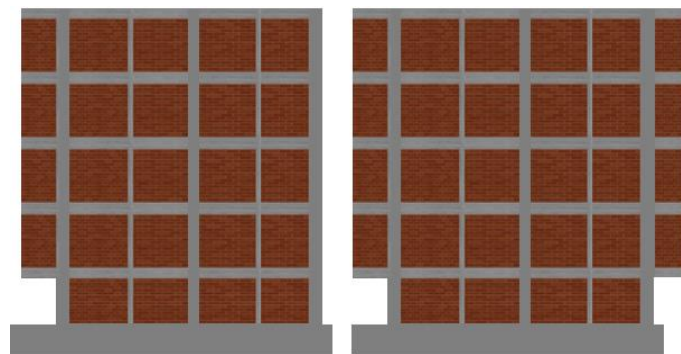
Figure 6. Detection of heavy overhangs in RC structures.

Heavy overhangs: The difference between the floor area on the ground and the floor area above the ground will be determined. The detection of heavy overhang is shown in Figure 6.

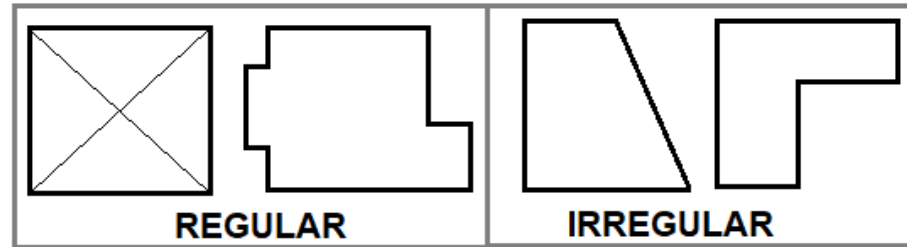
Figure 7. Determination of plan irregularities in RC structures.

Irregularity in plan/torsion effect: It is defined as the plan not being geometrically symmetrical and the vertical structural elements being placed irregularly. Plan irregularities that may cause torsion in the building are taken into account. Detection of irregularity in the plan is shown in Figure 7.

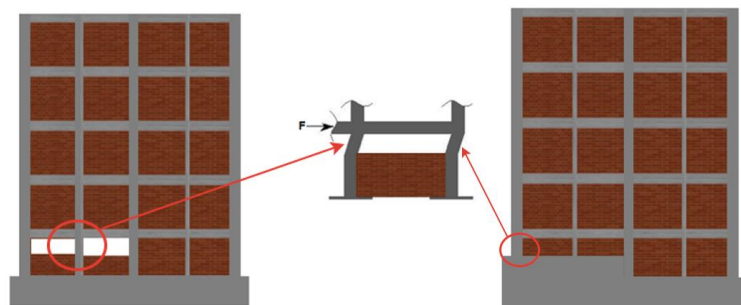
Figure 8. Short column effects in RC structures.

Short column: At this stage, only short columns that can be observed from outside will be taken into account in the evaluation. The determination of the short column situation that may occur due to changing column heights for different reasons is shown schematically in Figure 8.

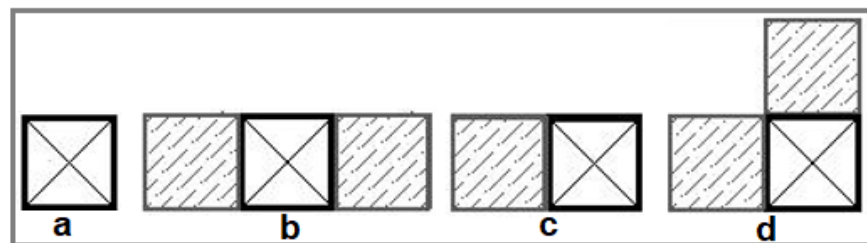
Figure 9. The status of adjacent buildings (a) isolated, (b) middle, (c) corner, (d) corner.

Building status/storey levels with adjacent buildings: The locations of adjacent buildings can affect earthquake performance due to collision. Buildings located on the edge are most negatively affected by this situation, and this negativity increases even more if the

floor levels of the adjacent building are different. Situations where the impact of a collision occurs will be determined by external observations. The building order status and the floor level status of adjacent buildings will be evaluated together. Determination of the building order is shown in Figure 9.

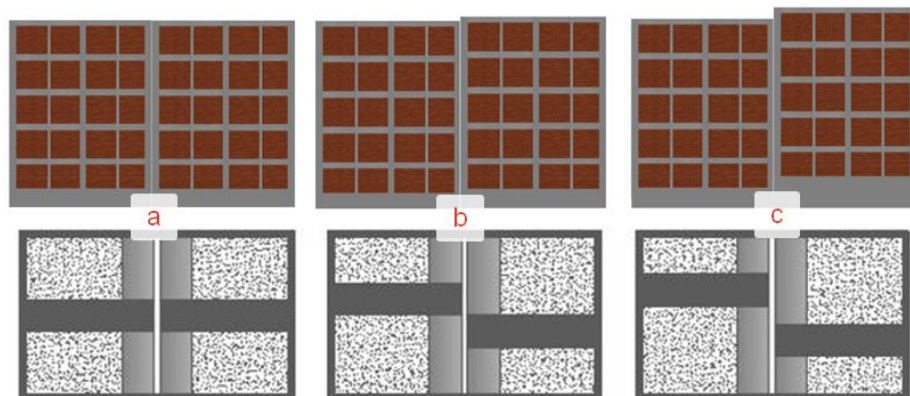
Figure 10. Detection of floor level change in adjacent buildings (a) same, (b) limit(same), (c) different.

Since the impact of the collision will depend on the relationship of the floors of the neighbouring buildings to each other. The method also requires the determination of the floor levels of the adjacent buildings. Situations to be taken into account in the interaction of floors in adjacent buildings are shown in Figure 10.

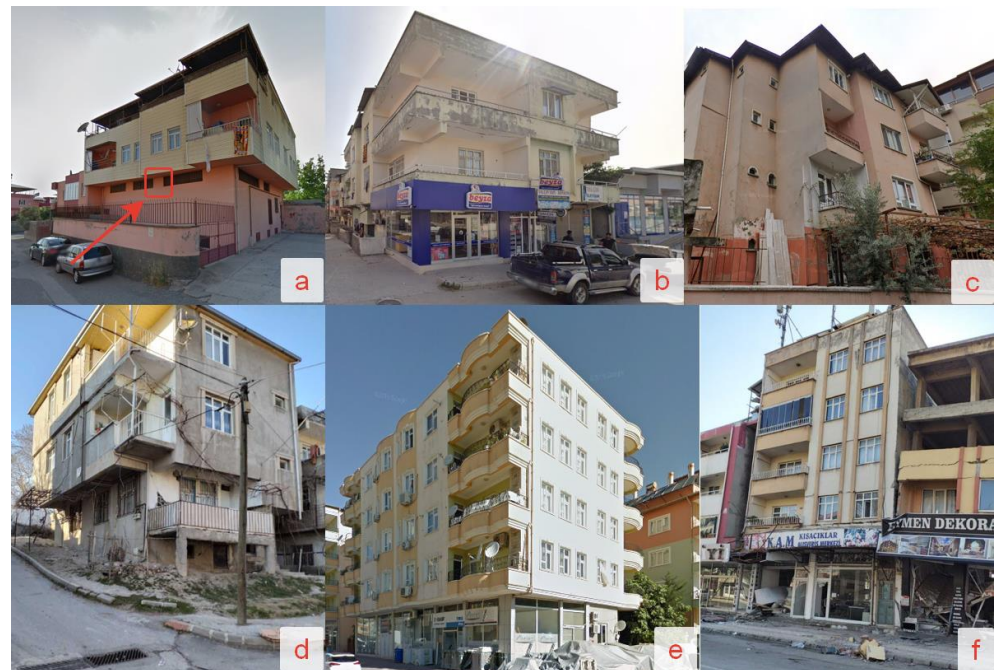
Figure 11. (a) Short column, (b) soft/weak storey, (c) plan irregularity, (d) hill/slope effect, (e) heavy overhang, (f) adjacent buildings.

Application examples of the parameters considered in this study on the existing building stock in the earthquake region are shown in Figure 11. Google Street [72] was used to obtain images.

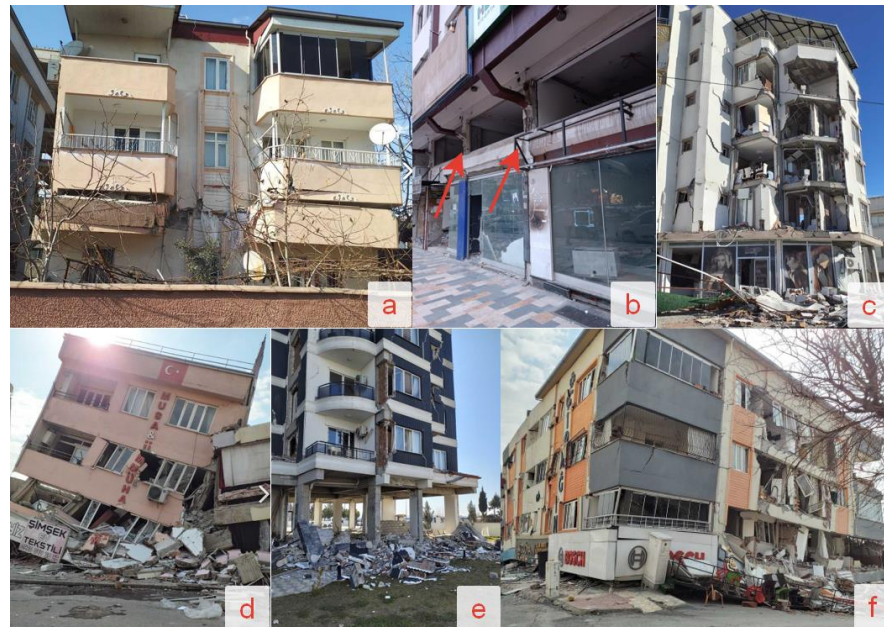
Figure 13. (a) Soft/weak-storey damage caused by mezzanine, (b) structural damage caused by short column, (c) example of damage caused by irregularity in plan, (d) example of damage caused by collision, (e) example of damage caused by heavy overhangs, (f) soft/weak-storey damage example caused by ground story.

Examples of structural damage that occurred in RC structures as a result of the presence of one or more of these parameters as a result of field observations are shown in Figure 13.

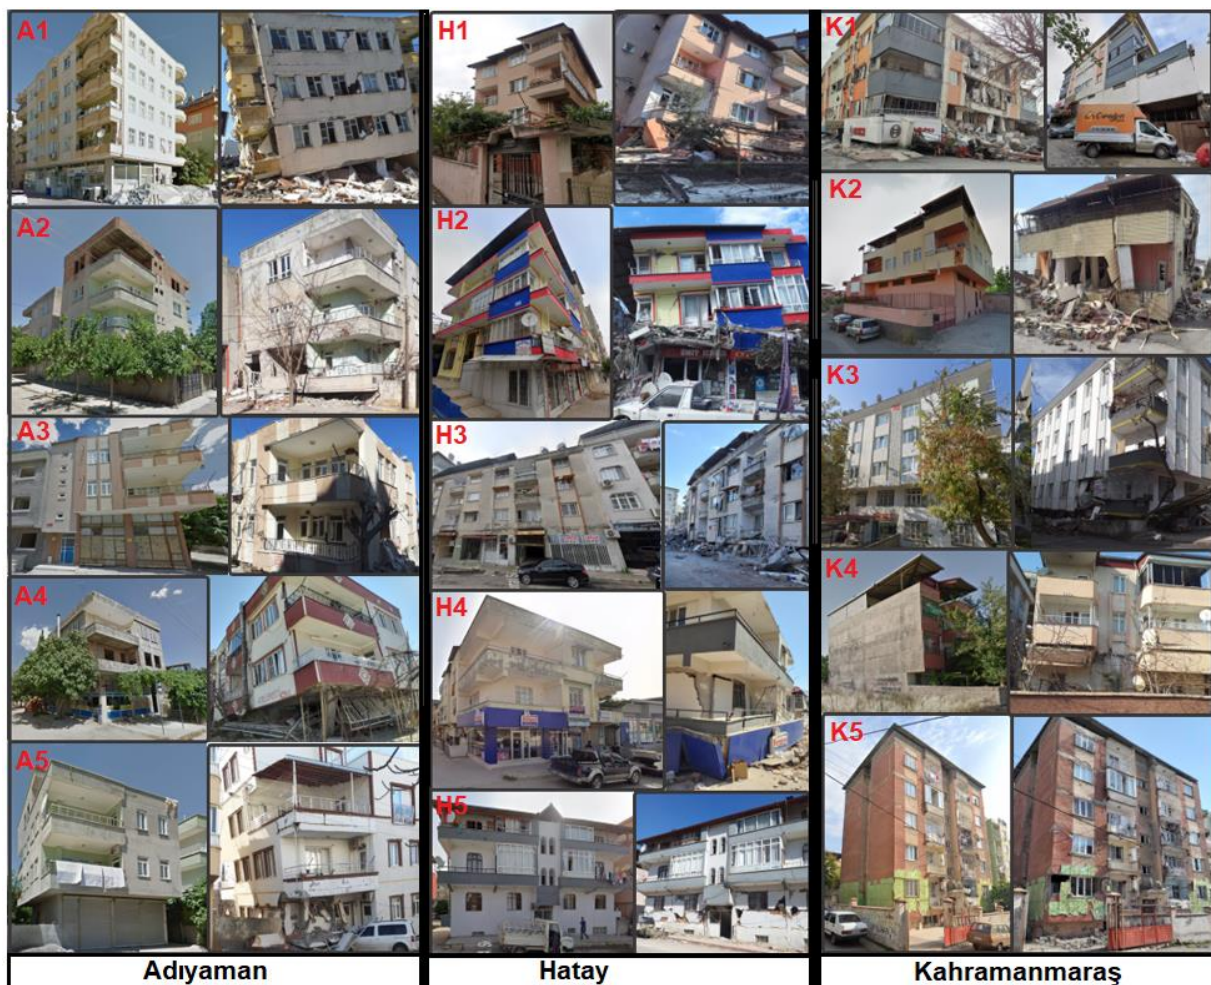
Figure 14. Before and after earthquake images of the RC structures. (RC structures examined in Adiyaman between A1–A5; in Hatay between H1–H5 and in Kahramanmaraş between K1–K5).

Within the scope of the study, five RC building examples taken into consideration from Adiyaman, Hatay, and Kahramanmaraş, the three provinces most affected by earthquakes, are shown in Figure 14. To compare the damage conditions obtained as a result of field investigations, pre-earthquake images of these buildings were obtained with the help of the Google Street application [72].

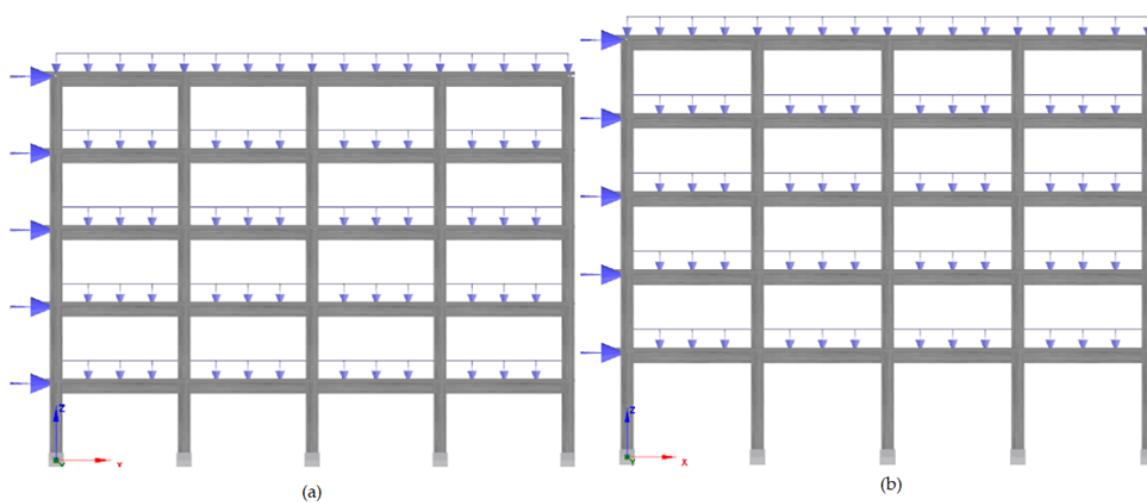
Figure 16. Two-dimensional models of sample RC buildings. (a) Same storey height, (b) different ground storey height.

In the 12 reinforced concrete buildings taken into account in the field observations, great destruction occurred as a result of the complete collapse of the ground storey. This situation, which is called relatively soft-storey damage, can generally occur for different reasons. One of the reasons for such damage is that the ground storey height is higher than the other storeys. In this part of the study, separate structural analyses were carried out for the sample RC building model for all three provinces, in case the storey height was the same throughout the entire building. Afterwards, the structural analyses were performed for the three provinces by selecting the ground storey height as higher than the other storeys, respectively. Structural analyses were carried out separately for each city and different storey heights with Seismostruct software [74]. Pushover analyses were performed by averaging the *PGA*'s obtained for five different locations for each province. The *PGA* was 0.436 g for Adıyaman, 0.882 g for Hatay, and 0.707 g for Kahramanmaraş. The reference RC building model is five storeys and the story heights are equal and 3 m. The building model consists of four openings, chosen symmetrically in both directions. Each span was chosen as 5 m in both directions. The 2D models obtained for the sample RC structure are shown in Figure 16. In order to make comparisons, in the other RC building model, the ground storey height was chosen as 4 m, and the other storey heights were equal and 3 m.

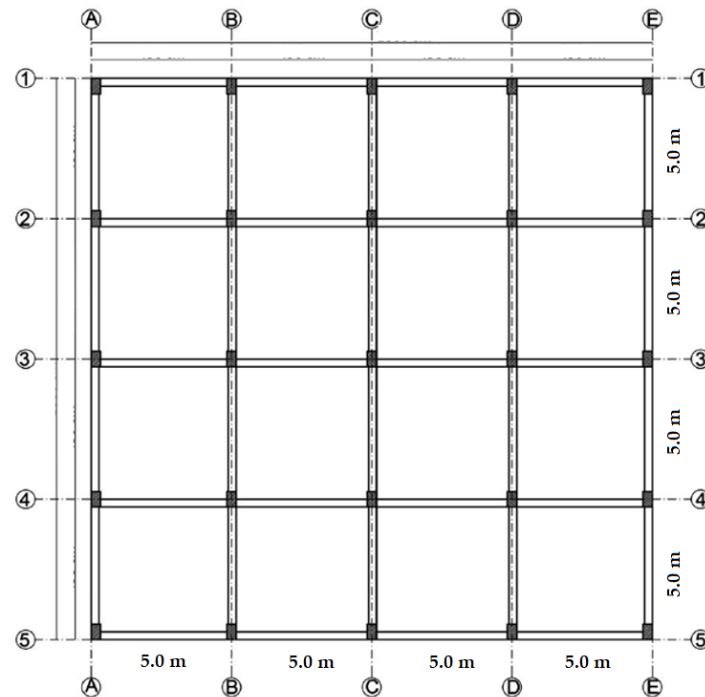
Figure 17. The blueprint of the sample RC building model.

infrmFBPH (force-based plastic hinge frame elements) were used for structural elements such as beams and columns in all structural models. Plastic-hinge length (L_p/L) was selected as 16.67%. The boundary conditions of the column were set in accordance with the cantilever boundary conditions, which resulted in a fully fixed column footing and a free top end. The boundary condition of the footings was fixed on the ground. The blueprint of the sample RC building model is shown in Figure 17. Building storey plans were taken using the same method from all structural analyses. There are two different variables in the analysis: storey height and PGA . All other chosen structural characteristics are the same. The axes in the X and Y directions are shown as 1–5 and A–E.
