Project 3 - Evaluation of seismic performance of a template design RC school building before and after strengthening

Source / Izvornik: **Model Validation and Simulation, 2013, 309 - 318**

Project 3 — Evaluation of seismic performance of a template design RC school building before and after strengthening

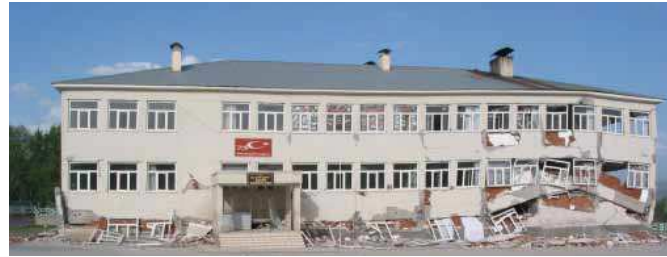
Figure 3 — Damage of a school building caused by the 1st May Bingöl earthquake [2]

The magnitude 6.6 Bingöl (Türkiye) earthquake on May 1, 2003 caused severe damages and collapse to school buildings (see Figure 3). The comparison of the general layouts from the damage structures and the study object indicates the representativeness of the studied object and provides the opportunity to adopt the experiences from the Bingöl earthquake to the study area Antakya. Thus, the results of the damage prognosis can be compared with the observed damages on school building with a nearly identical (template) design for a known seismic action.
