Project 3 - Evaluation of seismic performance of a template design RC school building before and after strengthening

Source / Izvornik: **Model Validation and Simulation, 2013, 309 - 318**

Project 3 — Evaluation of seismic performance of a template design RC school building before and after strengthening

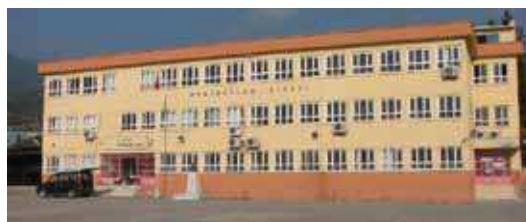
Figure 1 — Front view of the study object [1]

The aim of the project was to introduce the participants into advanced requests in the field of earthquake engineering. The studies were concentrated on a template design RC school building (Figure 1), which revealed low seismic resistant in the past earthquakes in Turkey. Therefore the Turkish Government started after the damaging events in 1999 a campaign to investigate and strengthen these buildings all over Turkey.

The considered school building is one of three school buildings in Hatay (Turkey), which could be dynamically investigated before and after strengthening. It is a 3-story RC frame structure building and was constructed in 1997 according to the 1972 earthquake design code (see Fig. 1).

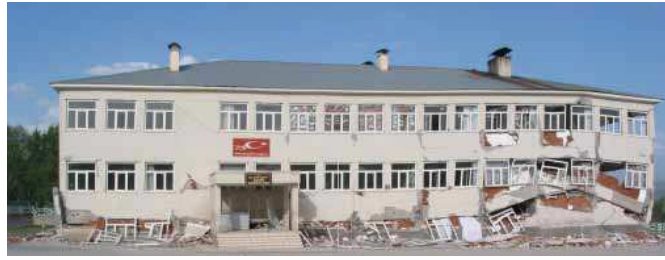
The magnitude 6.6 Bingöl (Türkiye) earthquake on May 1, 2003 caused severe damages and collapse to school buildings (see Figure 3). The comparison of the general layouts from the damage structures and the study object indicates the representativeness of the studied object and provides the opportunity to adopt the experiences from the Bingöl earthquake to the study area Antakya. Thus, the results of the damage prognosis can be compared with the observed damages on school building with a nearly identical (template) design for a known seismic action.

Figure 3 — Damage of a school building caused by the 1st May Bingöl earthquake [2]

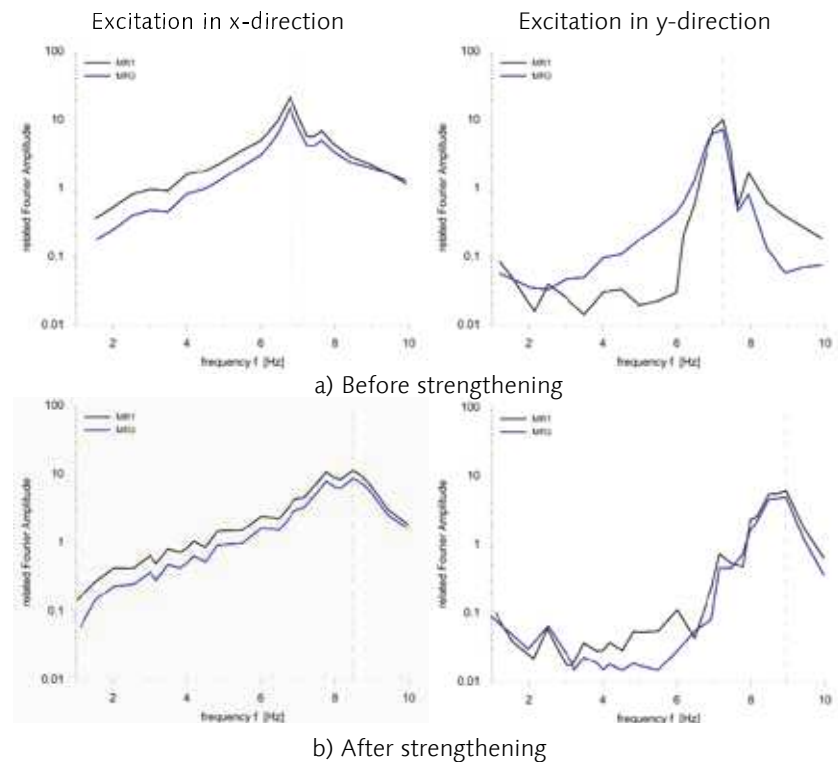
Figure 6 show the normalized FFT response values from the sensor MR1 and MR3 in x- and y-direction before and after strengthening; the normalization accounts for different amounts of weights which were used during the measurements to cover the whole frequency band [3]. Especially in the case without strengthening clear peaks can be determined, which indicate the highest amplification of the introduce signal due to the resonance to the natural frequencies of the building in each direction.

Figure 6 — Recorded building response (normalized FFT Amplitude) at Sensor MR1 and MR3 for excitation in x- and y- direction
