The Zagreb (Croatia) M5.5 Earthquake on 22 March 2020

Abstract: On 22 March 2020, Zagreb was struck by an M5.5 earthquake that had been expected for more than 100 years and revealed all the failures in the construction of residential buildings in the Croatian capital, especially those built in the first half of the 20th century. Because of that, extensive seismological, geological, geodetic and structural engineering surveys were conducted immediately after the main shock. This study provides descriptions of damage, specifying the building performances and their correlation with the local soil characteristics, i.e., seismic motion amplification. Co-seismic vertical ground displacement was estimated, and the most affected area is identified according to Sentinel-1 interferometric wide-swath data. Finally, preliminary 3D structural modeling of the earthquake sequence was performed, and two major faults were modeled using inverse distance weight (IDW) interpolation of the grouped hypocenters. The first-order assessment of seismic amplification (due to site conditions) in the Zagreb area for the M5.5 earthquake shows that ground motions of approximately 0.16–0.19 g were amplified at l

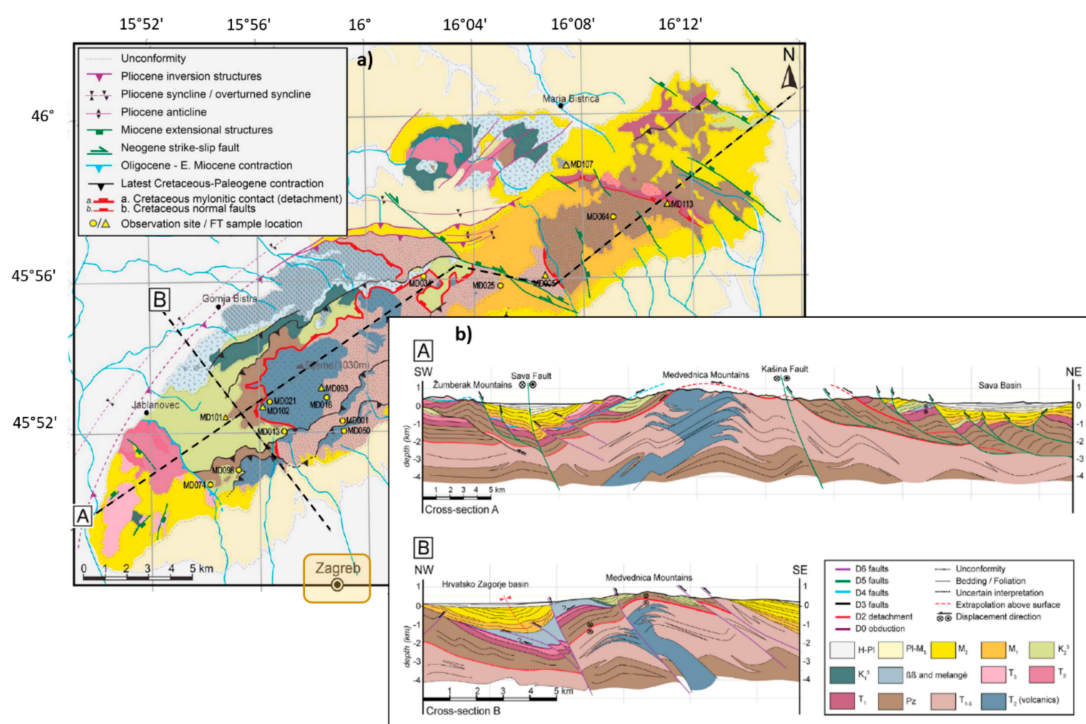
Figure 1. (a) Geological map of the Medvednica Mountains. The map shows the location of the cross-sections A and B; (b) Cross-sections across the Medvednica Mountains: (A) longitudinal (SW–NE) and (B) transversal (NW–SE) (after [11]).

The Medvednica Mountains are composed of a Paleozoic to Mesozoic metamorphic core overlain by non-metamorphic Mesozoic and Cenozoic rocks ([13–15]; Figure 1a). All units are truncated by normal and reverse faults and are surrounded by the Miocene–Quaternary deposits of the Pannonian Basin.

Using the previously described methodology, a primary fault plane was modeled (Fault 1) based on the dataset containing 45 hypocenters, including most of the highest magnitude events in the Zagreb 2020 earthquake sequence. The fault is characterized by an orientation similar to the southeast-dipping instrumentally calculated fault-plane solutions of the main shock and the strongest aftershock (Figure 4). The rupture along Fault 1 propagated towards the northwest, apparently along a deep-rooted southeast-dipping thrust fault (125/31, dip direction/dip angle). The thrust fault can be projected to the surface where it virtually appears in the central part of the Hrvatsko Zagorje basin (Figures 1b and 13).

A system of south-dipping longitudinal reverse faults has been mapped on the surface along the Medvednica Mountains [15] and interpreted in one of the latest tectonic models as the youngest (Pliocene to Quaternary) system of reverse faults ([11]; Figure 1) that are probably still active [7]. The reverse slip of the primary ruptured fault (Fault 1) of the Zagreb 2020 earthquake sequence (Figure 13; Supplement 1) generally corresponds to the frontal reverse fault striking along the northern foothills of the mountain (Figure 1b). However, the interpreted steep frontal reverse fault does not match the modeled gently inclined primary fault that is here interpreted as a thrust fault (Figure 13). Thus, a fault that could accommodate such a movement is probably a southeast-dipping thrust fault that completely dissects the basement of the central part of the Medvednica Mountains. This master thrust could represent a basal detachment (décollement) of the system of steeper reverse faults striking along the Medvednica Mountains. It could be steeper in the frontal part and thus could match the North Medvednica reverse fault, or it could be buried below the Neogene Hrvatsko Zagorje basin (Figure 1b; Figures 12 and 13).

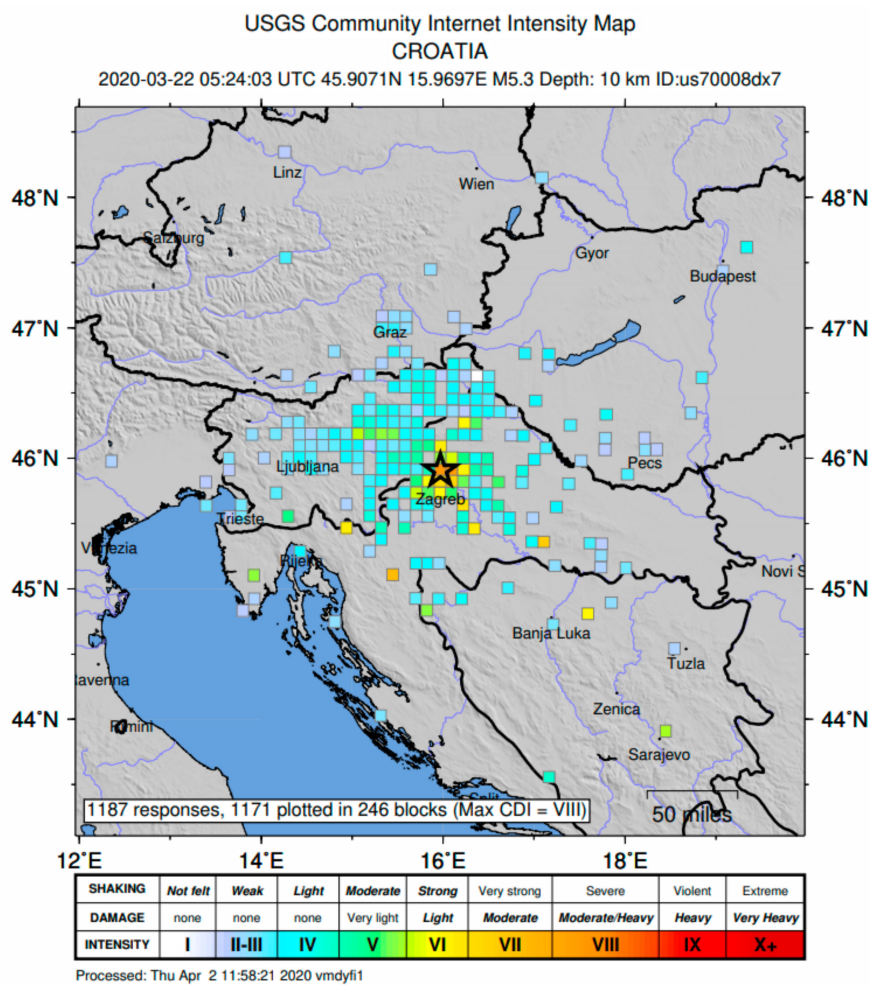
Figure 3. Intensity map according to data collected by USGS [19].

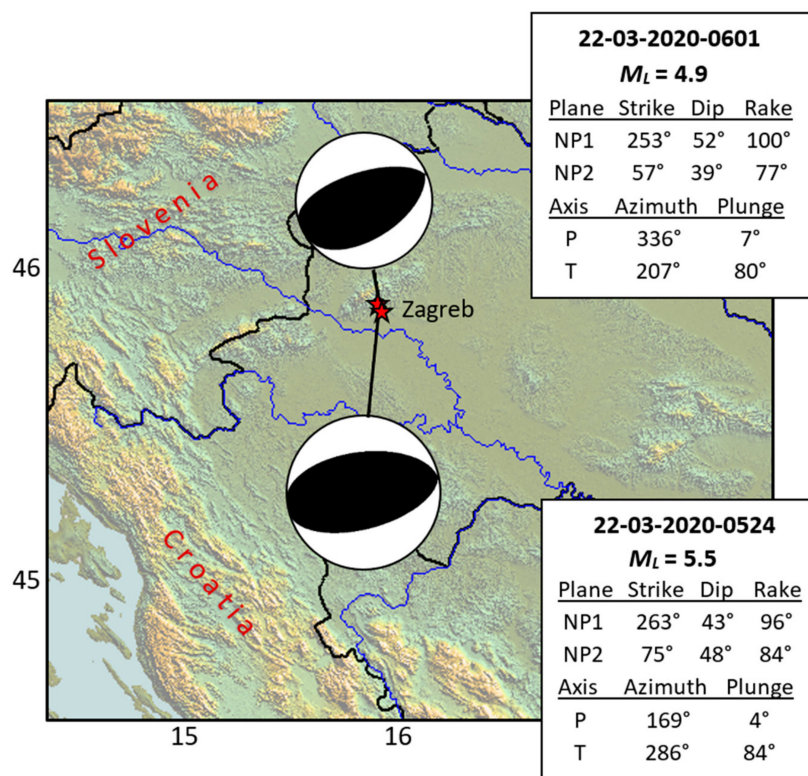
The fault-plane solution of the main shock indicates that the earthquake occurred on a reverse fault whose fault plane dips at an angle of 43° to the south-southeast or at an angle of 48° to the north-northwest. The axis of maximum tectonic pressure (P) was horizontal and in the SSE-NNW direction, while the axis of maximum tension (T) was almost vertical. The calculated fault mechanisms will be described in greater detail in Section 4.5 and linked to the geological features of the study area.

Figure 4. Fault-plane solutions of 22 March 2020 earthquakes at 05:24 UTC and 06:01 UTC. The focal sphere is shown in stereographic projection.

Based on the analysis of data recorded in Croatia and around the world (waveform data taken from the USGS National Earthquake Information Center [20]), the focal mechanisms of the main earthquake and the strongest aftershock were calculated (Figure 4).

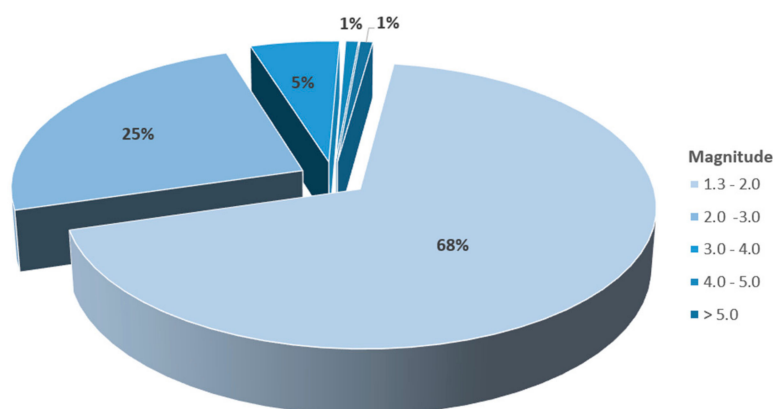
Figure 5. Percentage of earthquakes of each magnitude interval that occurred in the epicentral area of the Zagreb earthquake in the period from 22 March to 1 April 2020.

Since no one knows how much accumulated energy is released through a main earthquake, the aftershock activity is normal and not uncommon. Figure 5 presents the number of earthquakes of a certain magnitude (greater than 1.3) that occurred after the main earthquake of 22 March 2020 at 05:24 UTC.

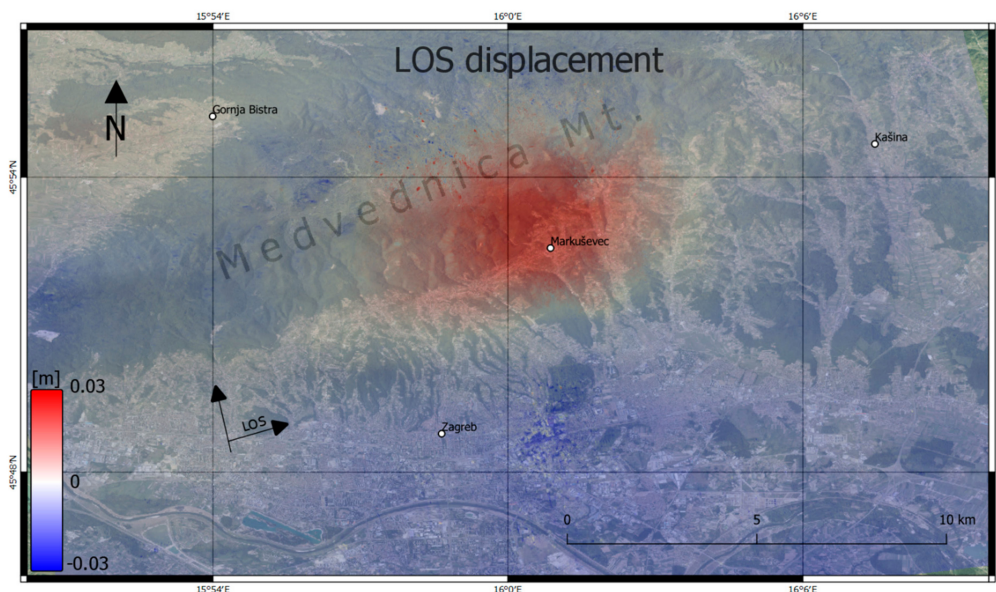
Figure 11. Unwrapped interferogram map indicating co-seismic line-of-sight (LOS) deformation of the 22 March 2020 earthquake.

The observed co-seismic deformation implies an approximately 3 cm uplift of the epicentral area that covers approximately 20 km².

Two Sentinel-1A IW SLC images were processed to derive the co-seismic surface deformation at the Medvednica Mountains (Table 1). Space-borne SAR data are available on the Sentinel data hub [67]. The co-seismic displacement was investigated using differential interferometric synthetic aperture radar (DInSAR) technique [68]. The estimation of earthquake strength was based on the determination of the differential phase angle between two SAR images taken from almost the same satellite position at different times. The differential interferogram was filtered by relevant coherence (>0.2). Interferogram coherence values were moderate on average (0.46), although the affected area is covered with thick vegetation. Time series processing and post-earthquake analysis using radar interferometry were performed with the open-source Sentinel Application Platform (SNAP). Deformation was referenced with the line-of-sight (LOS) direction from radar. The LOS data were acquired by merging different swath phases and then unwrapped using SNAPHU (Statistical-Cost Network-Flow Algorithm for Phase Unwrapping). The results of co-seismic deformation were geocoded to a WGS84 geographic coordinate system (Figure 11). Figure 11 shows an unwrapped interferogram from which it is possible to identify the most affected area.

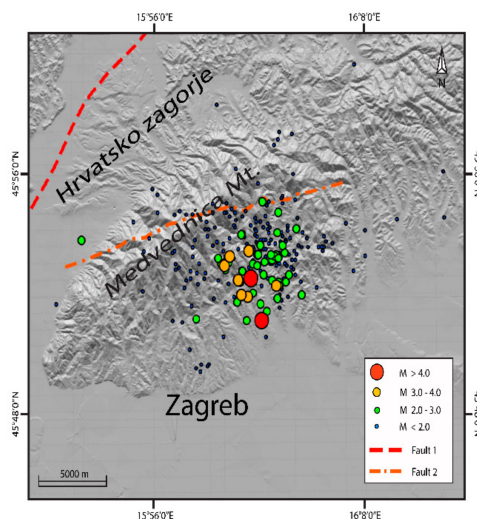
Figure 12. Spatial distribution of earthquake epicenter locations in the period from 22 March to 1 April 2020 (the Zagreb 2020 earthquake sequence). Fault lines are simple projections of the two modeled fault plains from the deep subsurface of the Medvednica Mountains to the surface (see Supplement 1 and Figure 13).

A set of 257 measurements was analyzed both spatially and temporally and processed for import into geological 3D modeling software. To achieve better visual insight, the hypocenters were scaled based on magnitude values (M_L) into four intervals: <2.0, 2.0–3.0, 3.0–4.0 and >4.0 (Figure 12).
