Source / Izvornik: **Geosciences, 2020, 10**

The Zagreb (Croatia) M5.5 Earthquake on 22 March 2020

Keywords: Zagreb earthquake; Medvednica Mountains; seismicity; amplification; structural modeling; building damage

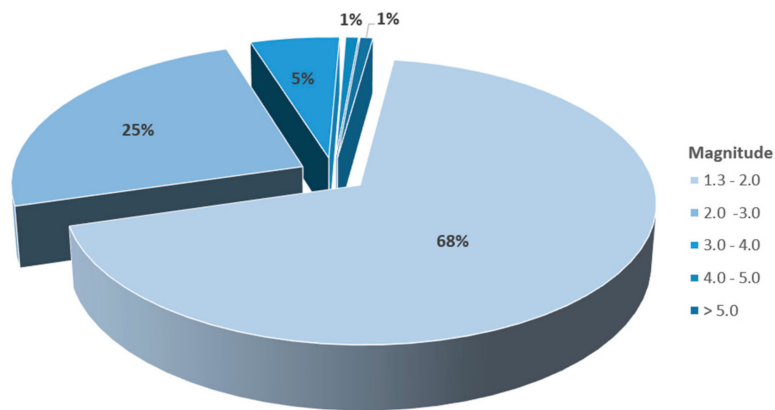
Since no one knows how much accumulated energy is released through a main earthquake, the aftershock activity is normal and not uncommon. Figure 5 presents the number of earthquakes of a certain magnitude (greater than 1.3) that occurred after the main earthquake of 22 March 2020 at 05:24 UTC.

Figure 5. Percentage of earthquakes of each magnitude interval that occurred in the epicentral area of the Zagreb earthquake in the period from 22 March to 1 April 2020.
