Source / Izvornik: **Buildings, 2019, 9**

Locating Hidden Elements in Walls of Cultural Heritage Buildings by Using Infrared Thermography

Keywords: cultural heritage buildings; nondestructive testing method; passive thermography; active thermography

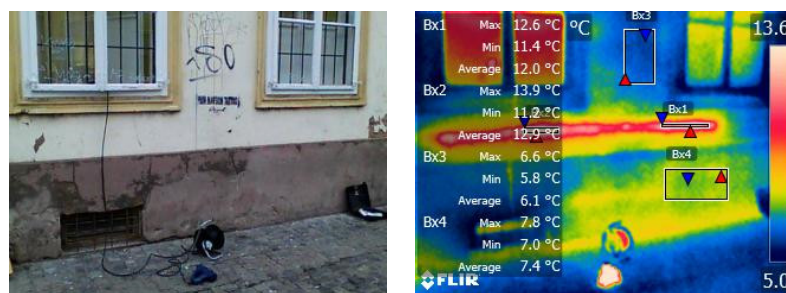
Figure 20. Homogeneous thermal pattern on excitation along the wall.

There was not any discontinuity by the analysis of the thermal pattern change. In Figure 20, a linear trace of the heating body, which is continuous and uninterrupted, can be observed.

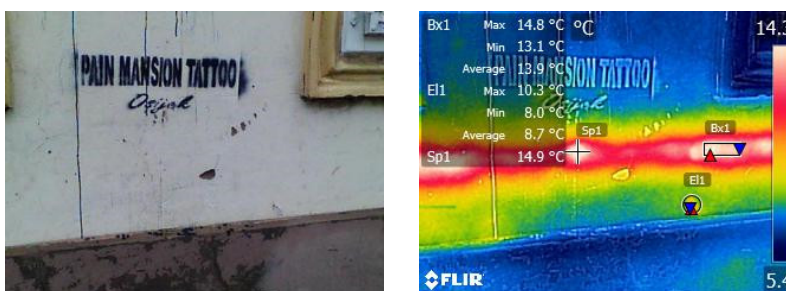
Figure 21. Influence of damage to the thermal pattern.

The detail below the left window in the lower left corner of the thermogram reveals that spot facade damage, due to a difference in emissivity, shows a higher apparent temperature (Figure 21).

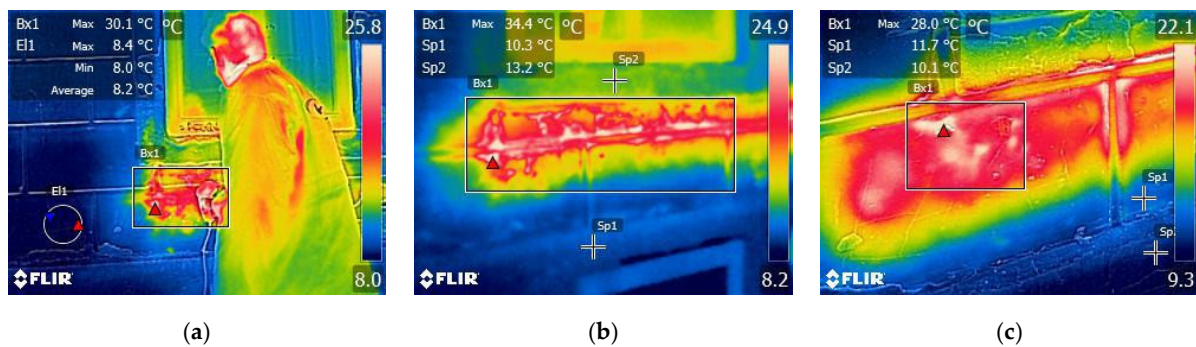
Figure 25. Changing the thermal pattern due to heating.

By analyzing the thermal pattern shown in Figure 24, the difference in the probing area, as a result of the difference in emissivity, is evident. The expected discontinuity observed by probing did not appear during the heat excitation of the parapet wall (Figure 25a). As can be seen from Figure 25b, a further line heating process raised the wall temperature but did not result in a change in the thermal pattern. During the heating and during the time, the thermal pattern seemed to be inhomogeneous, albeit in a manner that corresponds to the presence of moisture, rather than non-discontinuity in the structural elements. By analyzing the smaller parts of the wall, no additional information (as shown in Figure 25c) was obtained.
